Report on the Shaw House, 33 Synge Street, Dublin 8.

Appendix 1 - Notes on Inspection of 33 Synge Street, GB Shaw Birthplace

Appendix 2 – Engineer’s Report

Re: No. 33 Synge Street – Shaw birthplace

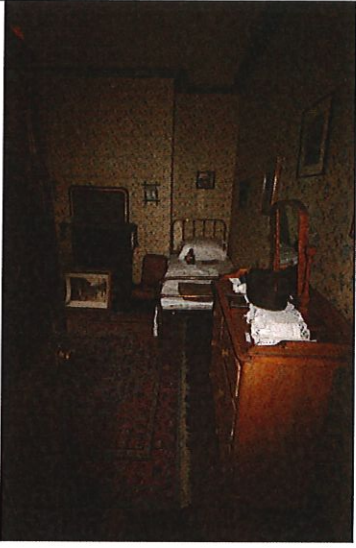
I have made a reference to springy floors and undersize floor joists. This is not unusual in such buildings, and would not need any intervention unless a change of use requires greater load capacity in the floors.

| | Photograph | Location | Comment |
|--|---|---|--|
| | | Nursery (Rear GF) | Floor slightly springy indicating undersize floor joists |

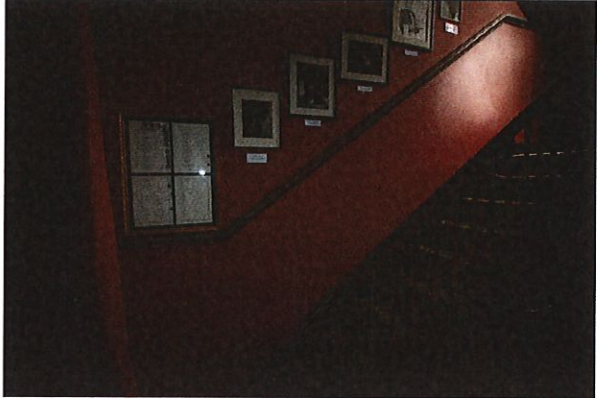
| | Photograph | Location | Comment |
|--|---|--|--|
| | | <p>Hall Former water damage top left</p> | |

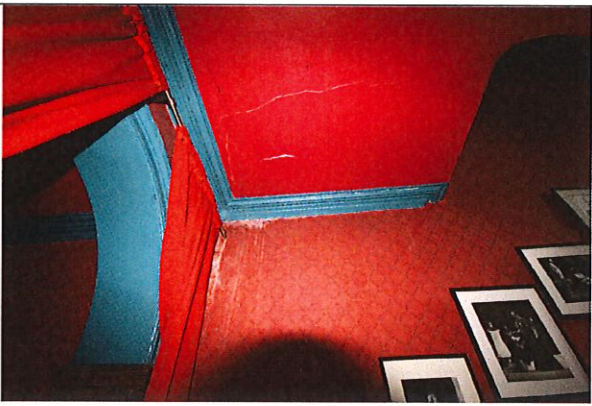
| | Photograph | Location | Comment |
|--|---|--|--|
| | | <p>Hall Former water damage top left</p> | <p>Damp meter indicates drying out</p> |

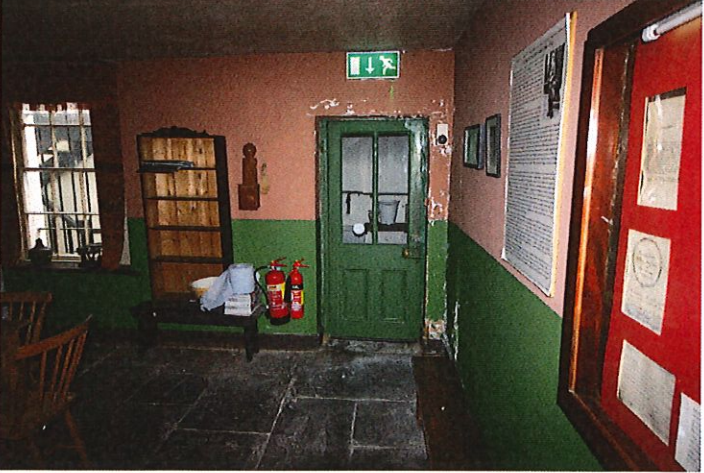
| | Photograph | Location | Comment |
|--|--|--|---|
| | | <p>Lower Ground floor to front – kitchen</p> | <p>Note previous dampness around rear door (under external front steps)</p> |

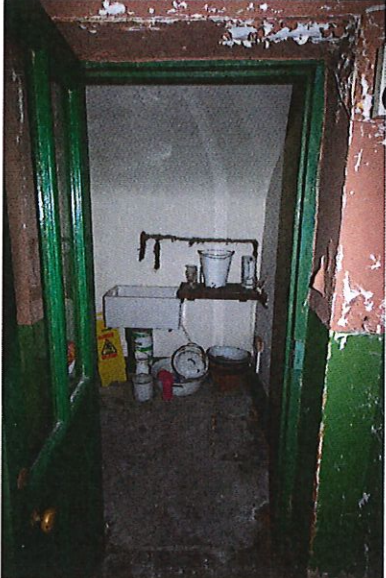
| | Photograph | Location | Comment |
|--|---|---|---|
| | | <p>Porch under front steps</p> | <p>Note damage to finishes caused by dampness</p> |

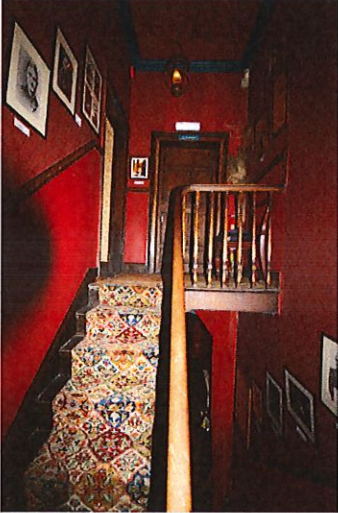
| | Photograph | Location | Comment |
|--|---|--|---|
| | | <p>First floor landing</p> | <p>Previous dampness to ceiling and wall top RHS (adjacent to No 34 – derelict)</p> |

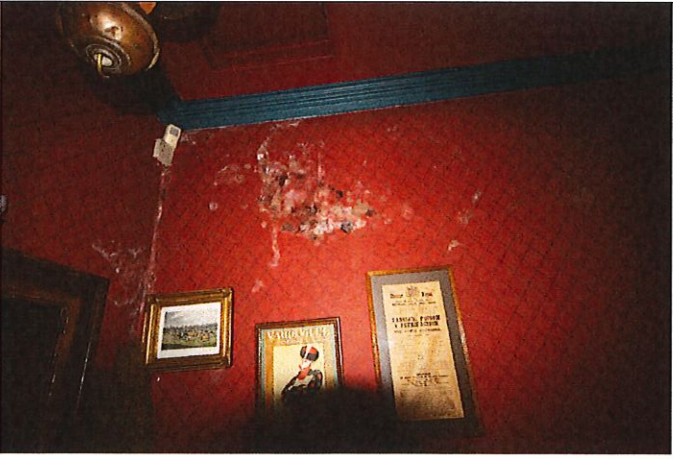
| | Photograph | Location | Comment |
|--|---|--|---|
| | | <p>First floor landing</p> | <p>Previous water damage – damp meter indicates some residual dampness but substantial drying out</p> |

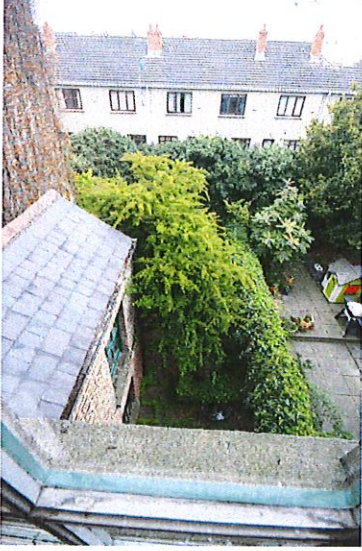
| | Photograph | Location | Comment |
|--|---|---|---|
| | | View over rear return from first floor rear bedroom | Roof and flashings in good condition |

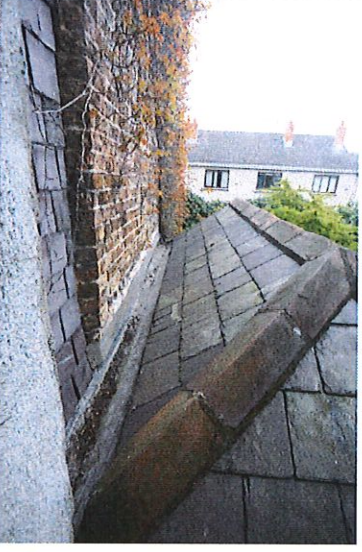
| | Photograph | Location | Comment |
|--|---|---|---|
| | | View over roof of rear return | Valley clean and in good condition |

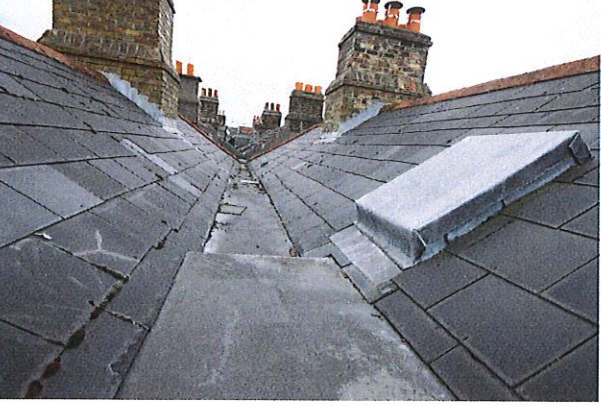
| | Photograph | Location | Comment |
|--|---|---|---|
| | | Main roof valley | Valley clean and in good condition |

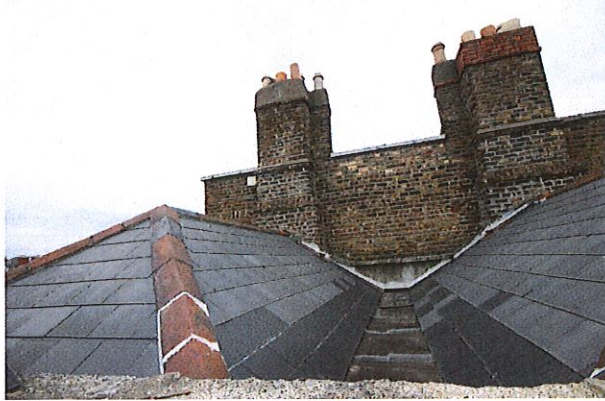
| | Photograph | Location | Comment |
|--|---|---|---|
| | | View of valley of No 34 | Valley shows signs of recent repair |

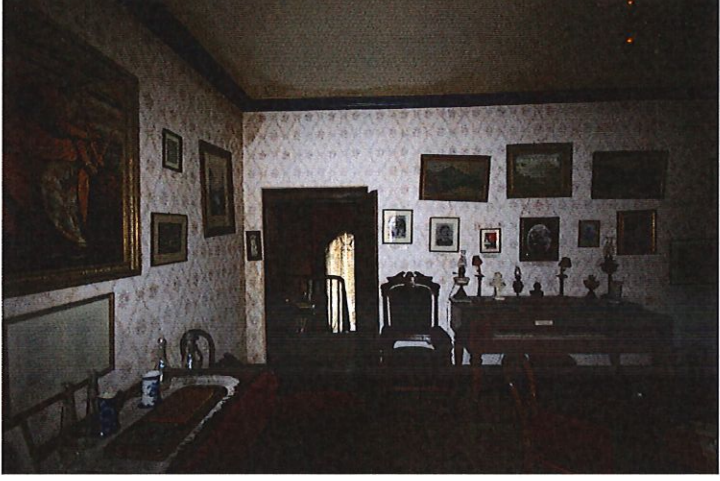
| | Photograph | Location | Comment |
|--|---|---|---|
| | | <p>Drawing room (Front first floor)</p> | <p>Note water damage to finishes top left over door</p> |

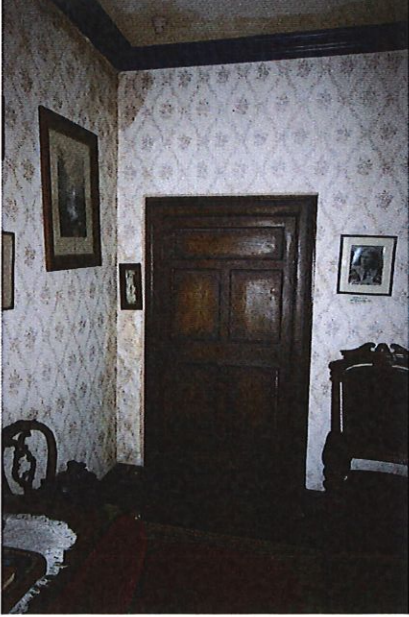
| | Photograph | Location | Comment |
|--|---|---|---|
| | | <p>Drawing room (Front first floor)</p> | <p>Note water damage to finishes - ceiling and wall</p> |
