SMALL SHELTER  
HERBERT PARK, DUBLIN 4

**Restoration Feasibility Study**

October 2017

HOWLEY HAYES ARCHITECTS

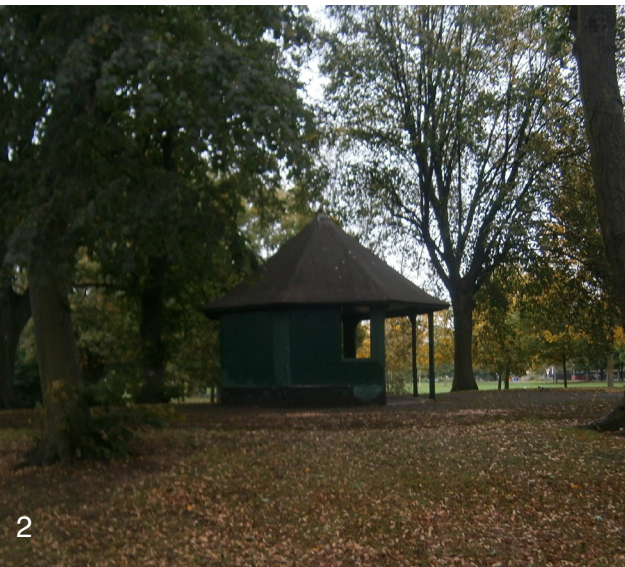
- 1: Aerial view of the north side of Herbert Park with location of small shelter indicated in red.  
2: View of exterior in 2014.  
3: Detail showing post, bracket, eaves and ceiling lining.  
4: View of interior in 2014.  
5: Detail showing post disengaged from base plinth.

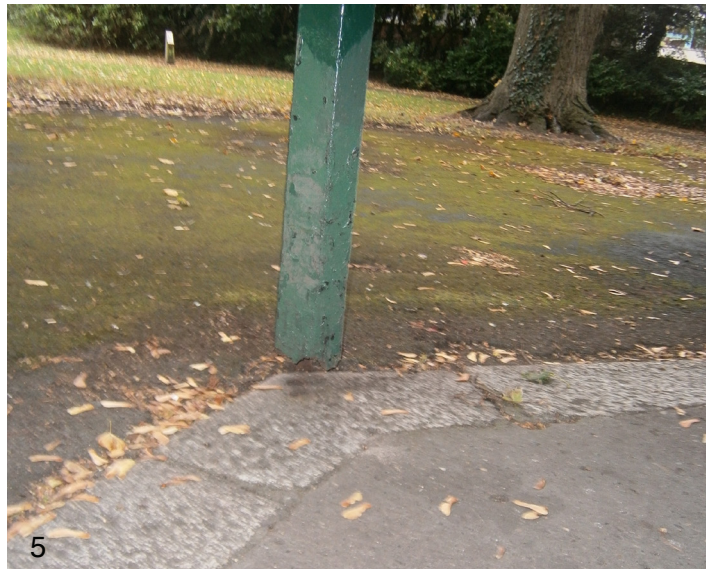
When the condition of the building was assessed in May 2017, evidence of fires being lit under the timber structure was found, and its condition was such that it was deemed unsafe for public use. In order to fully assess its condition, the rotten plywood panels were removed, and exposed the full extent of rot to the base of the timber posts. One of the posts in particular was no longer plumb and a number of bases to the posts were rotten; the building was no doubt being held together by the plywood sheeting, without which it is unstable and prone to collapse.

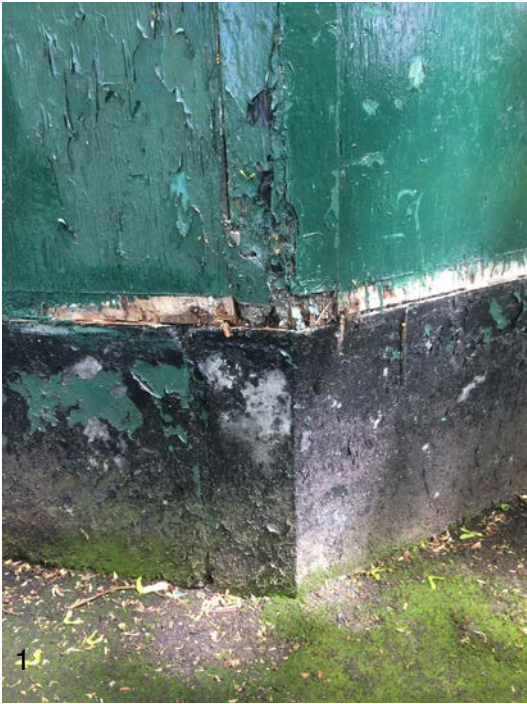
The shelter is constructed using timber posts on a base formed of rough concrete that support a timber octagonal pitched roof, which has been covered with asphalt and has a distinctive bell cast to the eaves with no gutters. Five sides of the structure have been infilled with painted plywood sheeting so that it is open to the south east in the direction of the main road. Along the infilled sides is a low timber slatted bench, simple rectangular openings give views on the north east and south west panels. The top surface of the concrete base is spalling under the rotting plywood panels.

- 1: Detail showing rotten timbers on base plinth.  
2: View of roof timbers showing plywood sheathing prior to dismantling.  
3: View of timber post framework following removal of plywood wall panels.  
4: Detail showing cyma recta timber moulding trim to ceiling boards.  
5: Detail of timber post showing socket for bracing.  
6: Detail of timber ceiling lining boards showing earlier colour scheme.

- A new colour scheme, perhaps using the blue-grey found under the green paint layer would complement the clay tiles and create a sense of lightness under the canopy. The charred and rotten timbers could be replaced using hardwood to match the original detail.

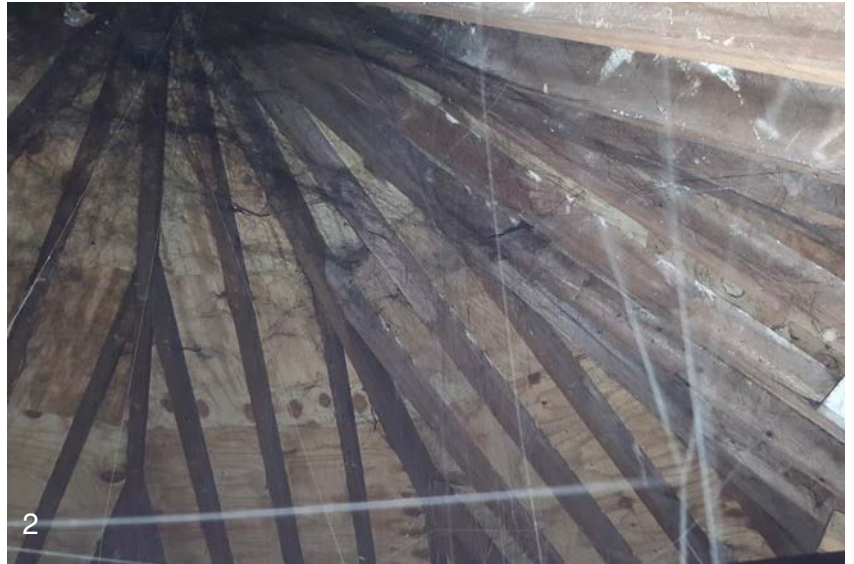
The timber-boarded ceiling has been badly scorched by flames, a significant safety concern. Opening up of the boarding exposed the timber ceiling and roof joists; no rot was identified with some staining visible from intermittent dampness, however the inspection was confined to a single area. The slopes are lined with plywood sheeting, further confirmation that the roofing was replaced.

- The open ends on the axis of the park gate allow ease of circulation through and around the shelter.
- New clay tile coverings, or cedar shingles, would significantly improve its appearance, although the tiles would be significantly longer lasting.

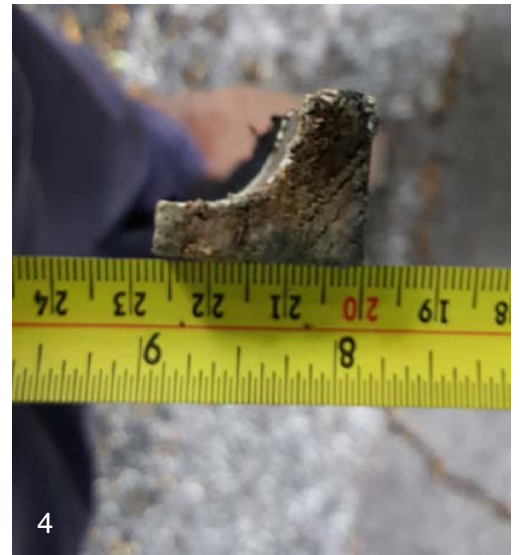
The structure is painted a dark green colour, with black overpainting in places and is in very poor decorative order generally. Exposed timbers show that an earlier paint scheme used a light grey colour. The ceiling boards appear to have had a cream colour prior to the green scheme. They are trimmed behind the wall plate using a simple timber 'cyma recta' moulding.

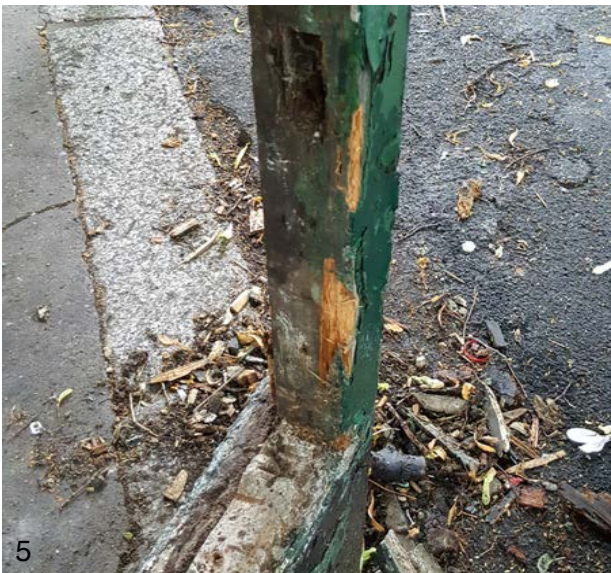
The timber roof is supported off a wall plate, set on the posts with simply carved timber brackets. The free standing posts appear to have been formed from a single timber, others sheathed by plywood have been formed from two sections. Slots on the sides of these posts show locations of either balustrade rails or internal bracing for boarding.

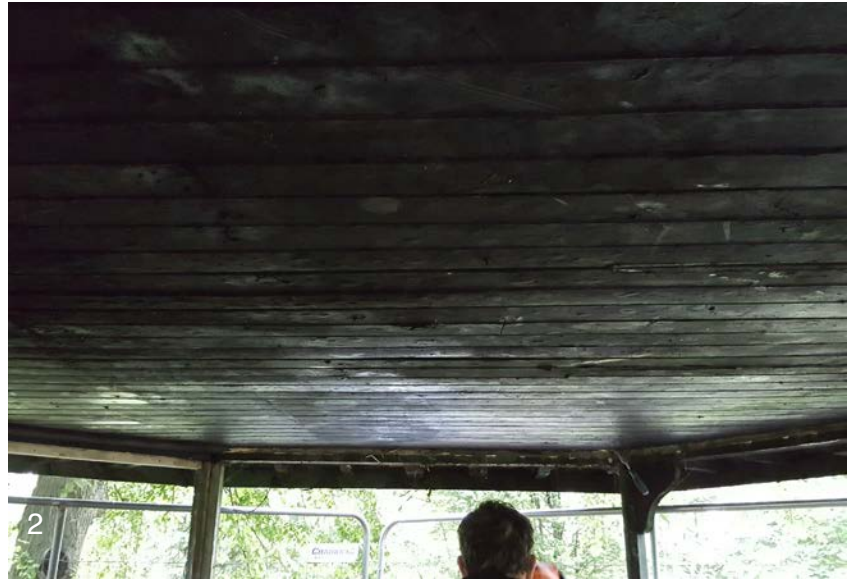
- 1: Detail at eaves showing wall plates, ceiling and roof joists.
- 2: View along scorched ceiling lining boards.
- 3: Detail of eaves showing fascia board and exposed roof joist ends.
- 4: View of post showing earlier colour scheme and socket for bracing.
- 5: Detail of spliced repairs to post.
- 6: View of cracked concrete floor.

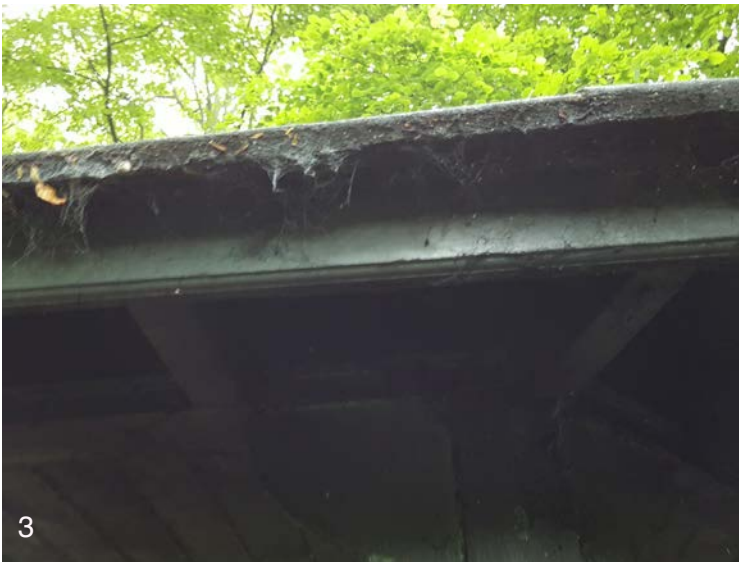
Sizeable spliced repairs and the use of shuttered concrete to replace rotted ends are evidence of different phases of repair and replacement over the decades. The bell cast is created using a board set on a furring attached to the ends of the roof joists. The underside of these joists are exposed under the eaves, with a timber moulded fascia fixed to the front.

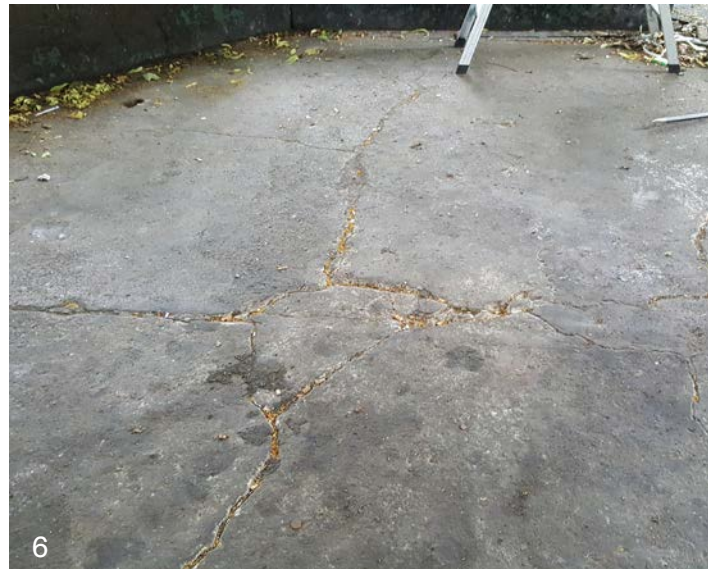
The floor still has the original granite kerb stones forming the front faces of the octagon although the surrounding path has been surfaced using asphalt, and the interior with mass concrete that is badly cracked.

- The unsightly cracked asphalt that surrounds the shelter should be replaced by hoggin or bound gravel. A bound surface could also be used internally, with the granite kerbing extended around the entire perimeter.
