S2S Cycle & Footway Interim Works Bull Road to Causeway Road

Stage 3 Road Safety Audit

August 2017

Dublin City Council

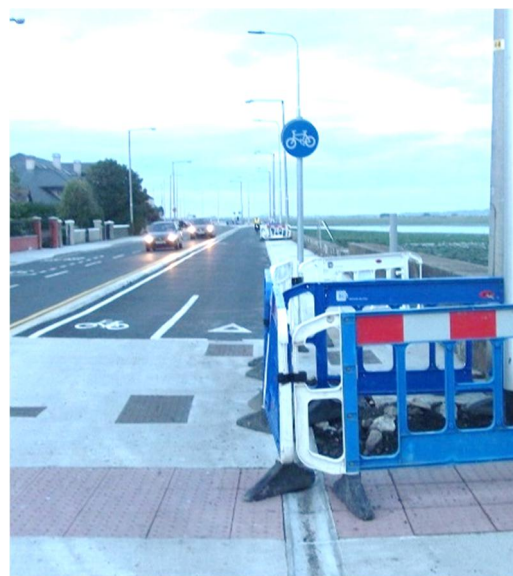
2.1.6 Problem (G6) Signage at exit from Shared Areas

The auditors noticed several instances of pedestrians entering into the cycle track, causing cyclists to swerve to avoid them. It was also noted that sign face RUS 009 has been provided at the exit from all of the shared areas. This sign indicates Pedal Cycles only and prohibits all VEHICLES from entering the cycle track.

The audit team are concerned that there may be confusion amongst pedestrians regarding the correct (and safe) side of the route upon which to travel. This problem could be exacerbated by the use of the incorrect signage.

The audit team recommend that, where appropriate, the RUS 009 signs are replaced by RUS 058CL or RUS 058CR, as these signs indicate the correct side of the route for pedestrians to take.

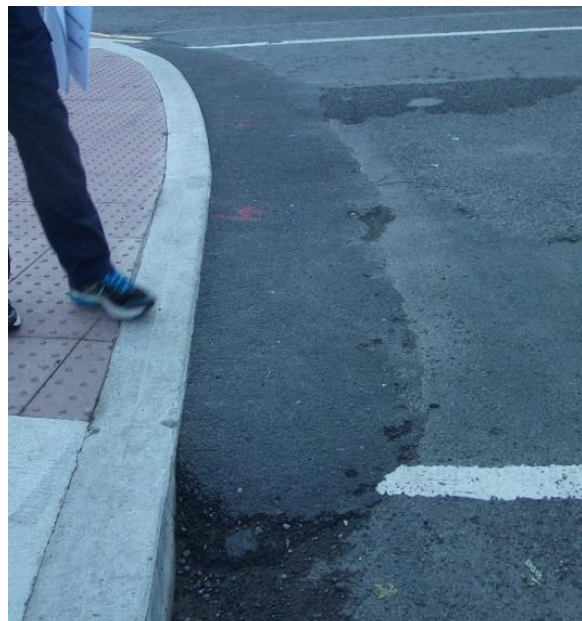
2.2.4 Problem (S4) No Dropped Kerbs at Crossing on Bull Road

The auditors noted there are no dropped kerbs provided at the crossing on Bull Rd, a temporary surfacing has been provided. In the absence of the appropriately constructed dropped kerbs all pedestrians including visually and mobility impaired pedestrians and cyclists may encounter difficulties navigating the route. This could lead to trip/slip hazards for pedestrians

or loss of control incidents for cyclists should they try to navigate a full height kerb.

It is recommended that appropriately constructed dropped kerbs are provided at the crossing location.

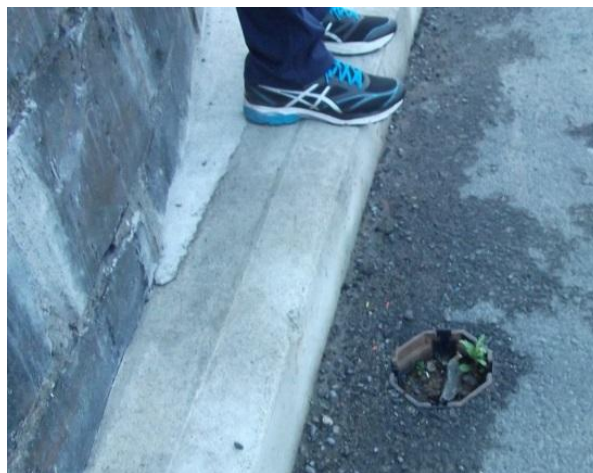
2.2.6 Problem (S6) Redundant Inductive Loop Box at Crossing on Bull Road

There is a redundant loop box on approach to the crossing on Bull Road. This presents a trip hazard for pedestrians or could result in loss of control incidents to for cyclists should they hit a low point unexpectedly.

Remove the loop box and finish the carriageway to an appropriate standard.

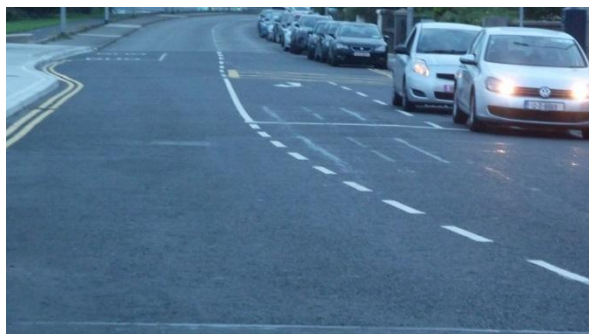
2.2.10 Problem (S10) Southwestern Arm of Bull Rd/Clontarf Rd junction

During the site audit the audit team observed several instances of vehicles crossing over the carriageway centre line to wait for a gap in opposing traffic before undertaking the right turn

into Bull Rd. There is potential for conflict between vehicles travelling southwest bound through the junction and these vehicles that have encroached over the carriageway centreline.

It is recommended that either: -

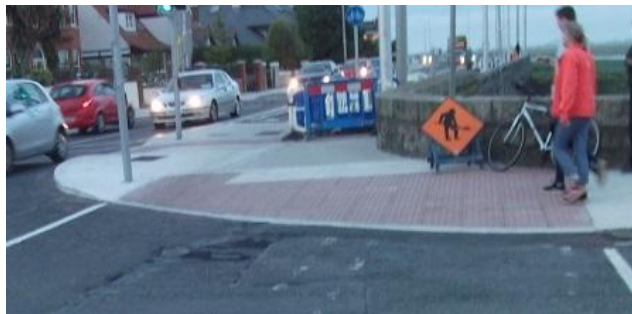
2.2.13 Problem (S13) North-Eastern Crossing Location at Bull Rd/Clontarf Rd junction

During the site visit the audit team noted the incorrect layout of tactile paving the toucan crossing (i.e. the stem is too short). In the absence

of the appropriate tactile paving visually impaired may encounter difficulties in locating the crossing point or they may enter into the road carriageway come into conflict with moving vehicles and cyclists.

It is recommended that appropriate tactile paving is provided to guide vulnerable road users along the most appropriate route.

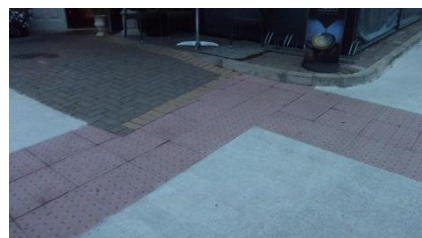
2.2.21 Problem (S21) Dollymount Park Pedestrian Crossing

During the site visit the audit team noted that the layout of the stem of the tactile paving at the northern side of the crossing is incorrect. This could result in visually impaired pedestrians encountering difficulties in locating the crossing point or could result in personal injury should they trip at the full height kerb.

As soon as the opportunity arises, the stem of the tactile paving should be extended to the back of the footway.

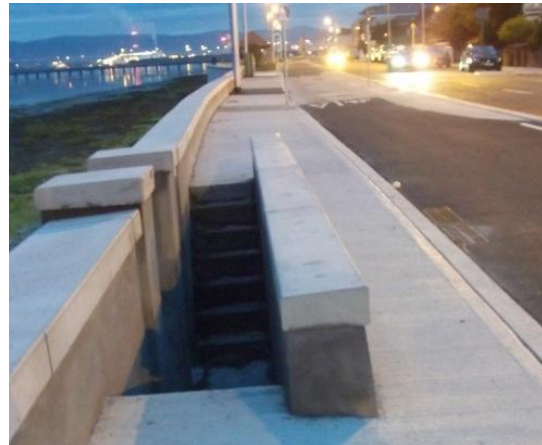
2.2.27 Problem (S27) Narrow Footway at Steps

Due to the narrow footway width at the steps pedestrians may be forced to enter into the adjacent cycle track to pass another pedestrian which could lead to conflict with cyclists/vehicles travelling along the cycle track/road carriageway.

It is recommended that a clear footway width of at least 1200mm (at obstructions only) is provided to ensure pedestrians are not forced to enter the adjacent cycle track to continue their journey.

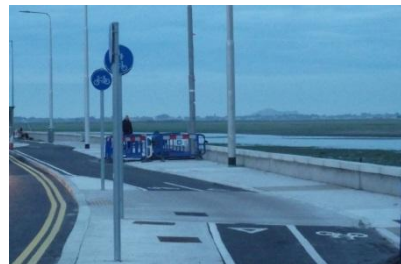
2.2.28 Problem (S28) Blocked Sign face opposite Seafield Rd East Junction

Visibility to the Shared surface sign is blocked by the cycle route sign. As a result, cyclists may be insufficiently advised of the presence of the shared area, the need to reduce speeds and the potential for pedestrians to be present. This could lead to conflict.

Ensure all sign faces are clearly visible to oncoming cyclists.

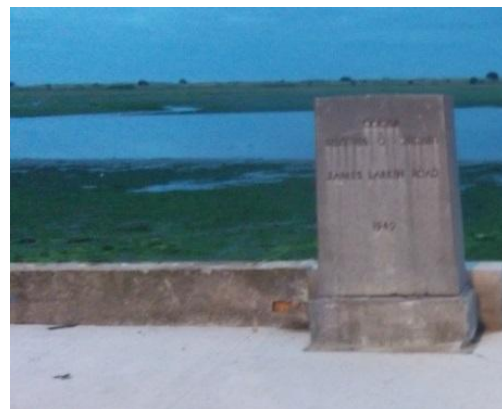
2.2.29 Problem (S29) Low Wall Height – Throughout Scheme

The auditors are concerned about the low sea wall height throughout the scheme and the flat top capping provided, particularly opposite the Mount Prospect Avenue junction (pictured). This presents a hazard to visually both impaired pedestrians (trip hazard) and to children who may be encouraged to run/walk/climb on the wall leading to falls from a height into the sea and/or drowning.

This problem was also noted during the Stage 2 RSA undertaken by PMCE (Problem Ref. 3.1.5).

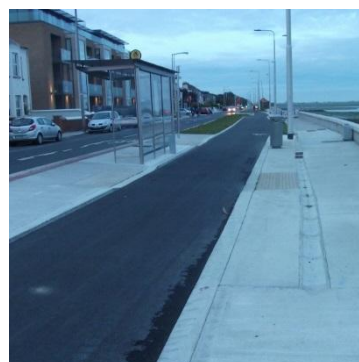
2.2.30 Problem (S30) Drainage Channels Located at Pedestrian Crossings

The audit team noted some instances of the provision of drainage channels immediately to the rear of pedestrian crossing locations. These drainage channels may present a trip hazard to visually impaired pedestrians as they expectantly encounter the channel upon undertaking the crossing. Or a slip hazard or all pedestrians could arise if the channel is full of water during wet or icy weather conditions.

Monitor the situation, if issues arise relocate the pedestrian crossing. Ensure the drainage channel can adequately shed surface water during poor weather conditions.

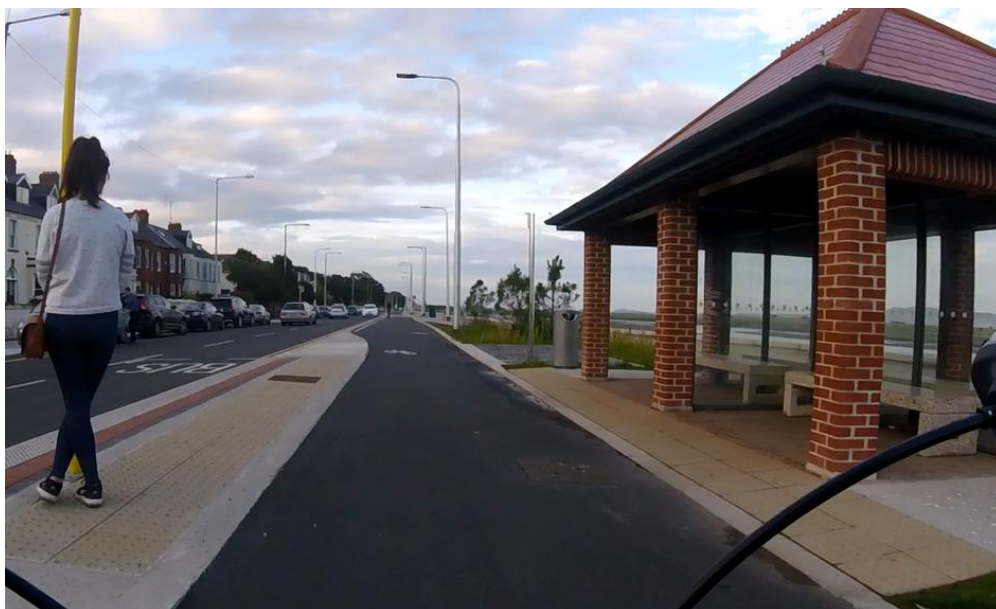
2.2.32 Problem (S32) Bus Stop on Clontarf Rd opposite Doyles Lane

The auditors have concerns regarding the narrow width of island/refuge area provided at the bus stop. Failure to provide a sufficient width of refuge may result in pedestrians encroaching into the adjacent cycle route, leading to conflict.

Monitor the situation, should the bus stop be utilised by high passenger numbers, either the refuge area should be widened accordingly; or cyclists are brought to the rear of the bus stop at appropriate transition points.

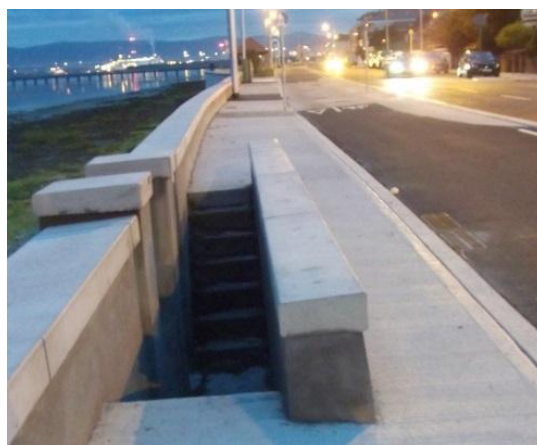
2.2.33 Problem (S33) Narrow Footway at Steps

There is no corduroy hazard warning paving provided at the top of the steps warn visually impaired pedestrians of the presence of the hazards. This could lead to them expectantly proceeding into the steps and subsequently falling down the steps.

Provide the corduroy hazard warning paving at the top of the steps.

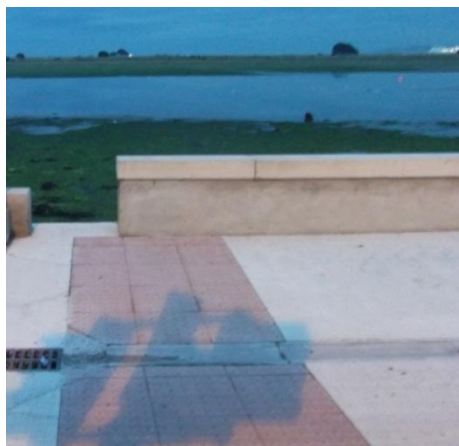
2.2.39 Problem (S39) Gap in Sea Wall at Mount Prospect Ave Junction

There is a gap in the sea wall opposite the Mount Prospect Avenue junction. This could lead to visually impaired pedestrians crossing the road carriageway and proceeding straight to the gap in the wall, resulting in falls and potential drowning.

This problem was also noted during the Stage 1 RSA undertaken by Roughan & O'Donovan (Item No. 5).

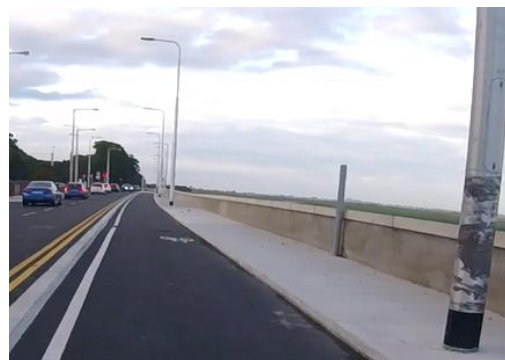
3.1.2 Comment (C2)

The auditors noted the provision of short poles along the edges of the footway. It is unclear to the auditors what the purpose of these poles is. Should they be unnecessary they should be removed to prevent clutter/over proliferation of sign poles.

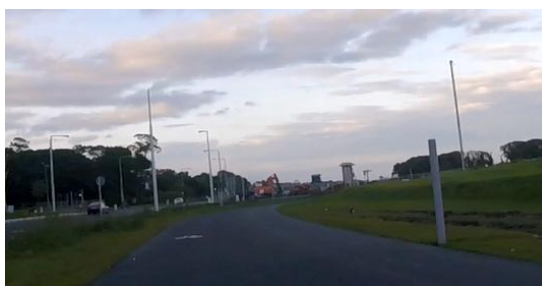
3.1.3 Comment (C3)

There is a sign pole located directly adjacent to the Cycle Track (south of Causeway Rd junction). There should be a gap of at least 500mm between the edge of the cycle track and any street furniture. Further to C2 above, if the sign is unnecessary remove it or relocate to a more suitable location.
