Report to Housing SPC

Mould and Condensation SPC Report

Pilot Condensation Subgroup Report.

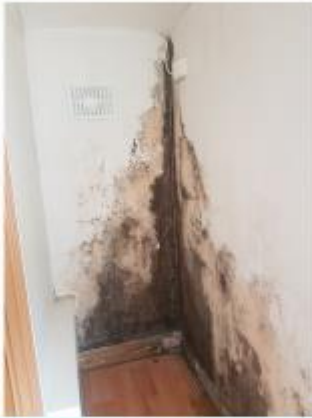
Before

Trialled Sempatap Thermal

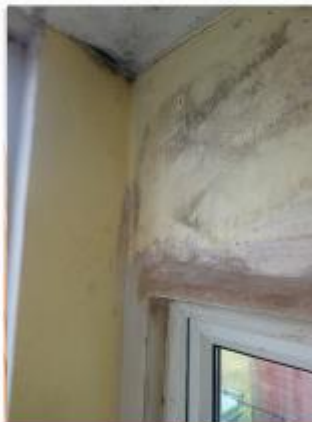
Before

Inducoat Trials
