February 2019

Irish Water

Ringsend Wastewater Treatment Plant

Investigation into a Darkened Plume Formation at Discharge Point of the WWTP

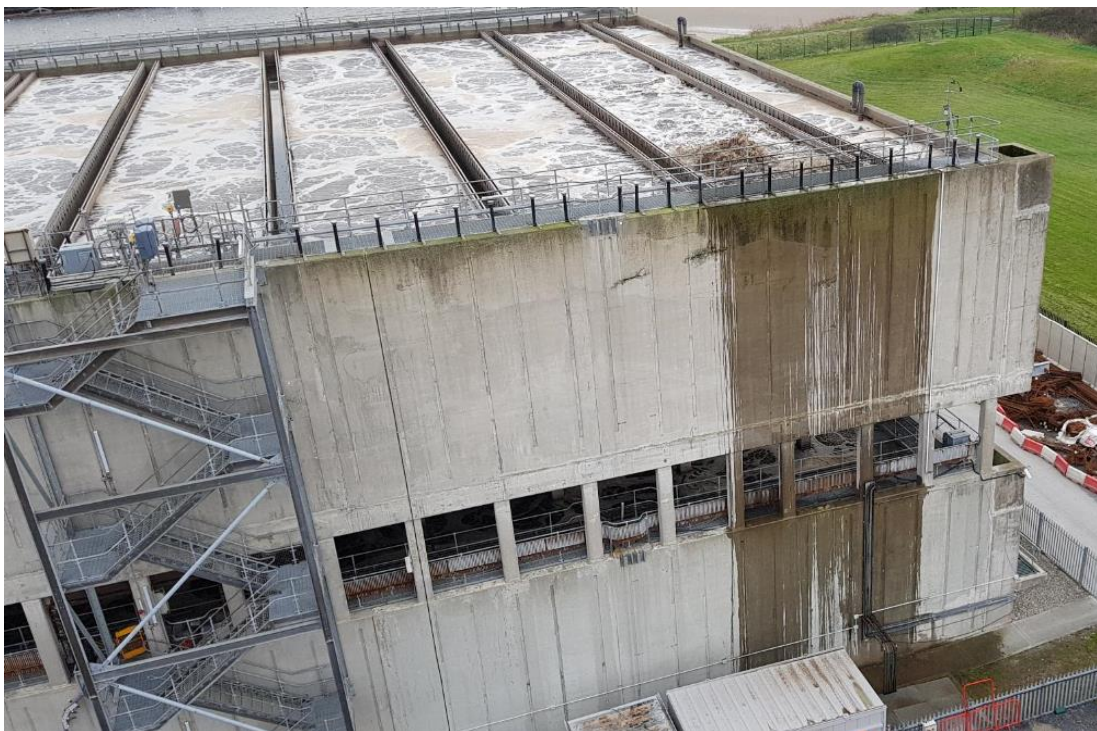
At 9am on the morning of the 23rd of February, the WWTP operator from Celtic Anglian Water carried out their daily routine walk around the site. At that point the plant was operating normally and there were no concerns. At approximately 9.30am, a spillage was observed from SBR Cell 3B which was reported to the plant operator. This spillage appeared to be due to a mechanical failure of some aeration pipework.

Following notification of this spillage, the plant operator isolated the SBR Cell and prevented it from receiving any more liquids. This isolation prevented any further emissions. As a result of the overflow, it has since been estimated that approximately 80-100m³ of inadequately treated effluent entered the discharge pipeline and entered Dublin Bay, with the discharge lasting for approximately 20 minutes. Irish Water staff on site, monitoring the upgrade works, were informed of the spillage, with staff agreeing at that stage that the incident was a low level incident. The plant operator then followed incident management procedures, noting that the incident was a low level incident, which would not necessitate immediate notification to the EPA. On Monday 25th February, the operator submitted the required incident notification form to Irish Water Operations staff, who in conjunction with Irish Water Compliance staff, noted

Fig 3.2 Overflow Incident – 9.30am - 23rd February

The affected SBR Cell 3B remains shut down as repairs are carried out. It is envisaged that these repairs will take approximately one month, and while shut down; the plant will be operating with a 5%-8% reduction in treatment capacity. This has been notified to the EPA.

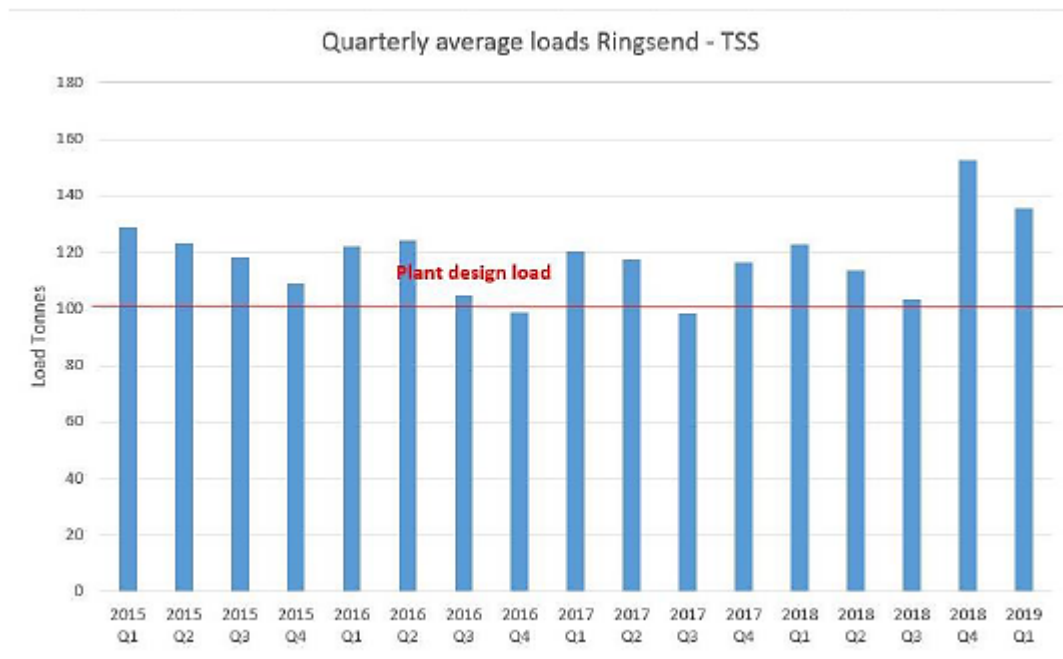
Fig 3.2 Quarterly Average Loads – TSS (Suspended Solids)

The plant is designed to treat 101 tonnes of suspended solids per day. Expectations of typical elevated levels, or normal overloading, would be for the WWTP to be operating at c.120 tonnes per day. However, during February 2019, c. 150 tonnes of solids per day was noted at the WWTP, while on 22nd of February 2019, c. 300 tonnes of solids was received at the inlet works. The consistently 'elevated' overloading conditions are now impacting on effluent quality and clarity of the effluent. In essence, this means that the on the day before the plume was observed, the loading of solids that arrived at the WWTP in the network was three times that which the plant was designed for, or twice the typical amount received at the plant.

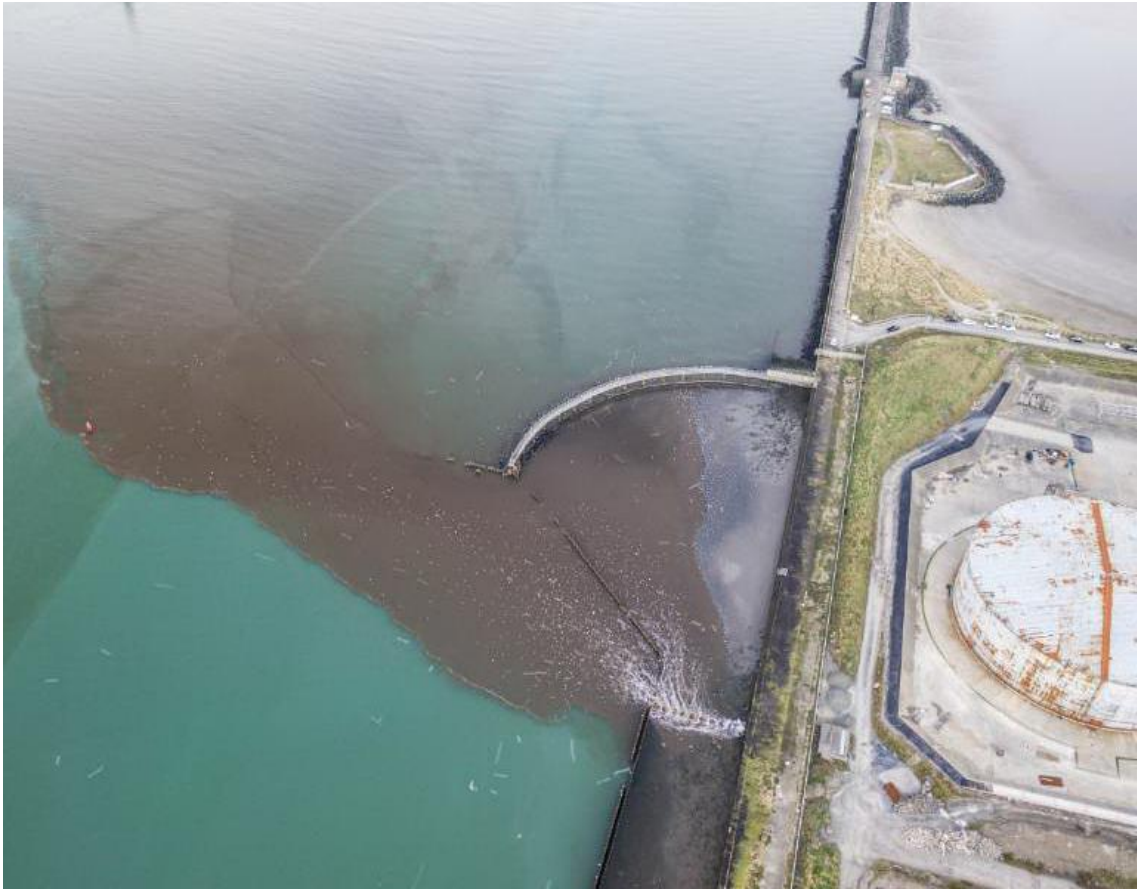
On Monday morning, Irish Water received a media query from the Irish Times, attaching a photograph taken by a drone photographer, which captured the formation of a visible darkened plume in Dublin Bay at the site of the discharge point from the WWTP into Dublin Bay. The subsequent communications and investigations into that query are addressed in the following sections of this report.

Fig 3.3 Drone Footage Received from Irish Times on 25 February 2019

26/2/19 13:00 EPA Audit at the WWTP, attended by Irish Water and Celtic Anglian Water staff. The volume of discharge due to aeration failure was determined to be low (less than 1% of total flow, and 3% of daily effluent solid load), based on the estimated volumes discharged. It was determined that the formation of the plume was most likely to have been as a result of the loading at plant in the immediate days prior to the 23rd-24th February 2019, rather than being significantly attributable to the aeration failure. Effluent quality varies significantly from day to day, so discolouration of the discharged effluent is also variable from day to day. In addition, a number of external factors are likely to have contributed to the apparent colour differential in the drone photograph

such as low tidal levels, sunlight, refraction, wind direction, receiving water temperatures and the absence of the dilution effect caused by rainfall. It is further noted that sampling results from Celtic Anlian Water on effluent quality are not real time and are not available for a number of days following the taking of the sample. The high solids content in the effluent would have been identified in the effluent sampling and would have likely indicated the potential for plume formation, had the sampling been available in real time.

- The provision of real time photographic recording of the discharge point, in order to have an indication of the plume formation potential at the discharge point;
- A review of the Incident Notification protocol to ensure better communications to stakeholders, including Dublin City Council and the public in the event that a plume is identified;
- Modification of the process control to investigate optimum settlement times based on the outcome of recent upgrade works;
- Investigate options to increase sludge removal from the process during periods of high solids loading received at the plant, thereby allowing speedier through flow of solids through the plant; and
- Analysis to identify and minimise the extent and impact of solids in the network on the treatment plant.

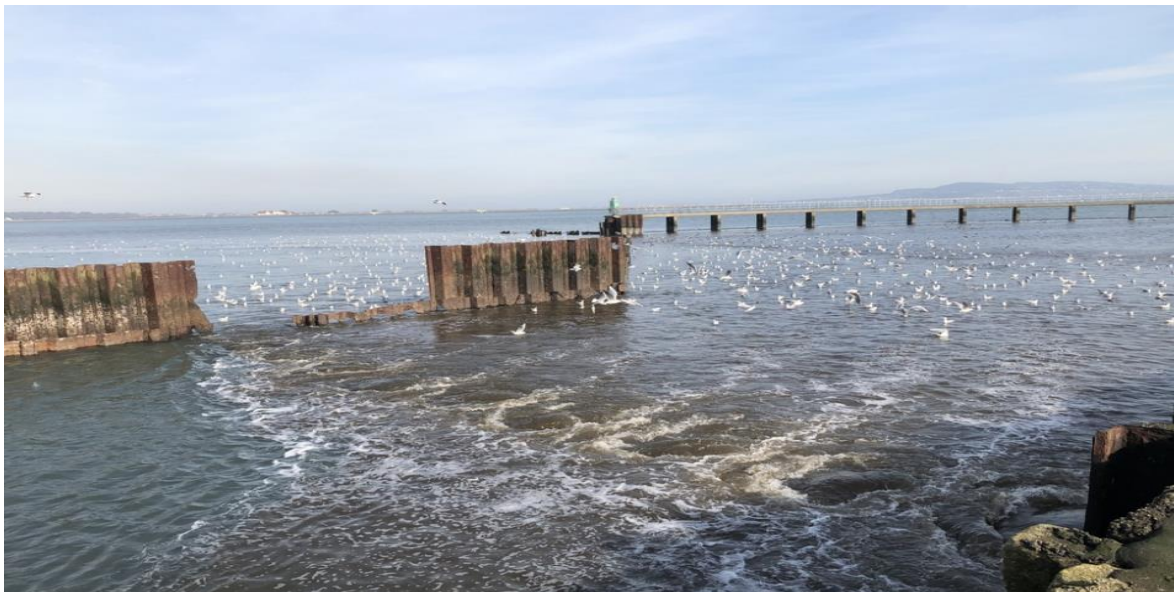
Fig 4.1 Discharge Point – 25 February 2019

In addition to the above investigations, analysis of the influent being received at the plant would seem to indicate that the influent is laden with solids that are not from wastewater, but appear to be inert solids that are possibly entering the combined sewer network as a result of the increase in construction activity across the city. The peaks being experienced in sampling for Total Suspended Solids are not being replicated in typical sewage indicators such as Ammonia or BOD loading, which would suggest that the solids are not from wastewater discharges.
