**26<sup>th</sup> January, 2021**

**Report on Proposed Tree Works in Brickfields Park, Drimnagh.**

In 2020, the Council's Tree Officer carried out a survey of trees in Brickfield Park. This is the first such survey of trees in this park. It is an action of the Dublin City Council Tree Strategy 2016-2020 to survey and create a baseline inventory of urban trees in public ownership with the goal of ensuring the City has a good and healthy urban forest which includes woodlands, copses and individual trees whether in open spaces or streets. A healthy tree population is important both for public safety and the multiple benefits for people and the environment that trees provide.

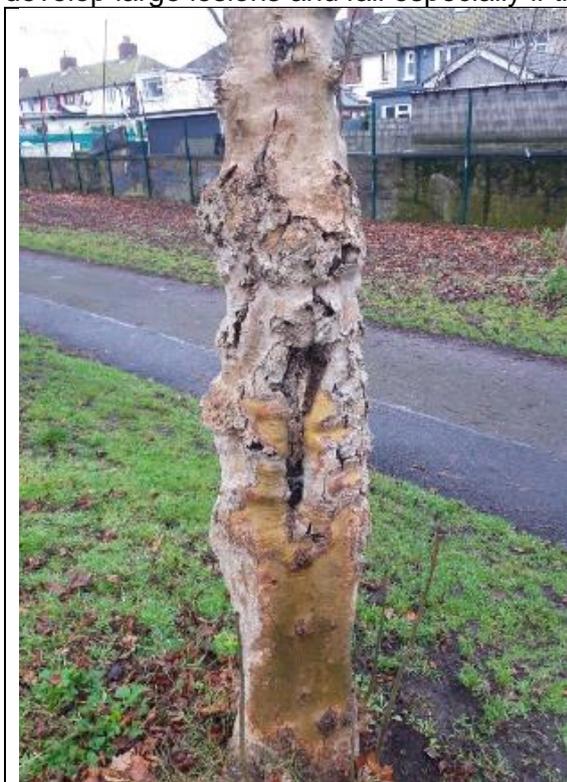
3 *Fraxinus excelsior* (Ash Trees) will be removed due to a disease called Bacterial Canker of Ash. It is caused by the bacteria *Pseudomonas syringae ssp. savastanoi pv. Fraxini* and it is not related to Ash Dieback disease. Previous wounds are invaded by the pathogen which develops into lesions that may exude a sticky fluid. Over time the bark dies and peels back. In some cases, trees with Bacterial Canker live for many years and be hardly affected; others develop large lesions and fail especially if the lesions ring the trunk or branch.

Ash Tree. Number: 01KP

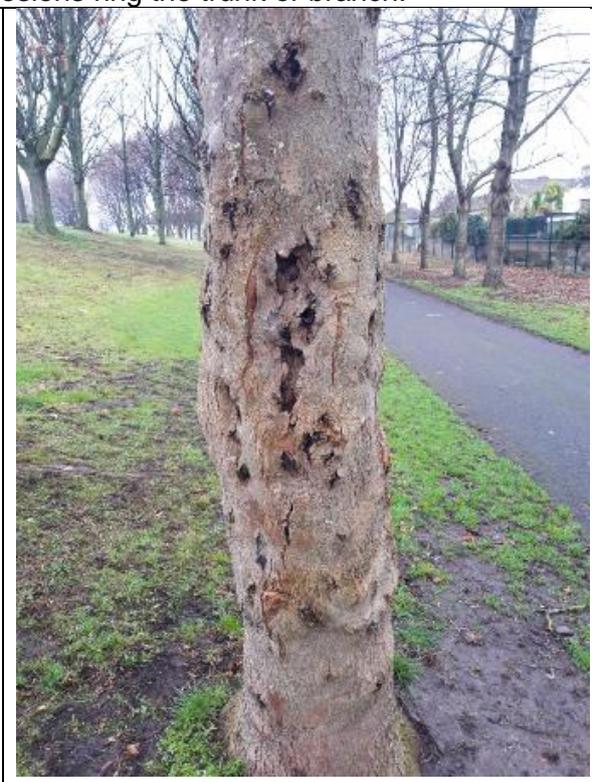
Ash Tree. Number 01KR

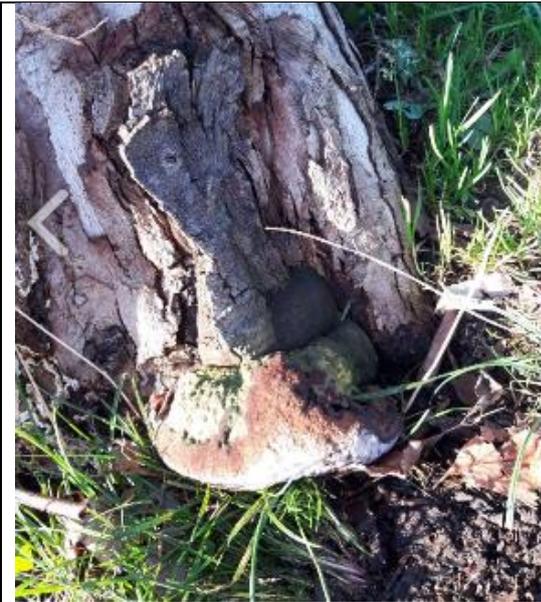
*Ganoderma australe* is a perennial woody fungus bracket. It can extend from damaged wood to previously sound sapwood. When advanced and extensive, the decay can result in failure of the stem, base and rootplate. The presence of 2 brackets shows that the fungi have started to successfully colonise the base of the tree. As the tree is located beside a playground, as the Eucalyptus is a brittle species in Ireland, and due to the fact that the tree has basal wound and codominant stems, the removal is inevitable.

*Ganoderma australe* (first bracket)

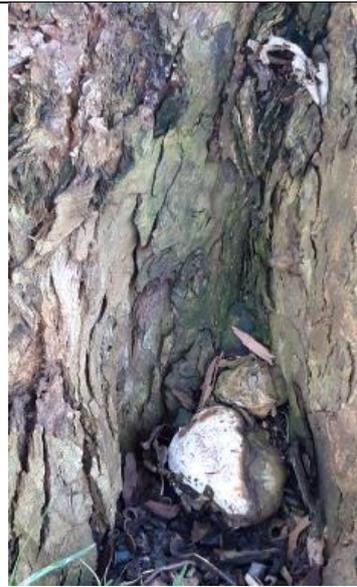
Immature form of *Ganoderma australe* (second bracket)

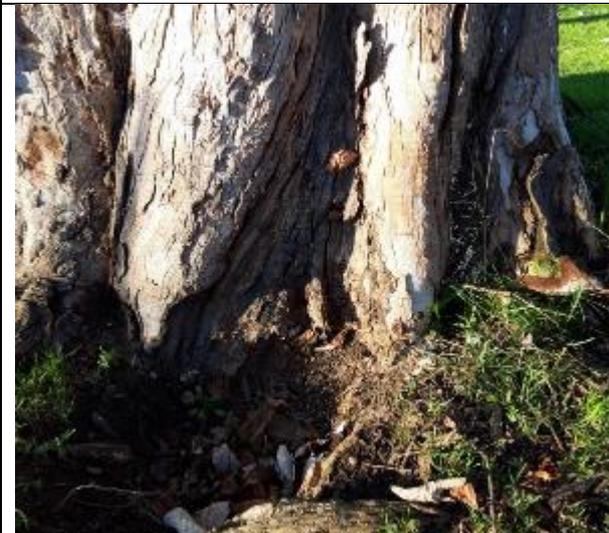
Basal wound and *Ganoderma* brackets

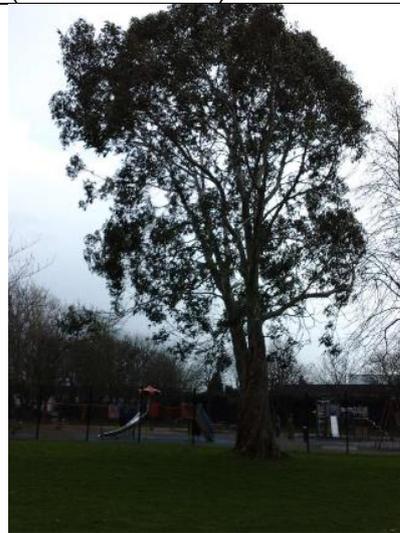
Tree with compression fork, codominant stems, basal wound, and fungi beside playground.

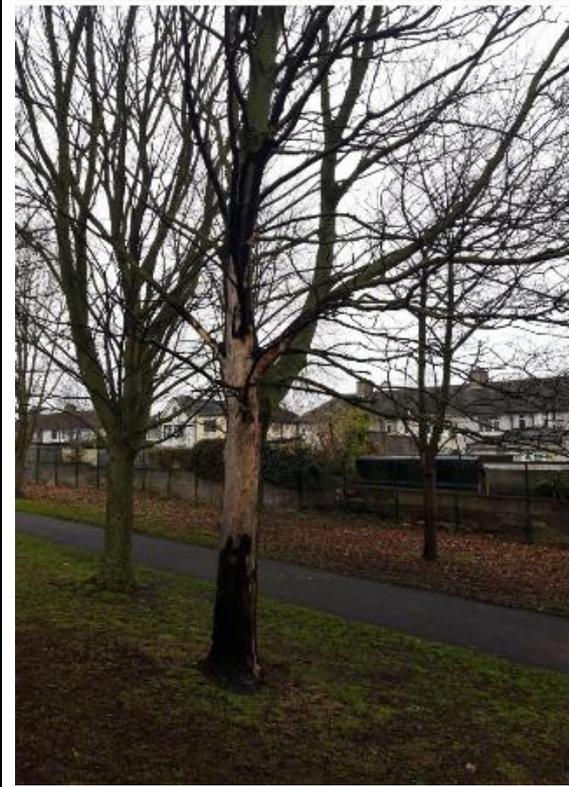
The inventory noted that 11 trees have been severely burnt by fires lit at their bases. The damage done is so extensive that the trees have to be removed.

Norway Maple Extensive damages due to fire.  
Tree Number 01KS

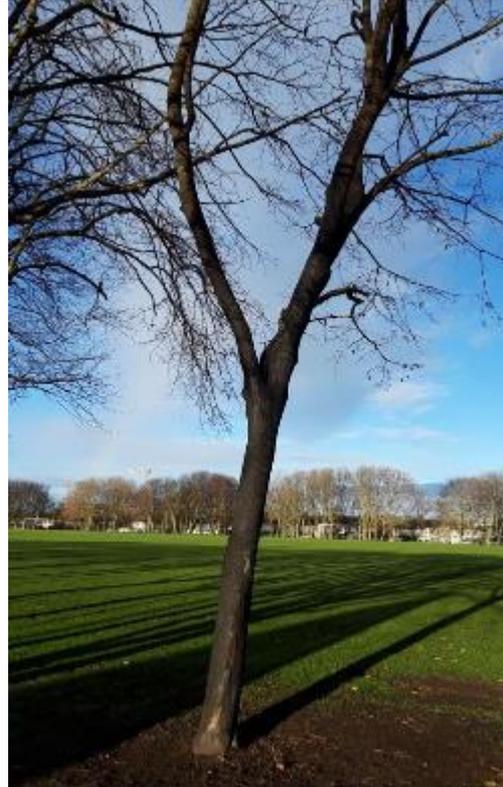
Lime tree, entirely scorched. Tree  
Number 01KA

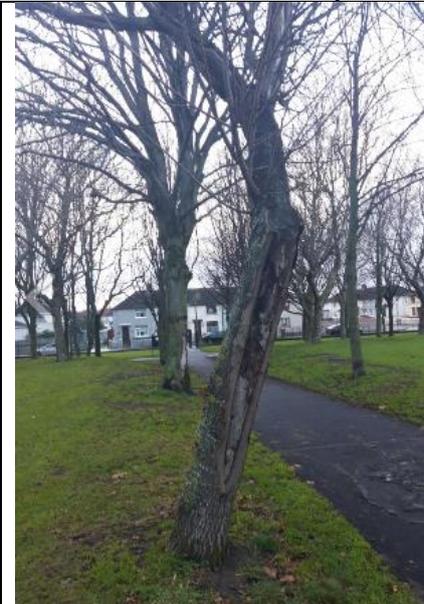
Lime tree. Tree Number 01K8

The inventory has uncovered 36 trees with large cavities associated with extensive decay and leading to dieback and decline. The origins of the wounds are not clear but it is likely that vandalism has been a major issue.

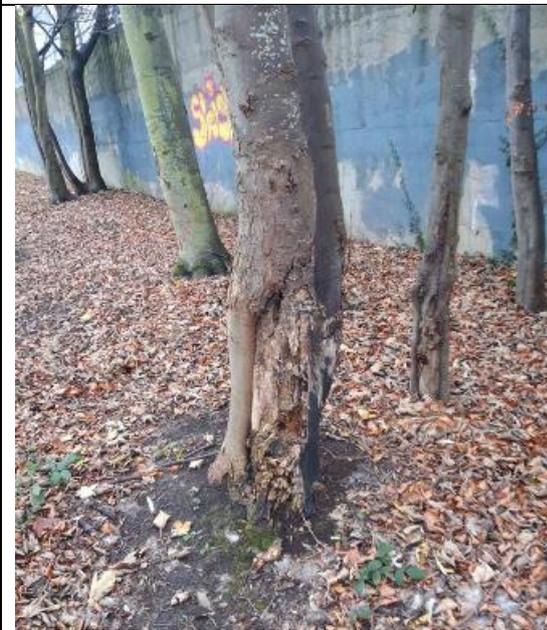
Beech tree. Cavity with extensive decay.  
Tree number 01J7

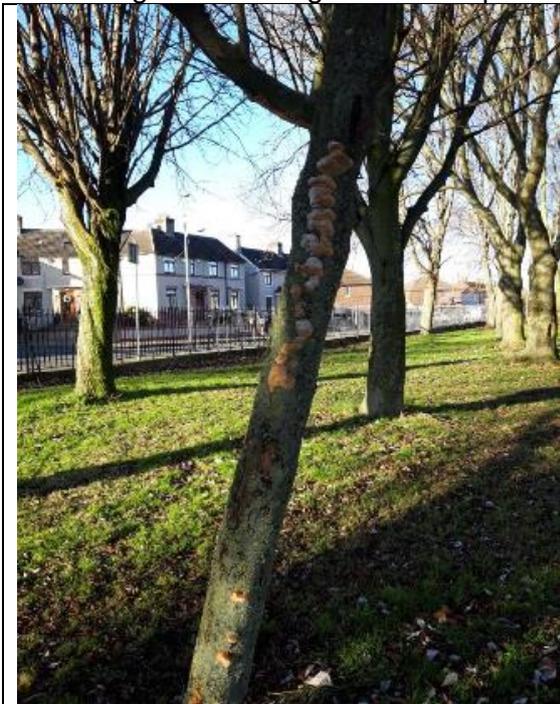
*Prunus cerasifera nigra*. Tree 01KJ

The inventory found 6 dying trees, notably 2 *Prunus cerasifera nigra* with fungal infection (*Phellinus pomaceus*). The reason for the decline of the other 4 trees is likely to be due to them being on the losing side of competition for light and water.

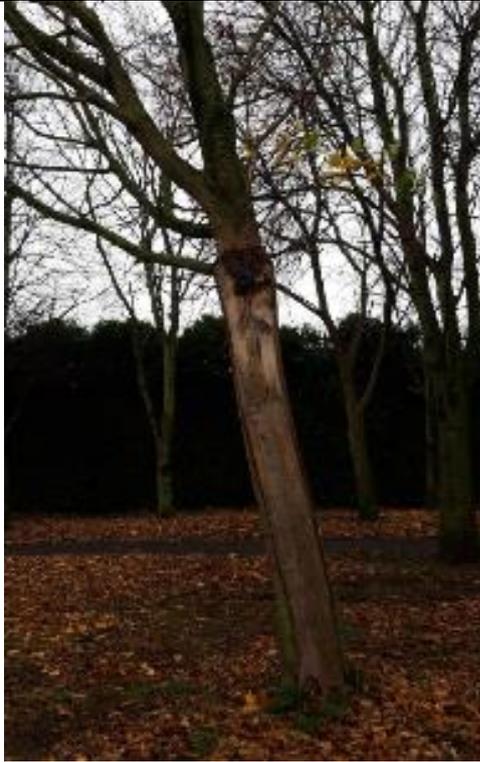
The assessment found 4 trees which suffered catastrophic damages during wind events. All 4 are Norway maples (*Acer platanoides*) which lost major limbs as a compression fork failed.

Norway maple has broken in 2 when compression fork failed during high wind  
Tree Number 01HS

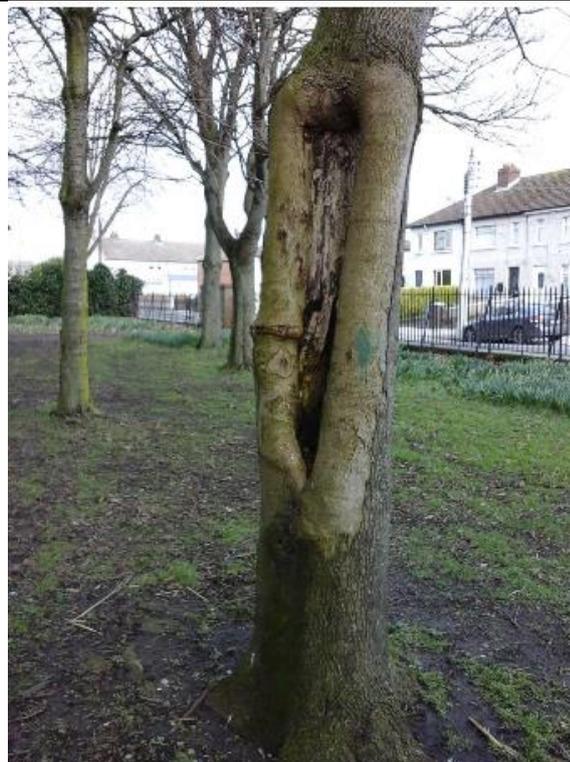
Norway maple with large cavity and decay due to compression fork failure during high wind  
Tree Number 01HS

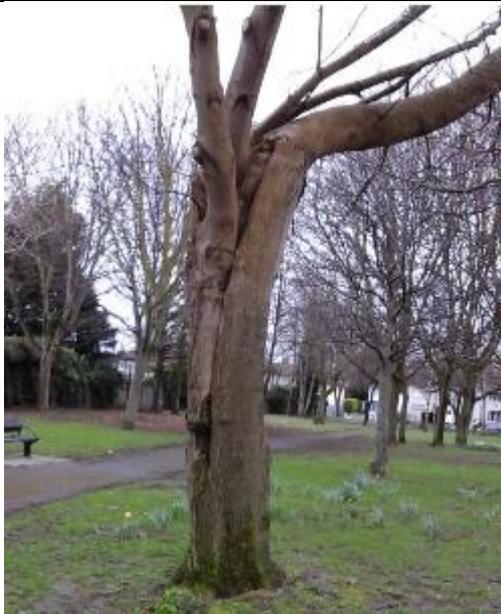
Norway maple compression fork failure.  
Tree Number 01Ak

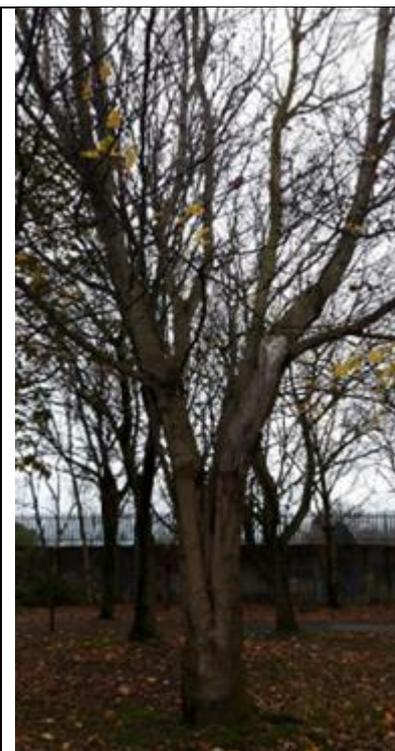
During the assessment, 8 trees were found with advanced stage of compression fork with included bark. Compression fork with included bark is a V-shaped narrow fork in which continued radial growth results in pressure which tends to push the limbs of the fork apart and lead to limb failure. This structural defect is common in Norway maples.

Large Norway maple splitting in 2. Tree Number 01HZ

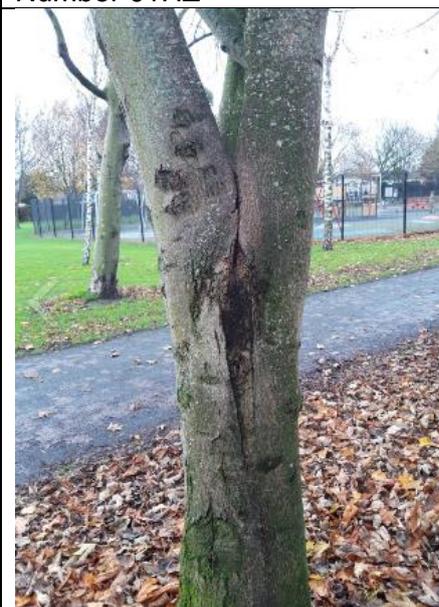
Norway maple with compression fork starting to split. Tree Number 01HP

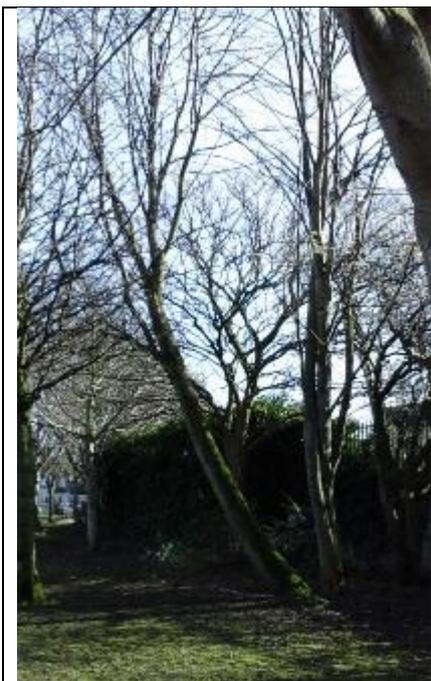
While trees can “correct themselves” by developing a balancing canopy, 2 trees will have to be removed as the lean is too advanced and due to their locations close to paths and playgrounds.

Beech tree with extensive lean close to footpath. Tree Number: 01B5.

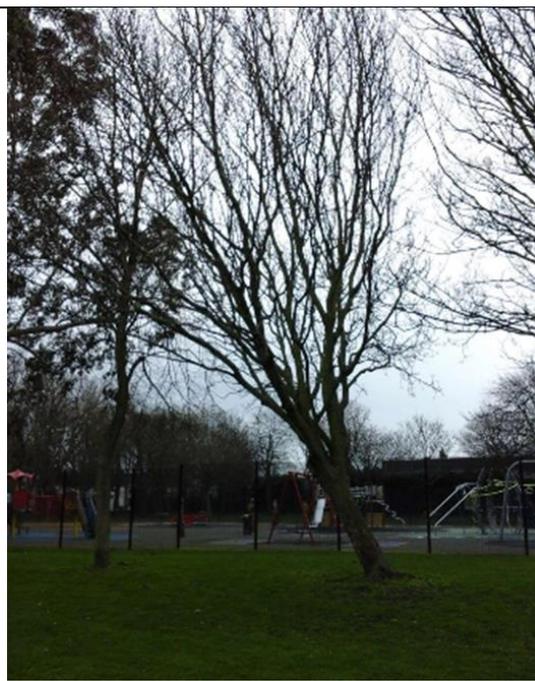
*Sorbus aria* with severe lean beside playground Tree Number: 01AL
