Re: City Architect Assessment on Condition Report of Proposed Property Disposal.

Property/Site: **The Plough, 28 Abbey Street Lower and 109 Marlborough Street, Dublin 1**

CA file reference: CA19037 The Plough, Abbey St

Site Condition (1st February 2018)

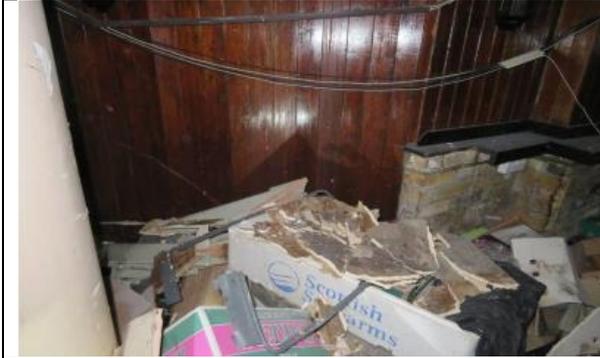
Figure 1 - Ceiling debris and previous tenant waste within public house.

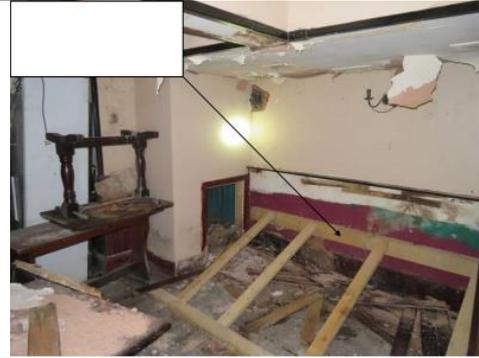
A large ope was noted as having been formed through a chimney on an upper floor which was not supported. Photographic record indicated some internal party walls had been crudely cut away and remnants left unsupported. The inspector report noted that works may have been done in recent times to '*possibly support*' basement walls '*as the luas lines runs very close to the building*'. The inspector report made recommendation that a structural engineer assess the building before any works would be carried out.

Figure 2 - Temporary supports applied to basement level external walls.

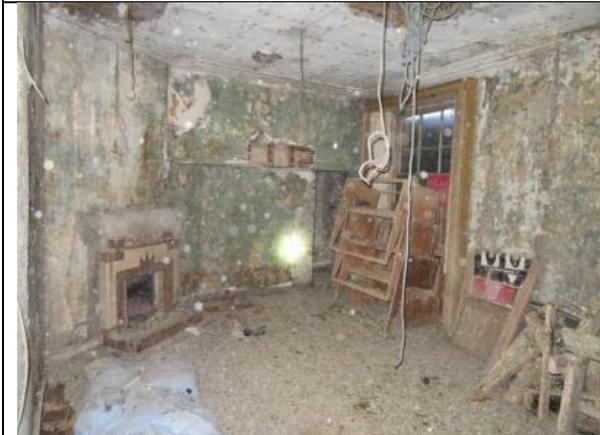
The inspector report stated that '*there is an infestation of pigeons in the building, and dropping covering all of the upper floors and stairs*' with a '*large number of plastic bags containing bird droppings stored throughout the building*'.

Figure 3 - Upper level rooms in poor condition and spoiled with pigeon droppings.

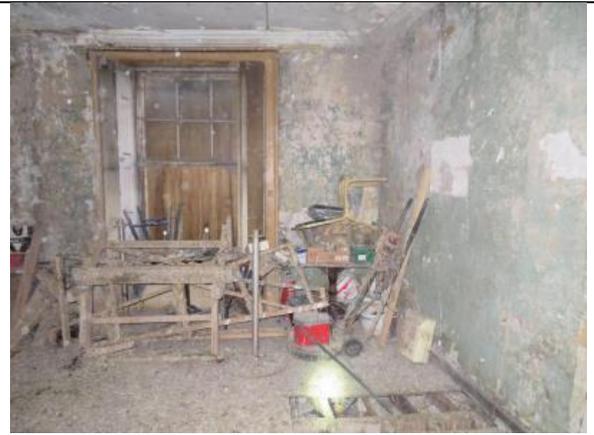
Figure 4 - Upper level rooms in poor condition and spoiled with pigeon droppings.
