**The Chairman and Members of  
North West Area Committee.**

**Meeting: 14<sup>th</sup> December 2021**

**Health & Safety Issue – Arboricultural Works, St Canice’s Graveyard, Finglas**

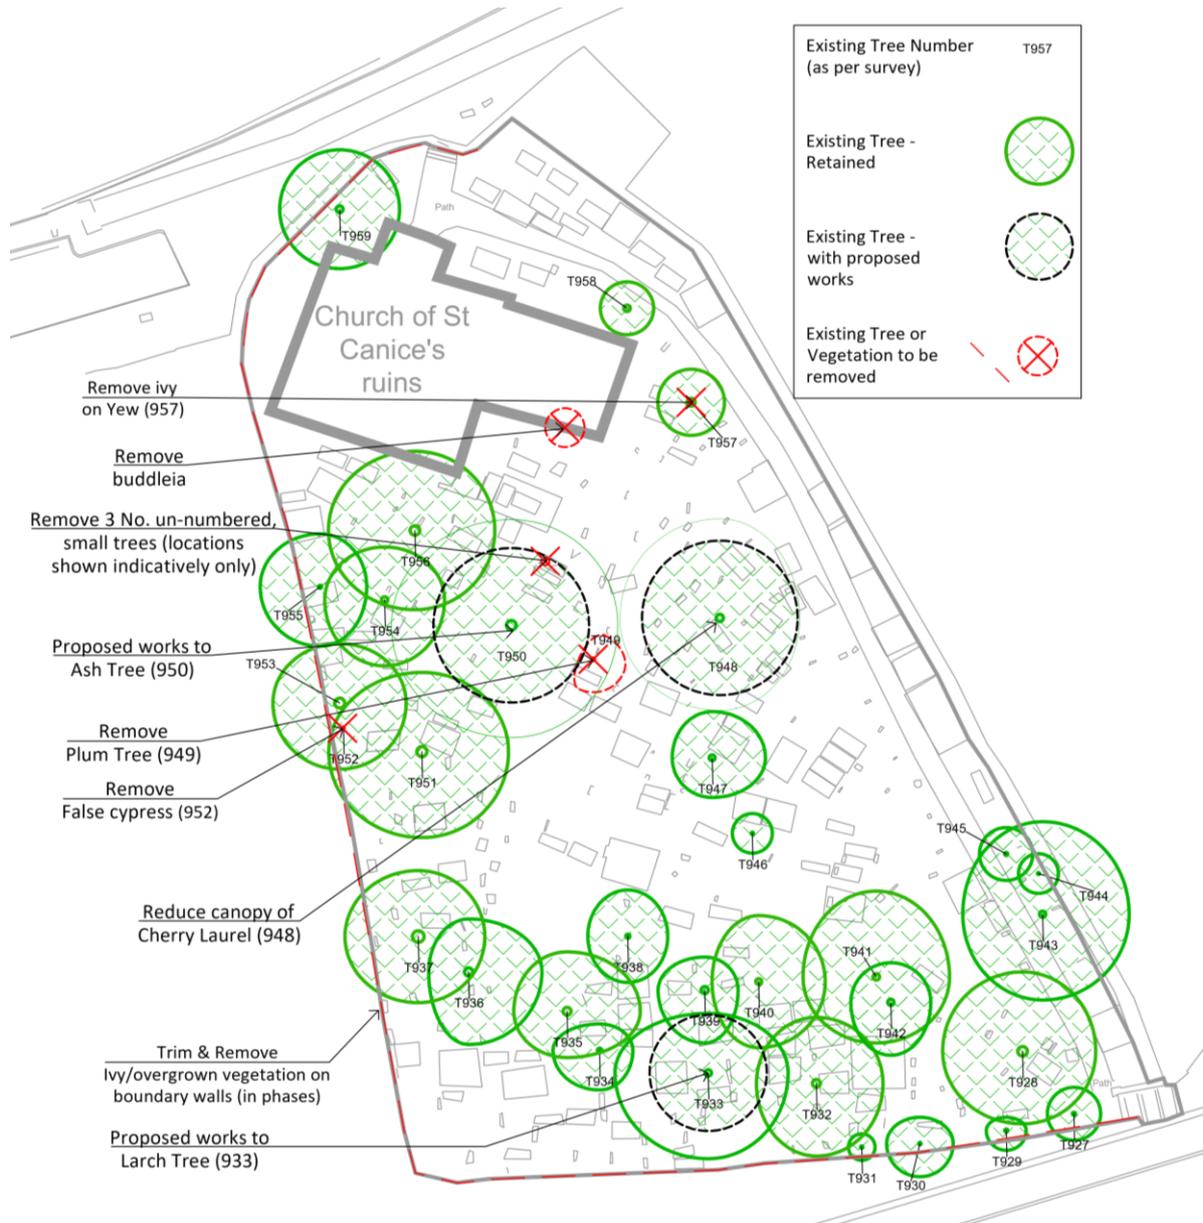
## Plan Diagram

Pertinent to this report, the survey finds that one of the trees is dead (952), one tree (949) is very poor condition; these two trees will have to be removed. These trees are summarised in the table below and illustrated in the accompanying plan diagram. These identified trees could become a health and safety issue and also damage head stones and/or the boundary wall if they fall or if limbs fall. Therefore as part of normal tree maintenance, we recommend that we remove these two trees as soon as it is possible, during the 2022 Quarter 1 winter/dormant season, to avoid any potential disturbance during the next nesting season. Also recommended by the arborists, pruning, ivy removal and dead wood removal will be carried out on a limited amount of trees.

<b>Extract of Relevant Information from the Arboricultural Assessment (Tree survey) by Charles McCorkell, September 2021</b>	
<b>Tree No.</b>	<b>Tree Species – Common Name (&amp; Latin Name)</b>
949	<b>Plum tree</b> ( <i>Prunus domestica</i> ) <ul style="list-style-type: none"> <li>• Structural condition Poor. Physiological condition Fair. Deadwood.</li> <li>• <b>Recommendation: Fell</b> - Ground level.</li> </ul>
952	<b>False cypress</b> ( <i>Chamaecyparis</i> sp.) <ul style="list-style-type: none"> <li>• Dead</li> <li>• <b>Recommendation: Fell</b> - Ground level.</li> </ul>
950	<b>Ash Tree</b> ( <i>Fraxinus excelsior</i> )

<ul style="list-style-type: none"> <li>• <i>Recommendation:</i> Reduce the canopy of the tree by 2m in width and 4m in height and monitor on a biannual basis. If retaining for the long term, further reductions in the future will be required due to the decay present.</li> </ul>
948	<p><b>Cherry Laurel:</b> (<i>Laurocerasus officinalis</i>)</p> <ul style="list-style-type: none"> <li>• <i>Recommendation:</i> Reduce canopy by 1.5- 2m all over, ensuring a greater reduction is carried out on heavily weighted laterals</li> </ul>
957	<p><b>Irish Yew</b> (<i>Taxus baccata 'Fastigiata'</i>)</p> <ul style="list-style-type: none"> <li>• <i>Recommendation:</i> Remove ivy.</li> </ul>
933	<p><b>European Larch</b> (<i>Larix decidua</i>)</p> <ul style="list-style-type: none"> <li>• <i>Recommendation:</i> Remove deadwood</li> </ul>
