Report No. 71/2023  
Report of the Assistant Chief Executive

**Review of the Architectural Heritage Assessment of 18 Moore Street, Dublin 1, dated 21 March 2022, with reference to the motion brought forward from the Planning and Urban Form SPC meeting of September 2021 for the addition of the façade of 18 Moore Street to the Record of Protected Structures, as agreed at the monthly meeting of the City Council on 7 November 2022.**

Architectural Heritage Assessment of **18 Moore Street, Dublin 1**, in relation to the City Council Motion to add the terrace at 10-25 Moore Street to the Record of Protected Structures

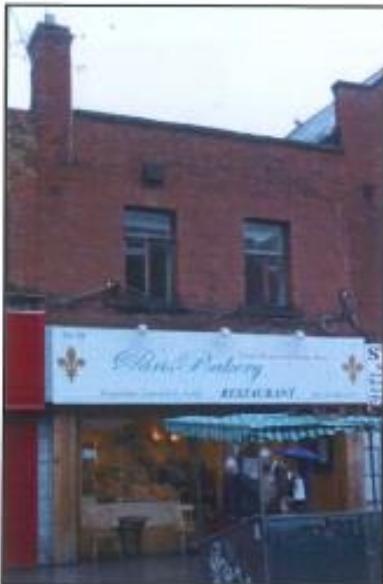
Plate 50

Both houses were in ruins immediately prior to the Rising and the façades reflect this in fabric and composition (Plates 50 and 51). The opening up of plaster from within No. 17 and No.20 both revealed concrete block party walls, thus confirming the post-1916 date. There were no claims made subsequent to the battle and evidence from the Ordnance Survey suggests that No. 19 was still unbuilt upon as late as 1939.

No. 18 Moore Street

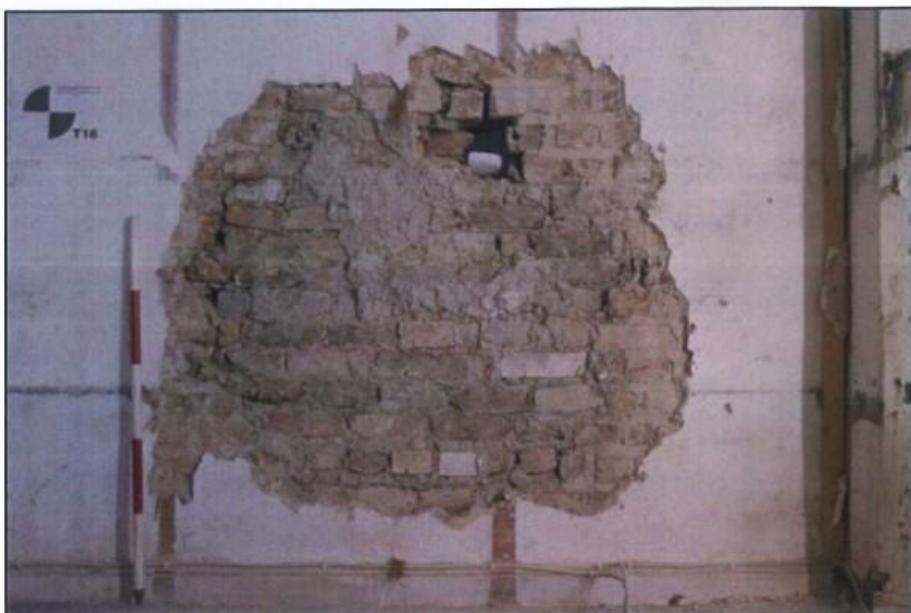
Plate 65 Location of opening within No. 17, at far side of Plate 64

Further stripping undertaken in No. 17 quickly indicated that the party wall with No. 18 was composed of concrete blocks which post-dated the events of the Rising.

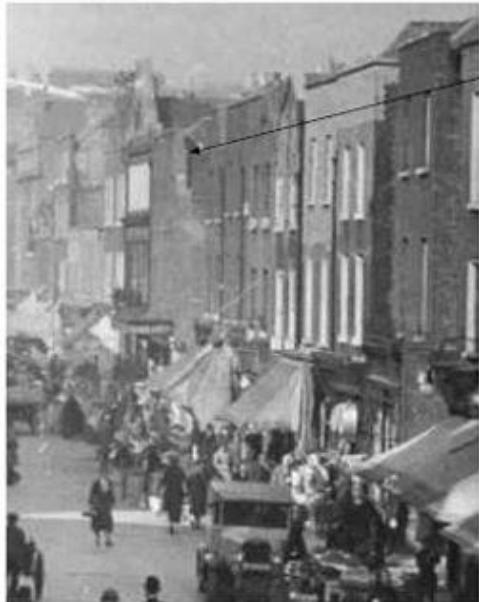
Moore St. c.1930  
Damage to no.18

The point at which the height of the building was reduced can be established as happening sometime between 1930 and 1950. Photographic evidence from a picture taken in 1930 shows damage and a collapsed wall at second floor level to no. 18 Moore Street.

The extent of this damage eventually led to partially demolishing the front elevation, and roof, and reducing the building height of the building to two stories over basement. An early 1950's photograph of Moore Street clearly shows the buildings as they are today, i.e. 2 stories over basement.

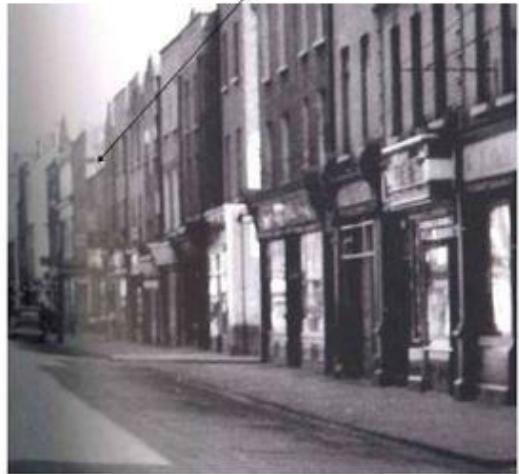
Moore St. c.1952  
No.18 & 19

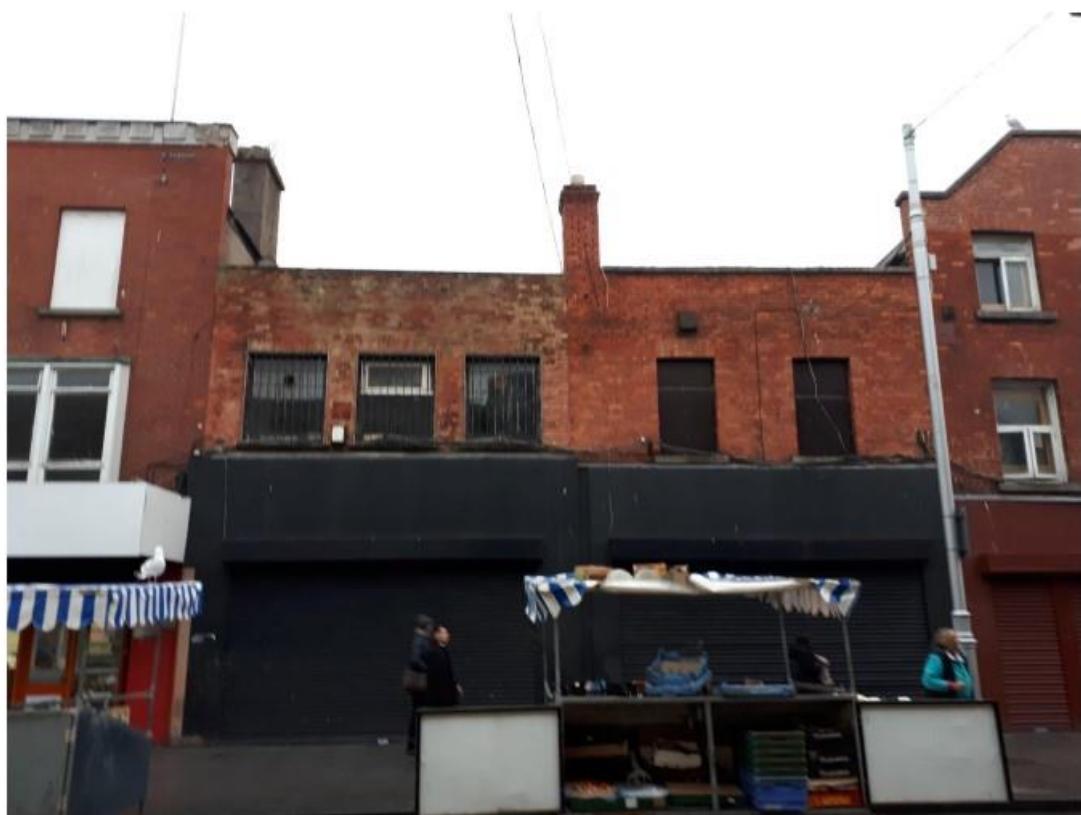
Fig 9: Nos 18 (R) and 19 (L)

#### No 18 Moore St (R in picture)

**Compensation:** No claims for damage under 1916 Compensation Act

**Thom's Directory** No 18 is listed as 'in ruins' between 1914 and 1921. In the 1915 Valuation books it was listed as 'house and yard ruins'. In the 1916 books the building was described as being in ruins. In the Bureau of Military History witness statements, William Saurin stated: '... we had to cross an empty space where a house had once stood and were hidden from the street only by a flimsy wooden boarding'. Another, Sean McLoughlin, noted in relation to the tunneling: 'We had now reached Hanlons. There *was an open space* between there and the next house. We got as far as Hanlons and I instructed them to continue the digging until, if possible, they reached what is now O'Rahilly Street, then Sackville Lane'.

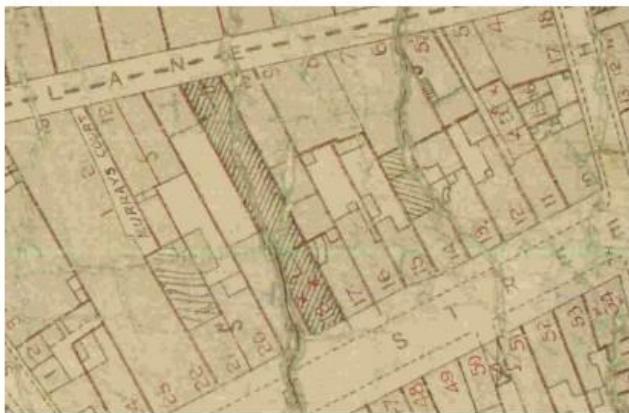
**Fig 11:** shows a Valuation Office map of the post-1916 period, showing derelict sites in the area. No 18 is clearly shown as derelict.

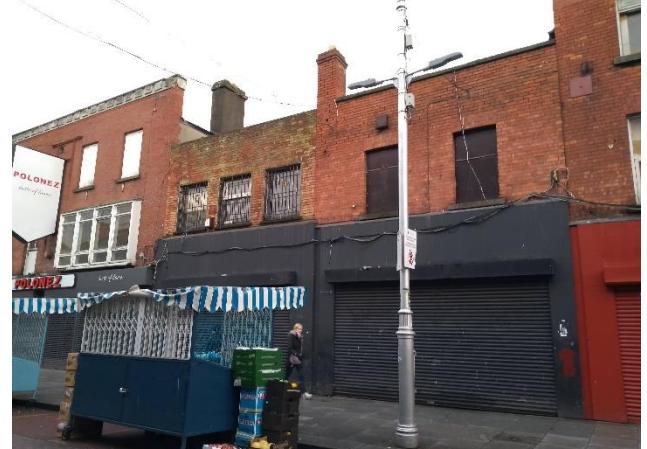
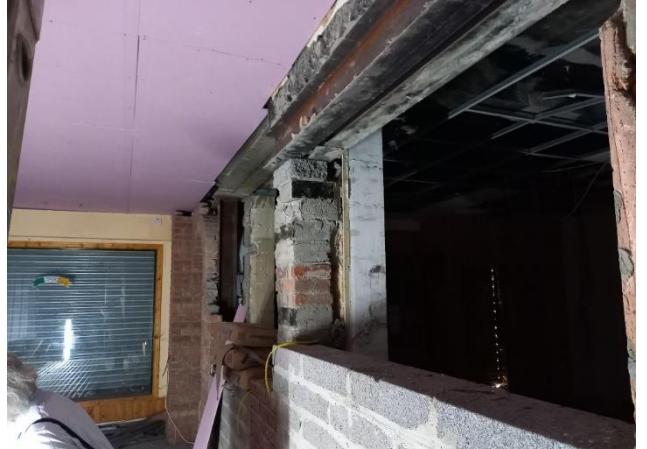
Fig. 2: View of 18 Moore Street (RHS) with 19 Moore Street (LHS)	Fig. 3: ground floor interior of 18 Moore Street

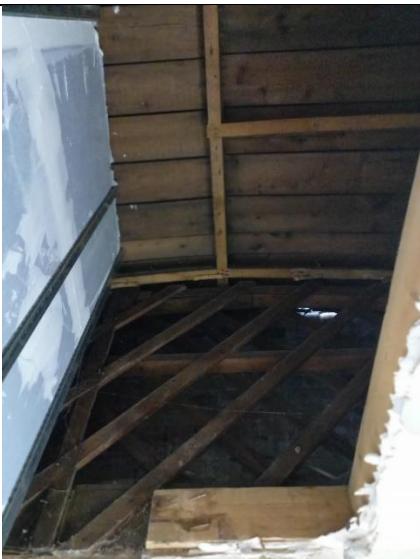
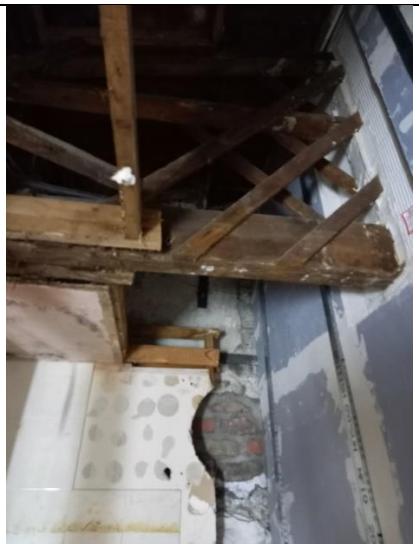
Figs. 4 & 5: View of Belfast Truss supporting curved roof.

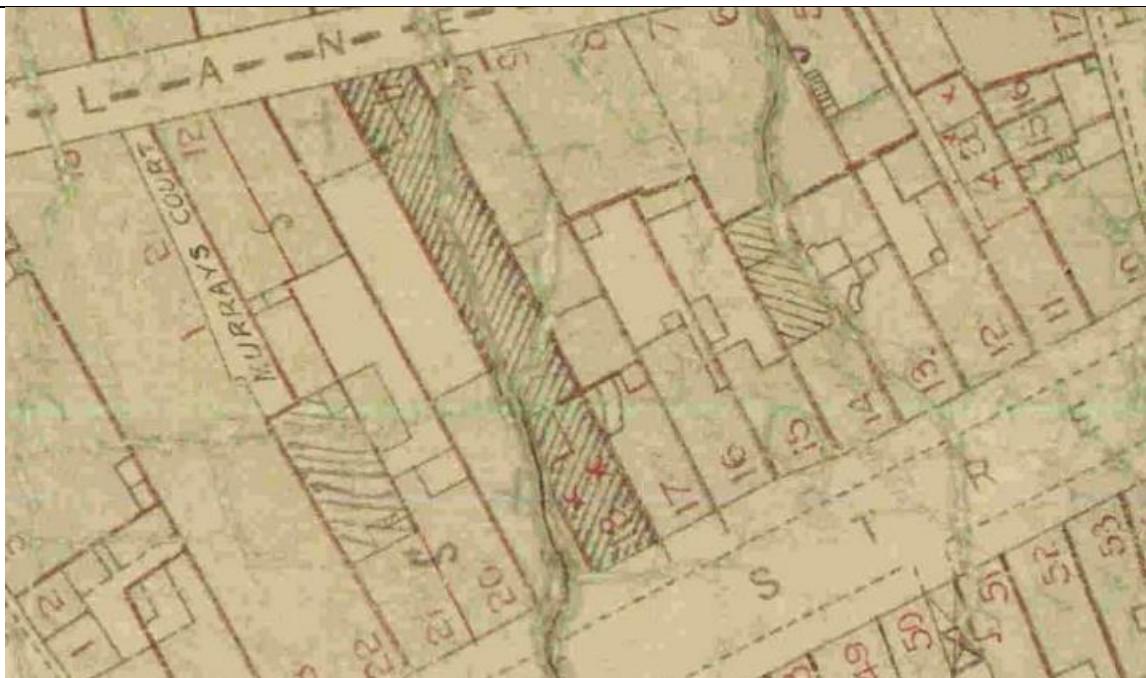
Fig. 8: Post-1916 Valuation Map illustrating 18 Moore Street (in black cross hatching) as derelict.
