RE: Amended Review of the Architectural Heritage Assessment of 18 Moore Street, Dublin 1, dated 21 March 2022, with reference to the motion brought forward from the Planning and Urban Form SPC meeting of September 2021 for the addition of the façade of 18 Moore Street to the Record of Protected Structures, as agreed at the monthly meeting of the City Council on 7 November 2022.

Amended Review of the Architectural Heritage Assessment of 18 Moore Street, Dublin 1

Architectural Heritage Assessment of **18 Moore Street, Dublin 1**, in relation to the City Council Motion to add the terrace at 10-25 Moore Street to the Record of Protected Structures

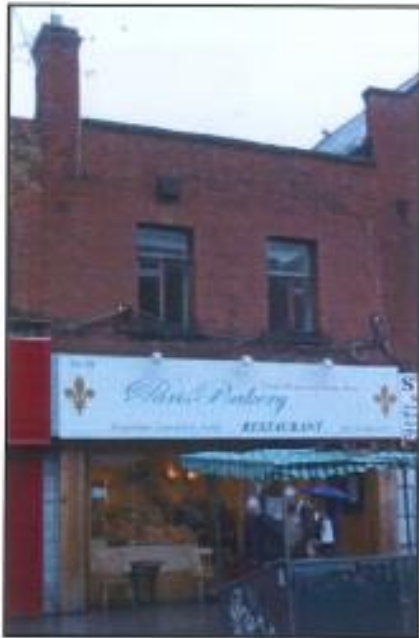
Plate 50

Both houses were in ruins immediately prior to the Rising and the façades reflect this in fabric and composition (Plates 50 and 51). The opening up of plaster from within No. 17 and No.20 both revealed concrete block party walls, thus confirming the post-1916 date. There were no claims made subsequent to the battle and evidence from the Ordnance Survey suggests that No. 19 was still unbuilt upon as late as 1939.

No. 18 Moore Street

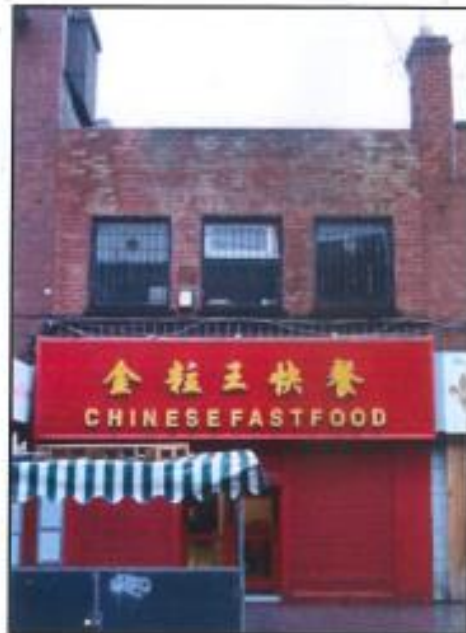
Plate 51

No. 19 Moore Street

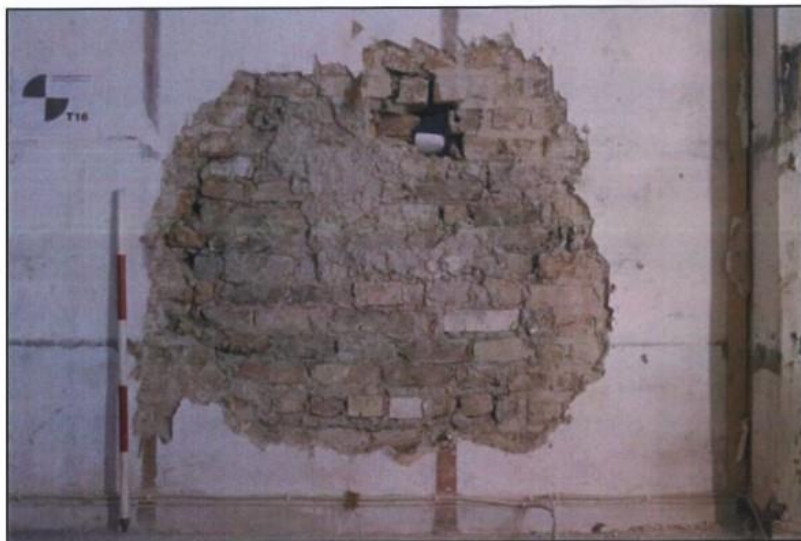
Plate 65 Location of opening within No. 17, at far side of Plate 64

Further stripping undertaken in No. 17 quickly indicated that the party wall with No. 18 was composed of concrete blocks which post-dated the events of the Rising.

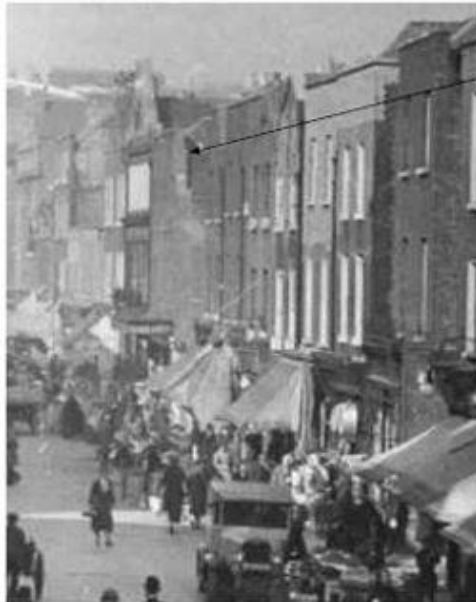
Photo 02.

Moore St. c.1930
Damage to no.18

The point at which the height of the building was reduced can be established as happening sometime between 1930 and 1950. Photographic evidence from a picture taken in 1930 shows damage and a collapsed wall at second floor level to no. 18 Moore Street.

The extent of this damage eventually led to partially demolishing the front elevation, and roof, and reducing the building height of the building to two stories over basement. An early 1950's photograph of Moore Street clearly shows the buildings as they are today, i.e. 2 stories over basement.

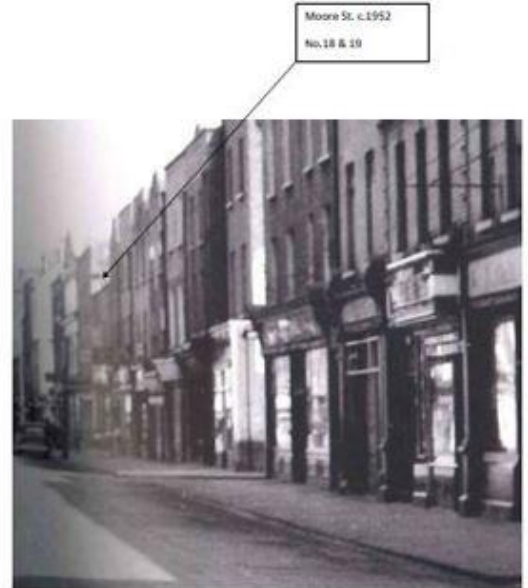
Photo 03 – Moore Street circa. 1950

Moore St. c.1950
No.18 & 19

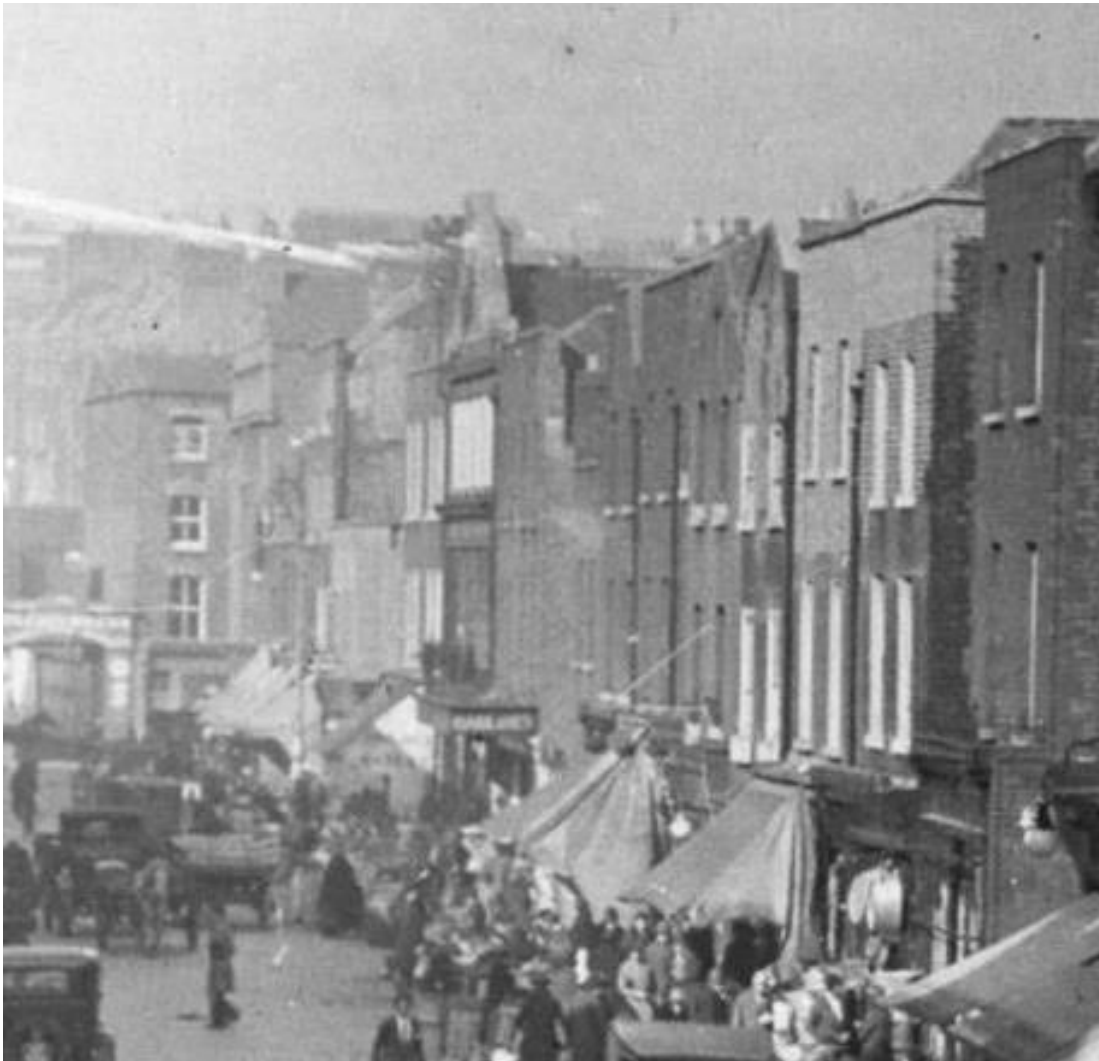
A Cropped Enlargement from Photograph of Moore Street, 1930

Although the enlargement is blurred, elements of some of the buildings may be made out or interpreted, including (from left to right):

- The large (light) triangular pediment on top of Nos. 22/23 with pitched roof (dark) behind, later demolished.
- The projecting canopy above the ground floor of Nos. 20/21 (Hanlon's).
- The flat cornice to raised parapet to front facade of Nos. 20/21, with angled hipped roof of No. 20 (dark) & ridge tiles (light) behind/to right.
- Chimney stack, with stepped coursing, to parapet above first floor of No. 18, topped with chimney pot (light grey).
- The triangular pediment of No. 17; the flat raised parapets to both Nos. 16 and 15, the pediment to No. 14 (appears triangular, actually rounded); the triangular pediment to No.13, later demolished; the flat raised parapets to both No. 12 and No. 11; and the 3-storey façade of No. 10 on the right at the end of the terrace.

It is somewhat unclear, but what seems to be referred to as the damage to 18 Moore Street (see Appendix 2, Photo 02 further above), may be interpreted as the side of the three storey front facade of No. 20, exposed by the lower height of 19 Moore Street. See also the 1950s photograph of Nos. 10-25 Moore Street by the Bureau of Military History (below).

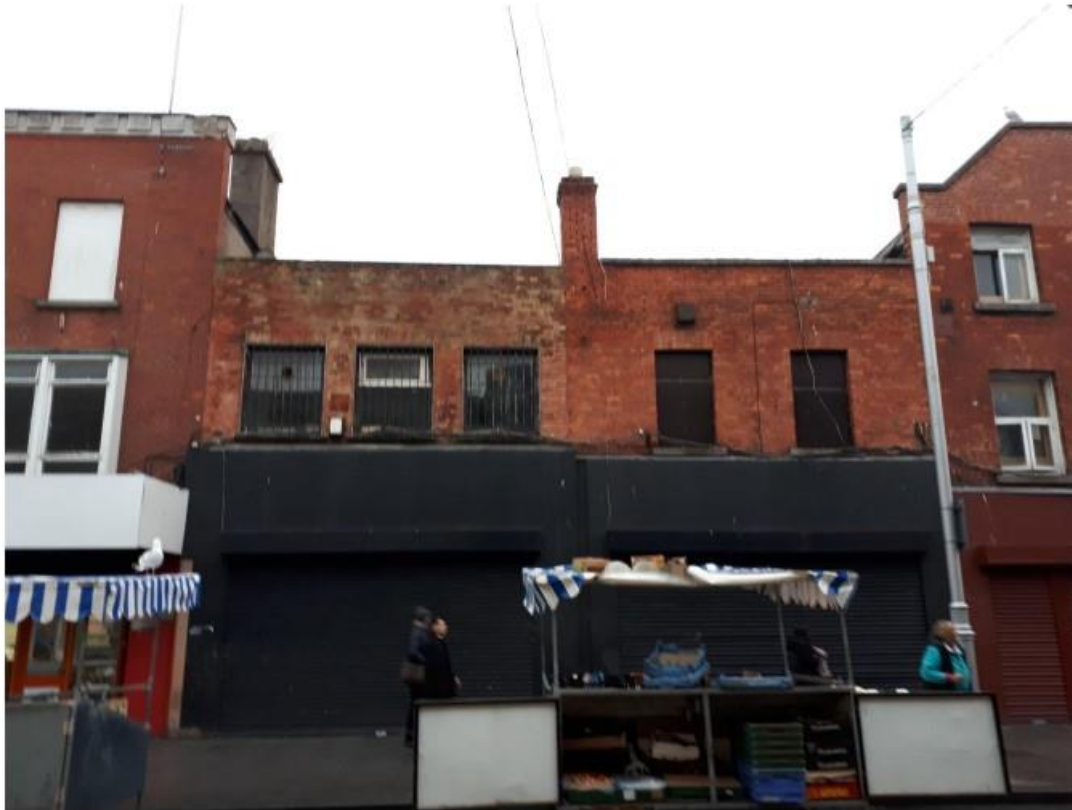
Fig 9: Nos 18 (R) and 19 (L)

No 18 Moore St (R in picture)

Thom's Directory No 18 is listed as 'in ruins' between 1914 and 1921. In the 1915 Valuation books it was listed as 'house and yard ruins'. In the 1916 books the building was described as being in ruins. In the Bureau of Military History witness statements, William Saurin stated: '... we had to cross an empty space where a house had once stood and were hidden from the street only by a flimsy wooden boarding'. Another, Sean McLoughlin, noted in relation to the tunneling: 'We had now reached Hanlons. There *was an open space* between there and the next house. We got as far as Hanlons and I instructed them to continue the digging until, if possible, they reached what is now O'Rahilly Street, then Sackville Lane'.

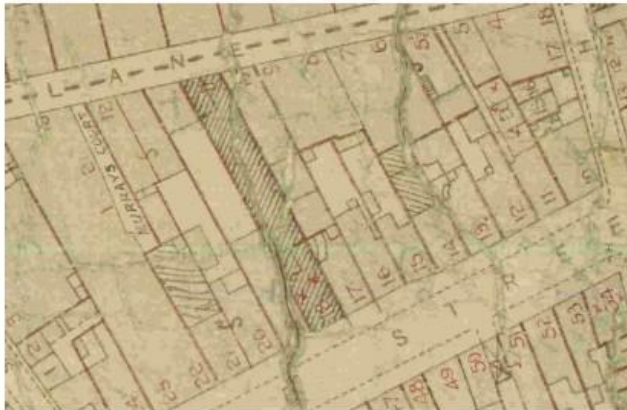
Fig 11: shows a Valuation Office map of the post-1916 period, showing derelict sites in the area. No 18 is clearly shown as derelict.

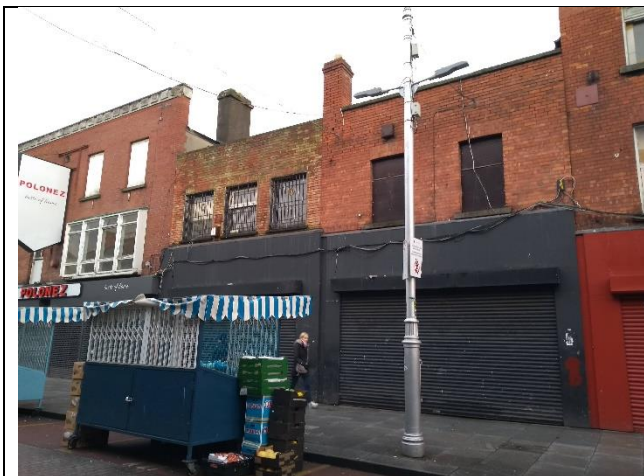
Fig. 2: View of 18 Moore Street (RHS)
with 19 Moore Street (LHS)

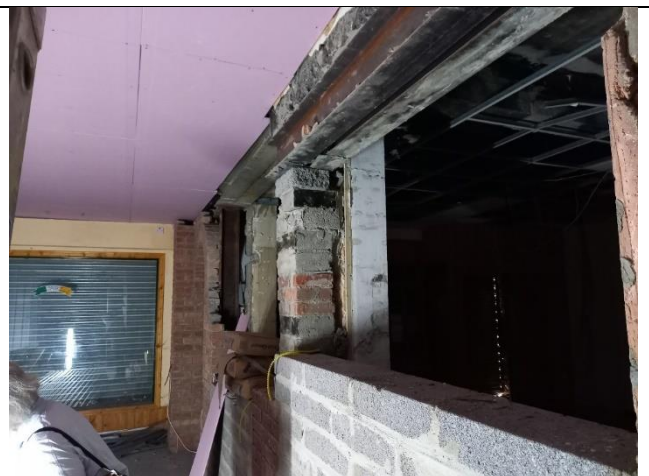
Fig. 3: ground floor interior of 18 Moore Street

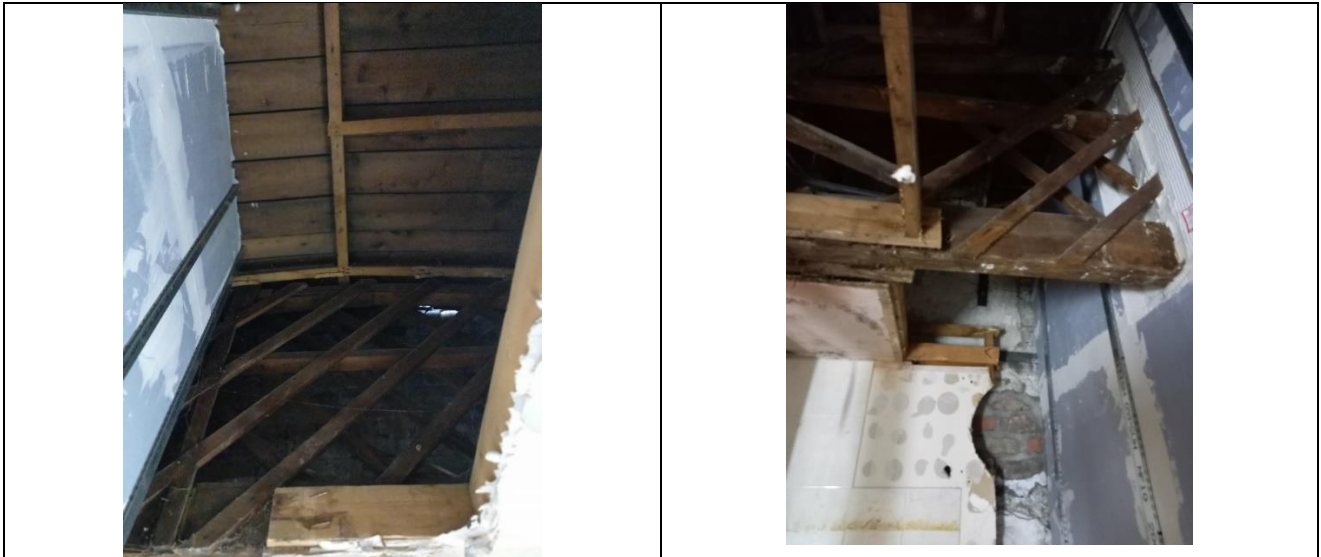
Figs. 4 & 5: View of Belfast Truss supporting curved roof.

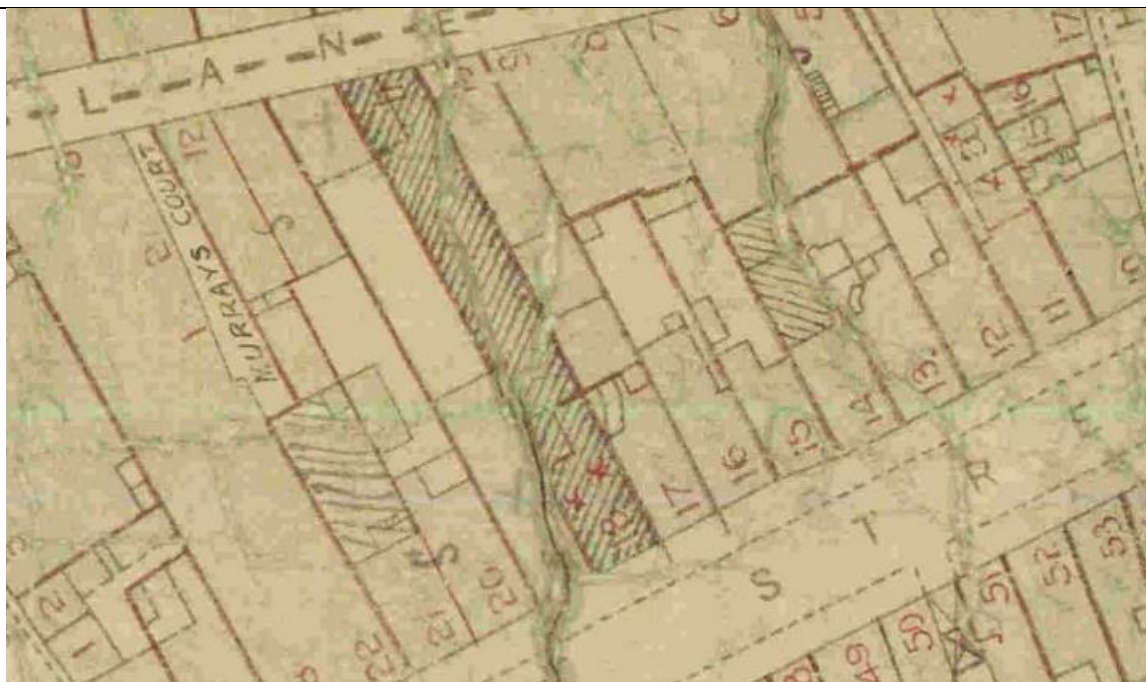
Fig. 8: Post-1916 Valuation Map illustrating 18 Moore Street (in black cross hatching) as derelict.
