### <u>Sandymount carriageway collapse – April 2024</u>

17<sup>th</sup> April 2024

#### Roy O'Connor, Senior Engineer, reports on the matter as follows:

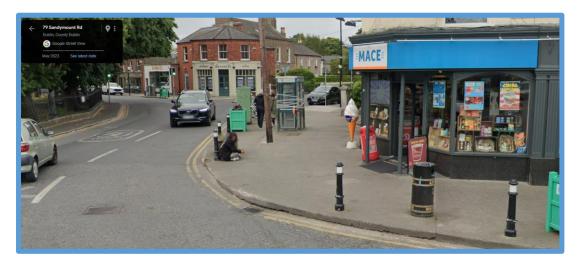
# Appendix A

On the afternoon of Wednesday the 10<sup>th</sup> April, Dublin City Council (DCC) received a report of a 'sinkhole' appearing in Sandymount Green outside the Mace shop (see Appendix A).

Location of the collapse on Sandymount Green, specifically on the carriageway surrounding the gully visible in the foreground of the photo below:

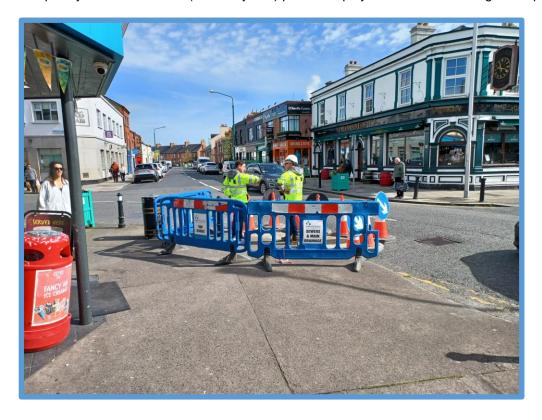
## Appendix B

On Thursday morning (11<sup>th</sup> April) staff from the Environmental Protection Division (Surface Water Management section) assessed the extent of void to determine the likely cause of the exposed void under the carriageway (Appendix B). The void under the carriageway covers an area of approximately 5x5m square and approximately 1.2m in depth. Initial assessment of the cause appears to be that the void was formed over a prolonged period of time, whereby the sandy soils (typically to the Sandymount area) have slowly washed into the drainage network, forming the void which eventually undermined the structural integrity of the carriageway layer above.

Temporary site cordoned off (Thursday 11th) prior to deployment of traffic management plan.

Temporary traffic management plans were put in place to allow the safe passage of traffic and pedestrians through the junction and to ensure access to local businesses and properties is unimpeded. This included a 4 way stop/go traffic management arrangement (Thursday evening) which continues to be in place due to the unsafe nature of the site location being on a well trafficked bend on the road.
