Report to North Central Area Committee 20th November 2023

Re: Flooding In Clontarf on the 05th of August 2023.

Report prepared by Dublin City Council in conjunction with Nicolas O' Dwyer LTD

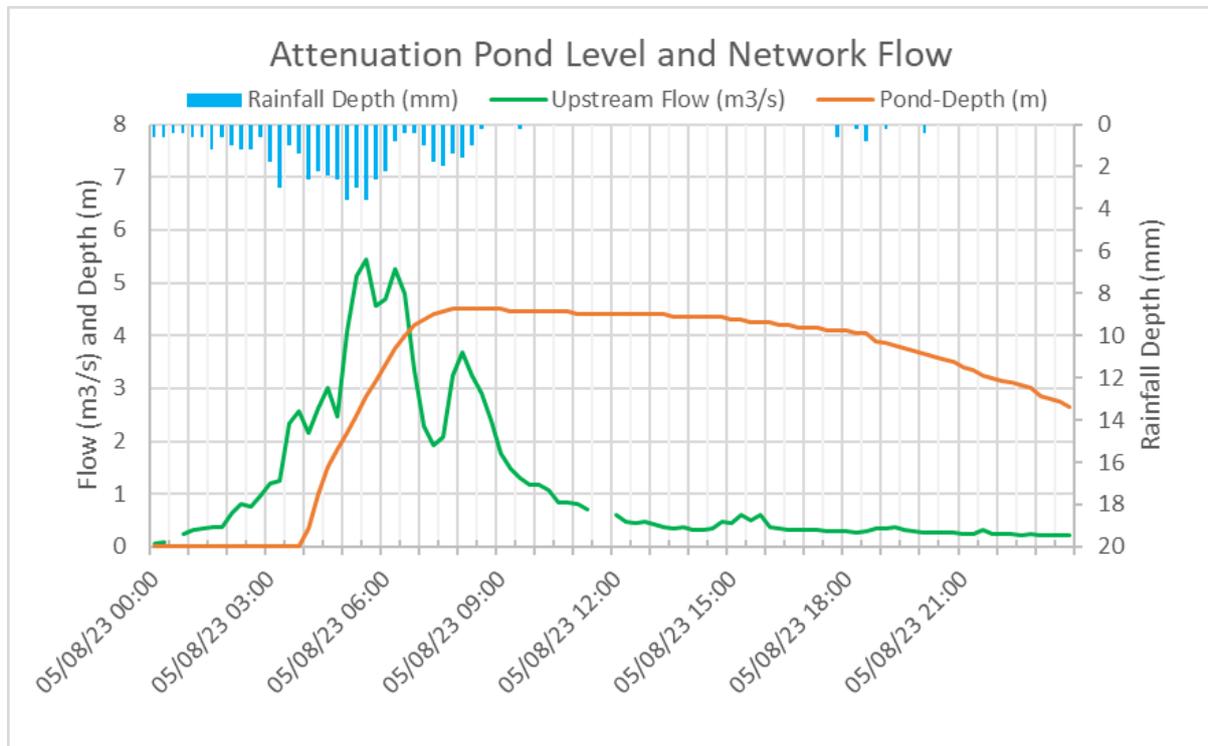
Figure 2-1: Recorded flows and pond levels

The recorded data (Figure 2-1) shows that the flows upstream of the Clontarf Golf Club pond increased steadily from approximately 0.3m³/s at 1am to approximately 2.5m³/s at approximately 4:45am. Flows then increased rapidly to more than 5m³/s by 5:15am.

Based on the recorded data, the attenuation pond in the golf course started to receive flow at approximately 3:47am. Between 3:47am and 10am that same day approximately 70,000m³ of water was diverted into the attenuation pond.

The attenuation pond has a capacity of approximately 35,000 m³, so at approximately 7am the pond overflowed causing flooding of the golf course. At 8:05am the flooding on the golf course had reached the elevation of the recording instruments in the flow return chamber no. 3 (FRC3), recording a fault event as those recording instruments went offline. These instruments are for recording only and are not involved in controlling the attenuation system, so their loss did not impact the system operation.

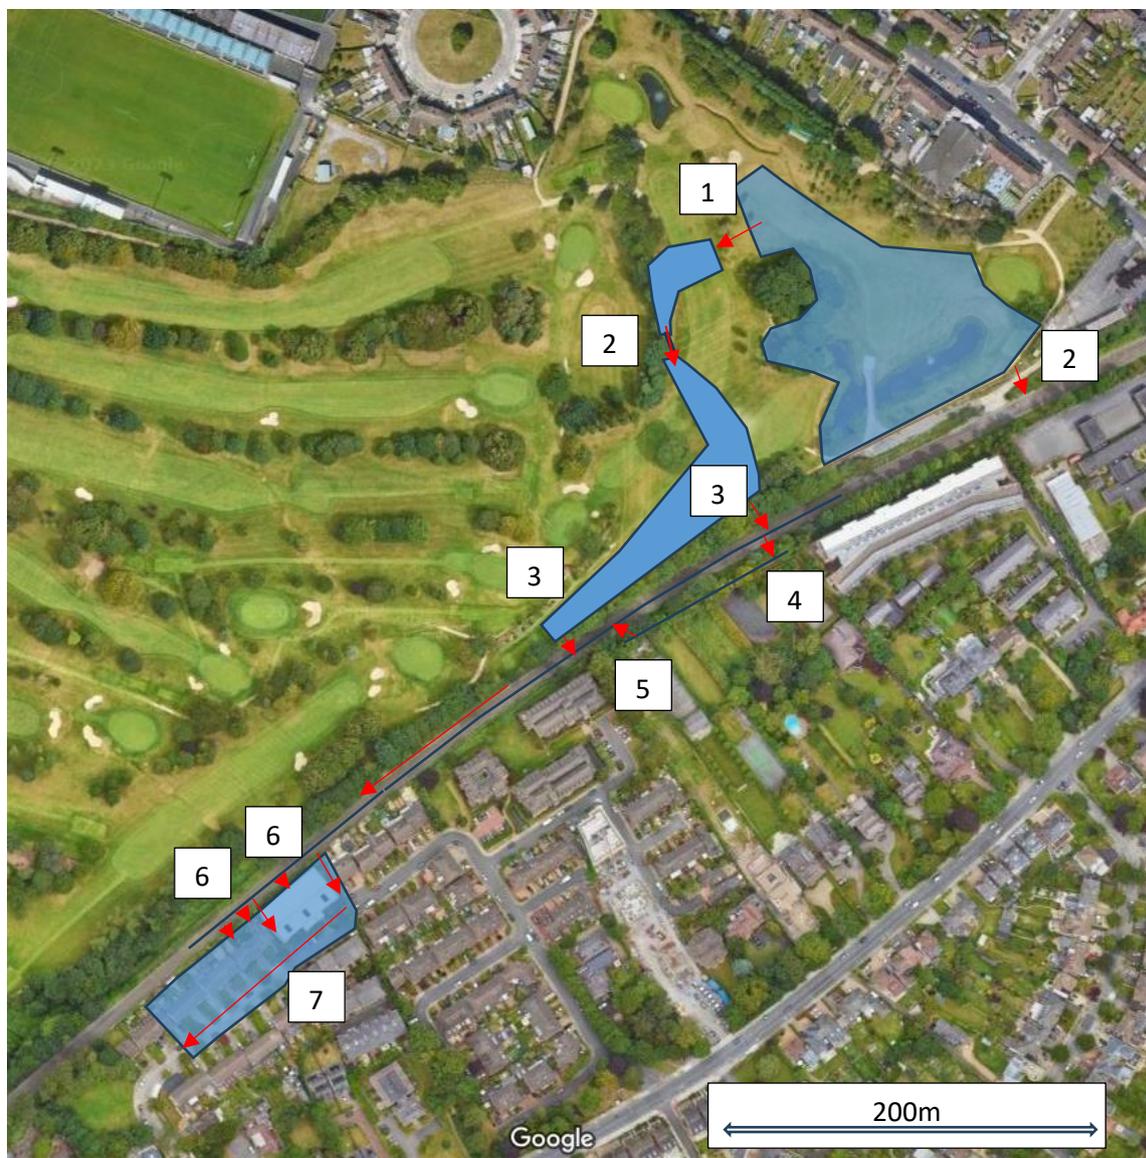
Figure 2-2 Sequence of flooding, 5th August 2023

The stored water escaped from the golf course onto the adjoining railway tracks via several low points in the boundary and via some potential seepage around the pond wall. Some flow also escaped via the old Wad culvert beneath the railway track. This joins into the trackside drainage and contributed to flooding of the railway line.

As water accumulated on the railway line it flowed southwest along the railway track following the gradient of the tracks. The ground level on the south side of the railway is initially high in the vicinity of the No. 150 Howth Road complex, and remains high into the Apartments at Ashbrook. Continuing southwest the houses at Ashbrook are at a level with the tracks but are protected by a solid wall between the tracks and the gardens. The ground surface at the next property southwards, the Auburn Apartments, is approximately 1m below the level of the tracks, and the divider between the apartments and the track is a wooden slat fence. The rear gardens of the adjoining Castle Court

At approximately 8:45 am the flood waters on the railway line came beneath and through the wooden fence, particularly at the rear of the Auburn Apartments, and flooded the surrounding landscaping. The basement car park of the Auburn Apartments has several large ground level ventilation openings at the rear and side of the building, and these allowed water to rapidly fill the car park.

Some flow was coming through the fences into the rear gardens at Castle Court by this time, however it appears that the main flow of flood water came around the northern side of the Auburn Apartments onto the road. This road is at a higher elevation than the houses on the northern side of the road so floodwaters flowed down the driveways of these houses and into the houses.

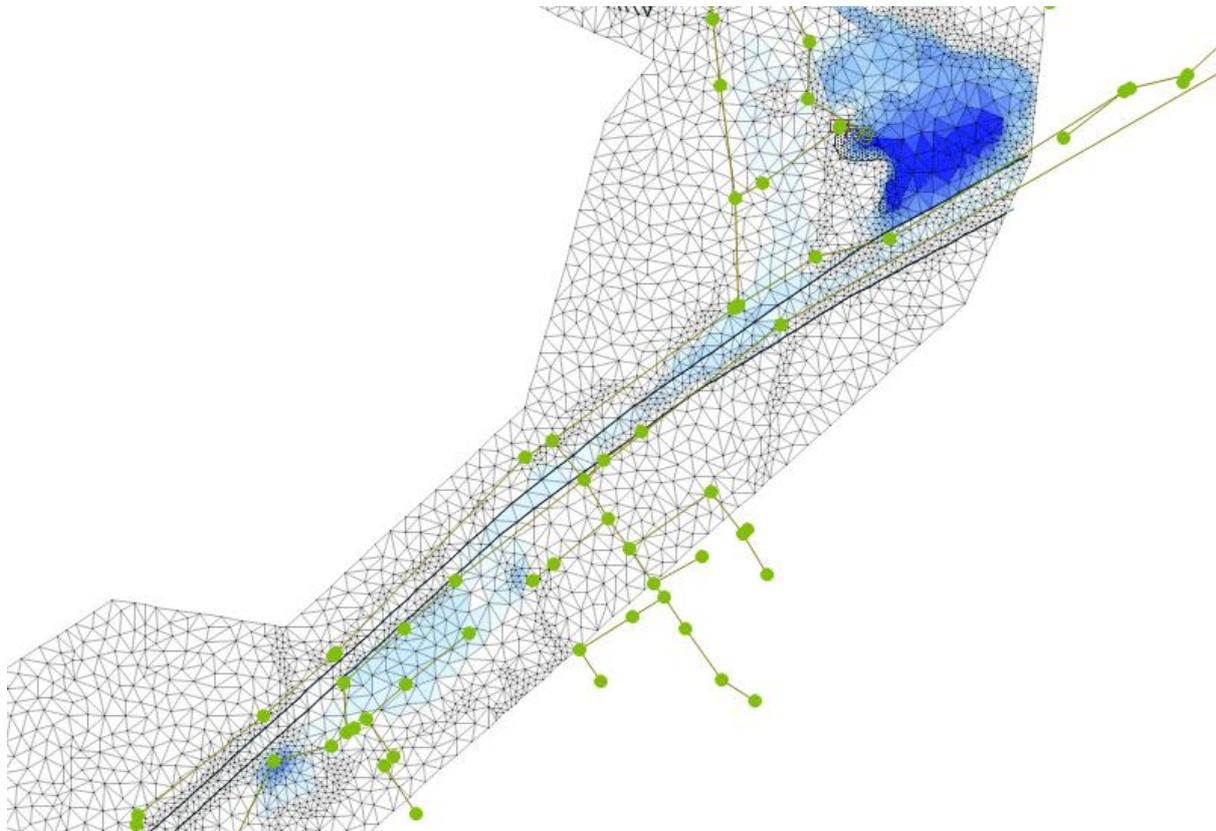
By 7:45am the pond level had reached the bank level of the earthworks on the golf course and the pond overflowed into the course. At 8:05am the flow and level instruments at Flow Return Chamber (FRC3) went offline, indicating that water had reached the level of the instrument kiosk. These instruments are for recording only and are not involved in controlling the attenuation system, so their loss did not impact the system operation.

NOD has model the sequence of events which caused the flooding on the day and a screenshot of the model predicted flooding is shown below, which is in line with the flooding encountered on the day.

Using the hydraulic model as a design tool it is possible to optimise and increase the setpoints which control the system operation and to improve the functionality of the system. The improved functionality allows for a greater flow within the existing Wad Culvert, before the system enters active mode and allows for greater flows within the existing Wad Culvert during flood active mode, thus decreasing the flow to the attenuation pond and optimising its storage capacity. The design team has noted that there is a balance required between passing enough water to prevent the pond overflowing and retaining enough water to prevent flooding at the Howth Road. However, using the hydraulic model as a design tool NOD are satisfied that the setpoints can be increased to allow for the optimal performance of the system. NOD has issued revised setpoints for the system controls, which have been implemented within the control logic.

The hydraulic model estimates that had these setpoints been in place on the 05th of August the building flooding theoretically may not have happened, as the flows to the attenuation pond may have been managed and the attenuation pond may not have reached capacity and over spilled.
