ARCHITECTURAL HERITAGE ASSESSMENT

PROPOSED SANDYMOUNT FLOOD DEFENCES

Strand Road, Sandymount, Dublin 4

Client: Dublin City Council

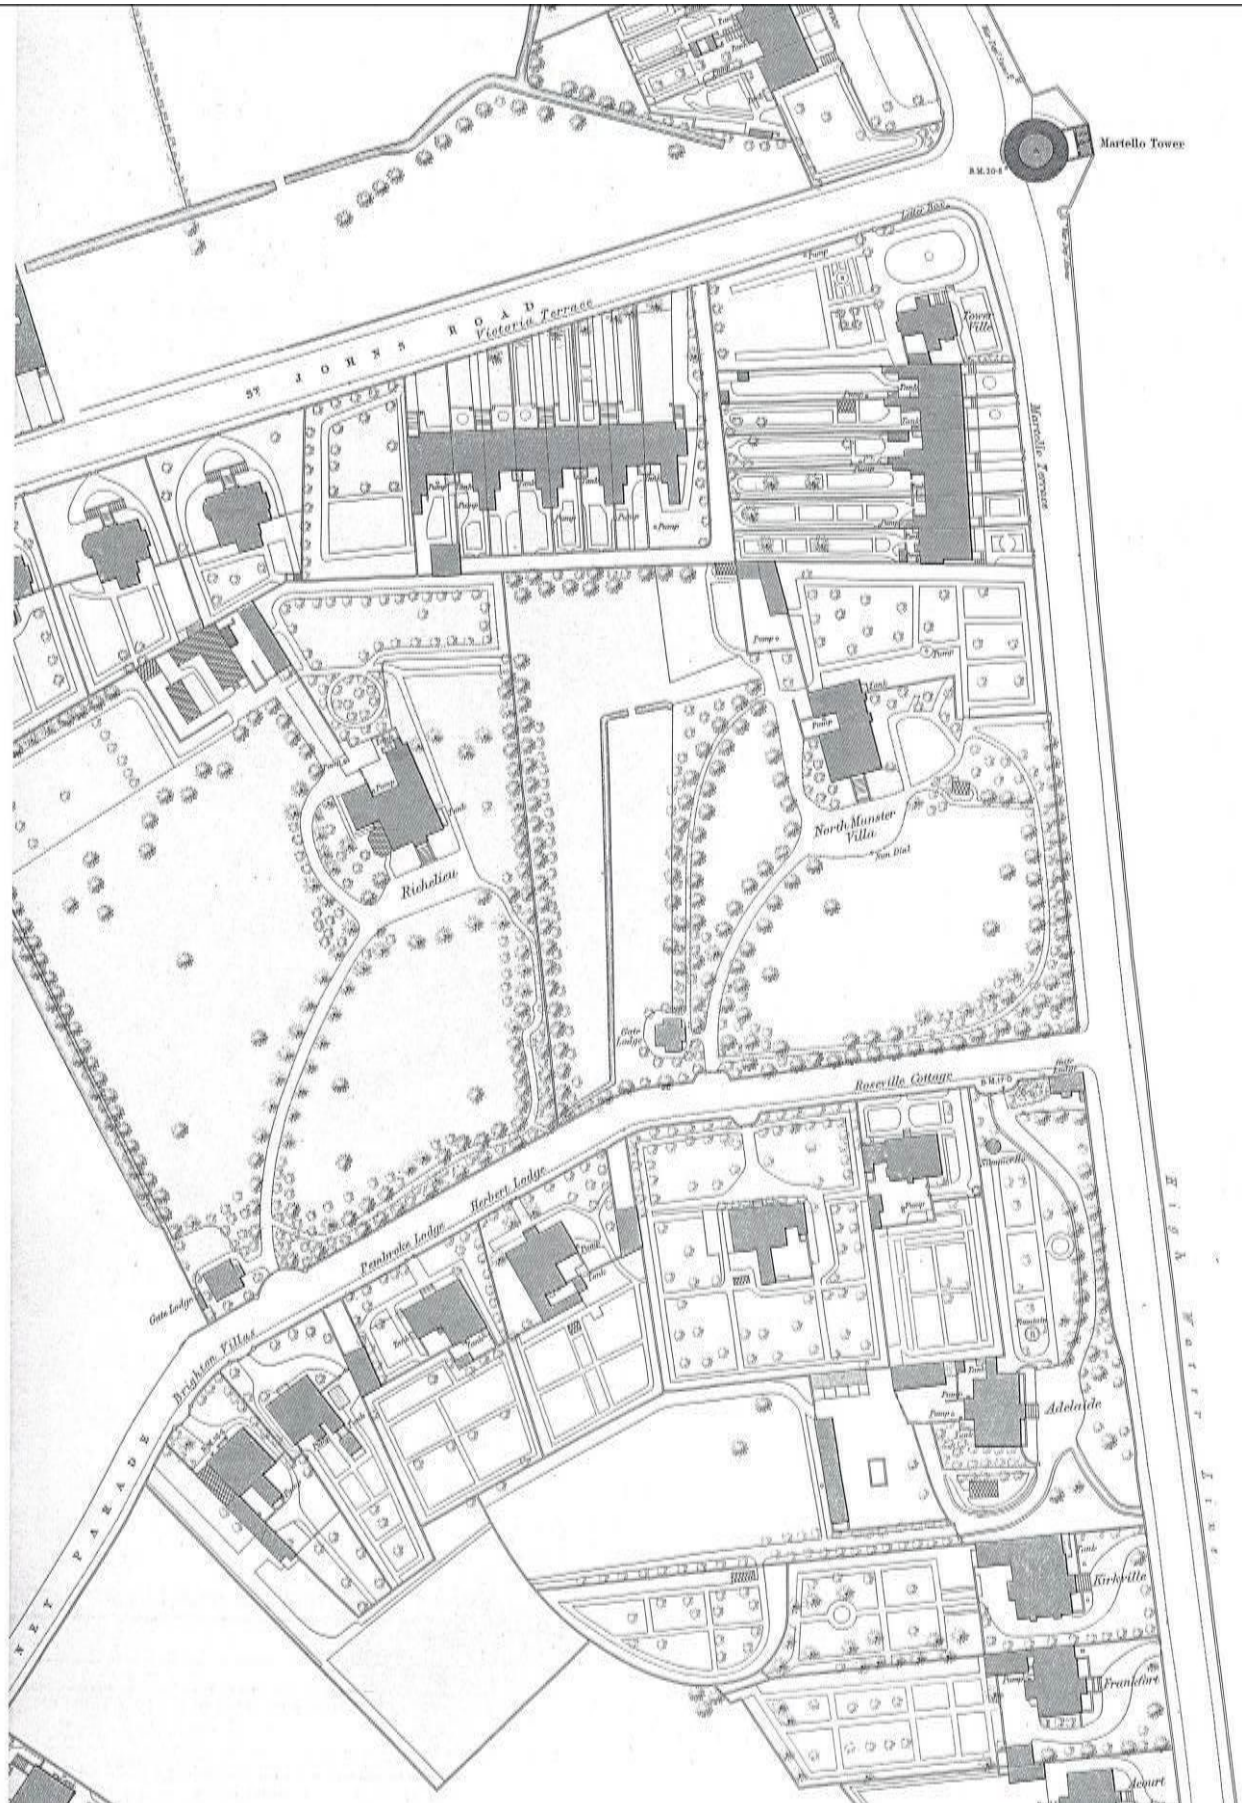
Fig. 8: Martello Tower and stretch of wall to south (as far as present carpark) as shown on large-scale OS map surveyed 1865 (original scale 5' to 1 mile)

The large-scale Ordnance Survey 5' map surveyed in 1865 gives a detailed layout of the Strand Road, then named Beach Road, including the wall and the Martello Tower. It shows only four breaks in the sea wall in the Proposed Works Area:

1. A narrow break at the present 'Gap 1', then a single opening with a projecting landing and four steps descending parallel to the sea wall on the strand side

2. A slipway c. 130m north of the Martello Tower. Shown on a Lawrence Collection photo of c. 1900 (see Figs. 12, 13 and 19), this survives today as a recess in the line of the wall.

3. A narrow feature just north of the Martello Tower at the present 'Gap 5', then having a flight of five steps beginning in the footpath and running perpendicular to the wall. It is not clear from the map if these descended through a break in the wall from footpath level to the strand, or rose up onto the top of the wall without a break. A freestanding OS 'War Dept Stone' shown next to this does not survive today.

4. A curved indent to the south of the Martello Tower at the present 'Gap 6'. This lay at the point where the sea wall splayed out to surround the tower on its seaward side. The indent is shown on a Lawrence Collection photo of c. 1900 (see Figs. 9 and 15) but does not survive today. A freestanding OS 'War Dept Stone' shown next to this does not survive today.

The Martello Tower is shown having a small low ancillary building on the seaward side, now replaced by a two-storey extension. The sea wall extended forward to meet this structure on both sides. A flight of steps rose around the road-facing side of the tower, visible also in a historic photograph).

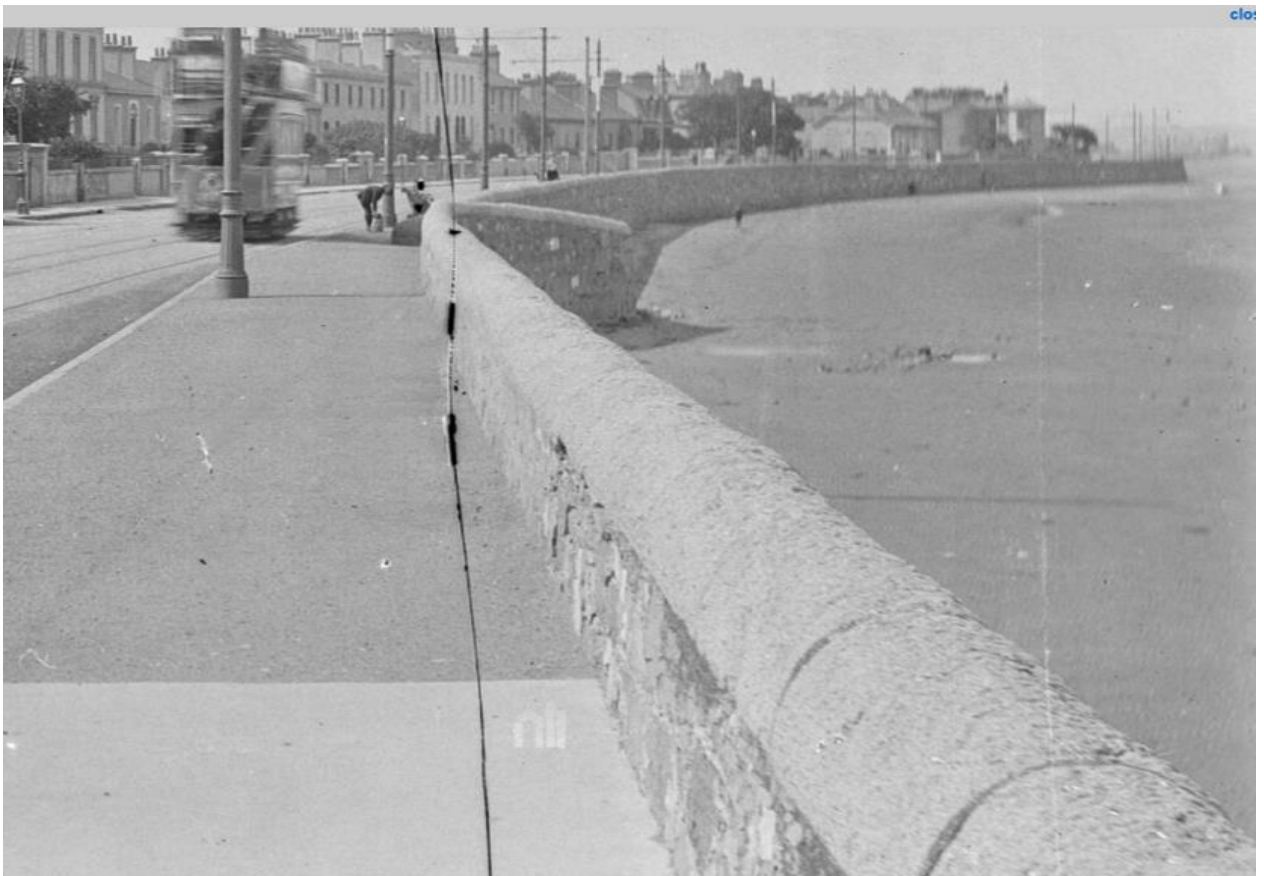
Fig. 13: Extract from previous image. Note steps/slipway onto strand (Copyright: National Library of Ireland)

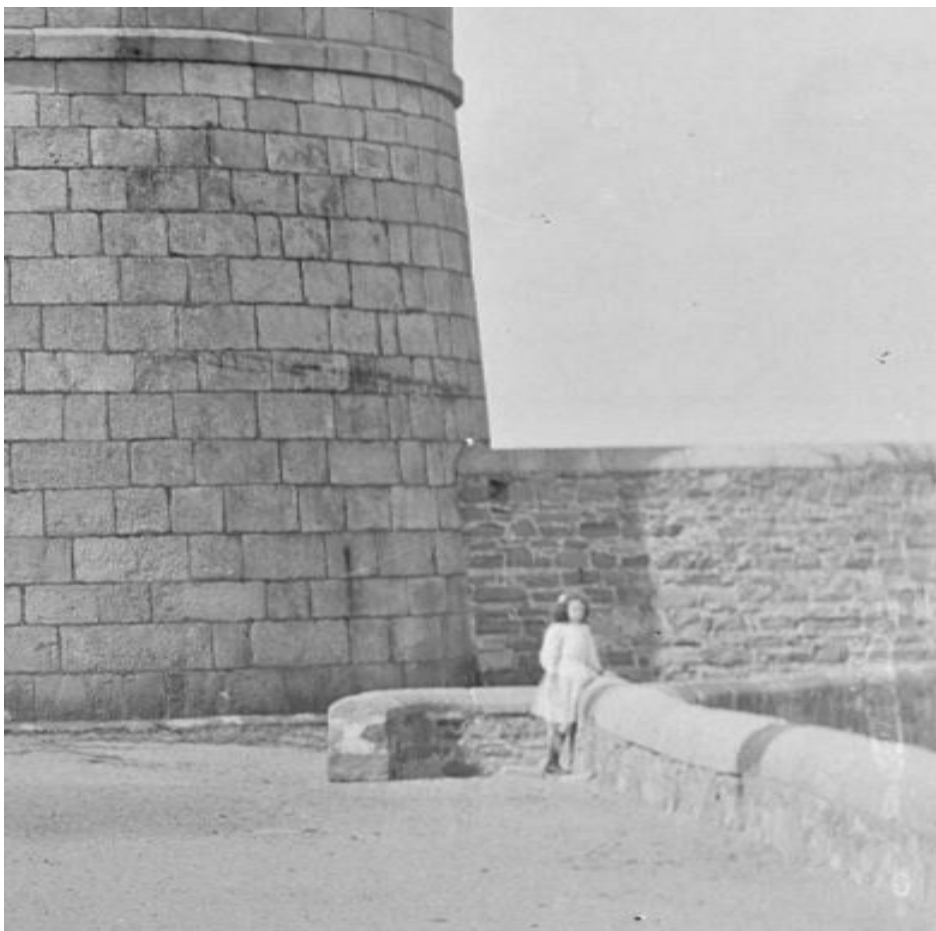
Fig. 15: Detail of previous image showing how the sea-wall joined the Martello Tower

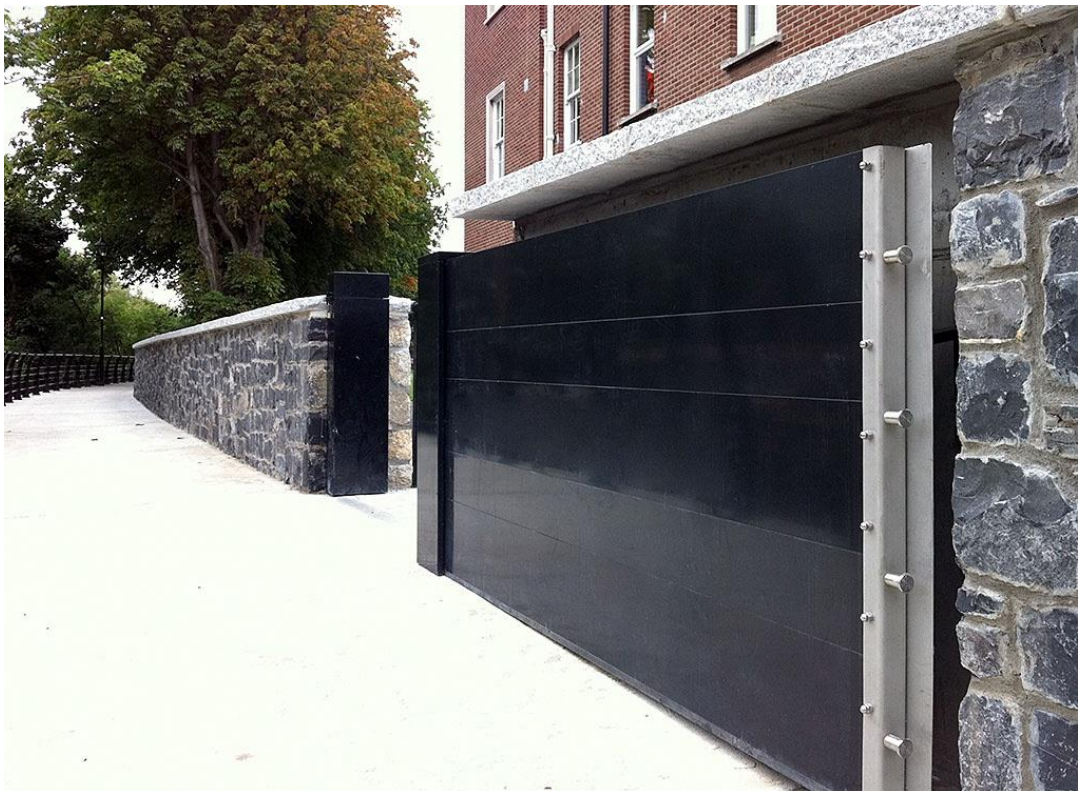
Fig. 24: Lift-hinged flood gate at Dodder Flood Protection Scheme

- This system can be provided in either double-leaf or single-leaf versions and can be lift-hinged or swing-hinged.
- In open position, the gates will open back against the seaward face of the wall.

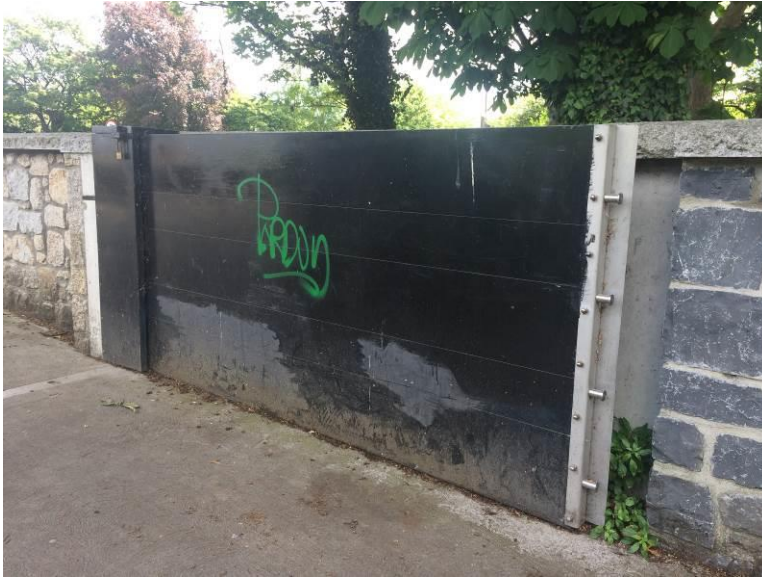
Fig. 25: Lift-hinged flood gate at Dodder Flood Protection Scheme

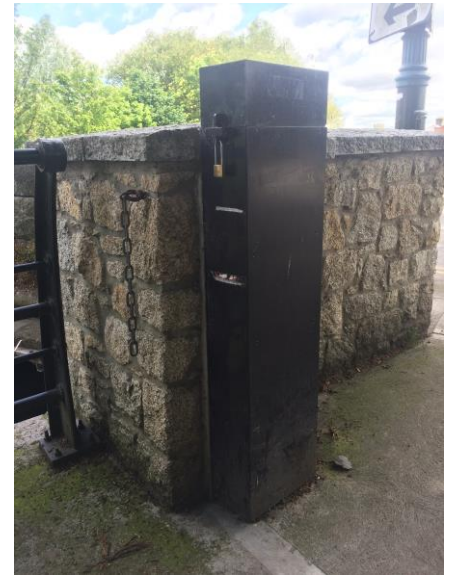
Fig. 26: Rectangular post with box to protect operating mechanism

- The hanging side of the gate will require an upright post of rectangular profile. These posts will be set behind the wall as seen from the Strand Road, with the long side parallel to it. A metal box secured with a padlock will form the top of the post to protect the operating mechanism from vandalism. This will cause the post to rise above the crest of the wall. The upper edge of the floodgates will align to the crest of the rounded wall coping wall.

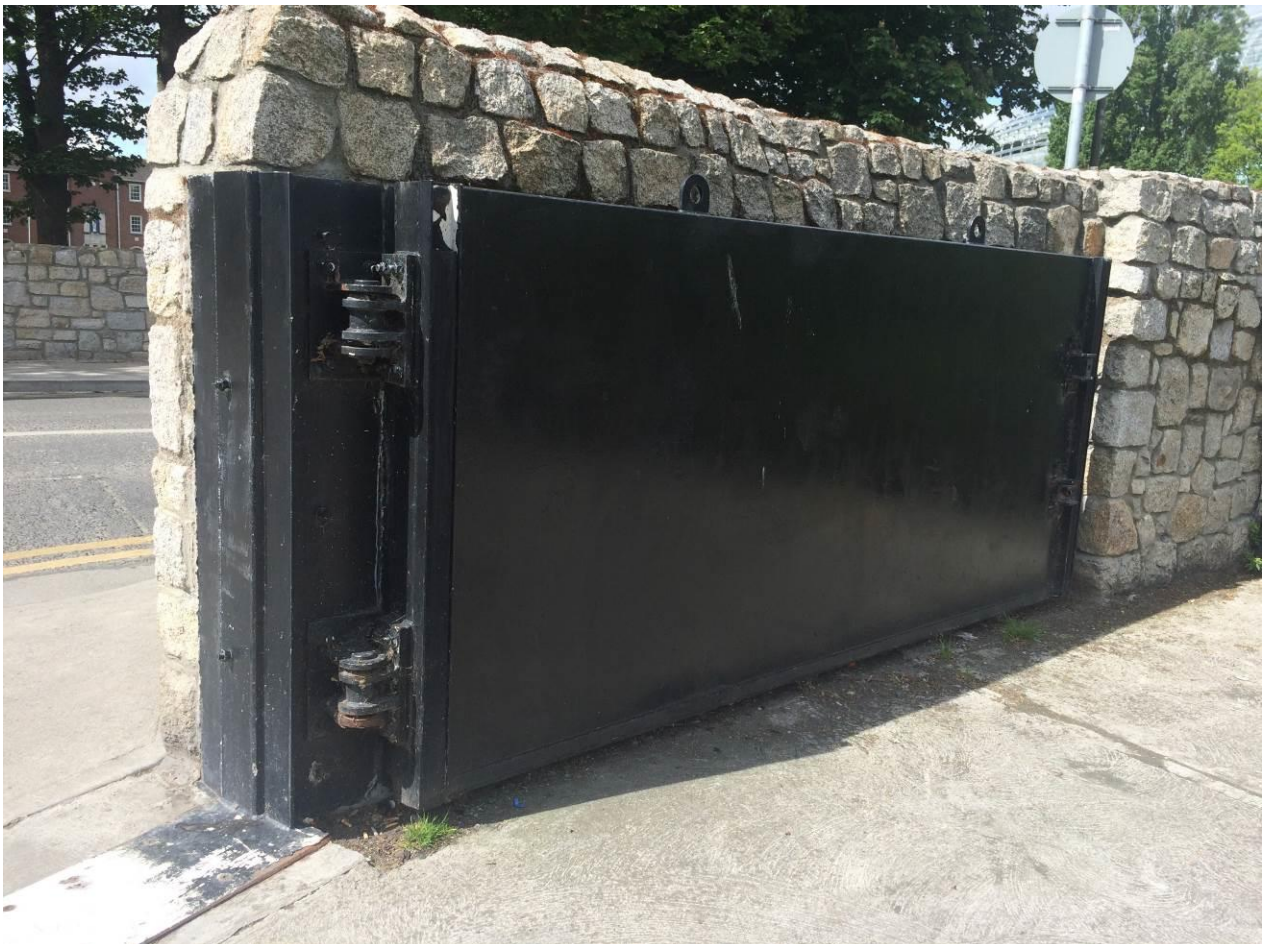
Fig. 27: Swing-hinged flood gate at Dodder Flood Protection Scheme

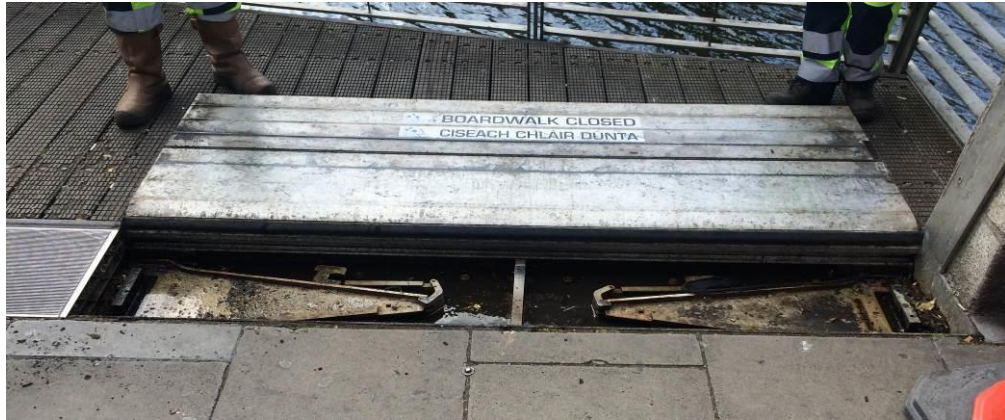
Fig. 28: Trench in which supporting fins and folding barrier are stored (Liffey Boardwalk)

- The folding barriers consist of two or more folding metal sections parallel to the ground level, which are lifted out of a metal trench.
- Supporting fins at either end are folded down into the base of trench.
- Where a wide barrier is necessary, additional fins are located at intervals along its length, which also fold down into the base of the trench.
- When the barrier is closed it stands at a tilted angle within the opening in the seawall.
- When the barrier is open it is folded away in the trench and forms a threshold similar in width to the thickness of the sea wall. A metal plate is required on the jamb of the opening of the wall.

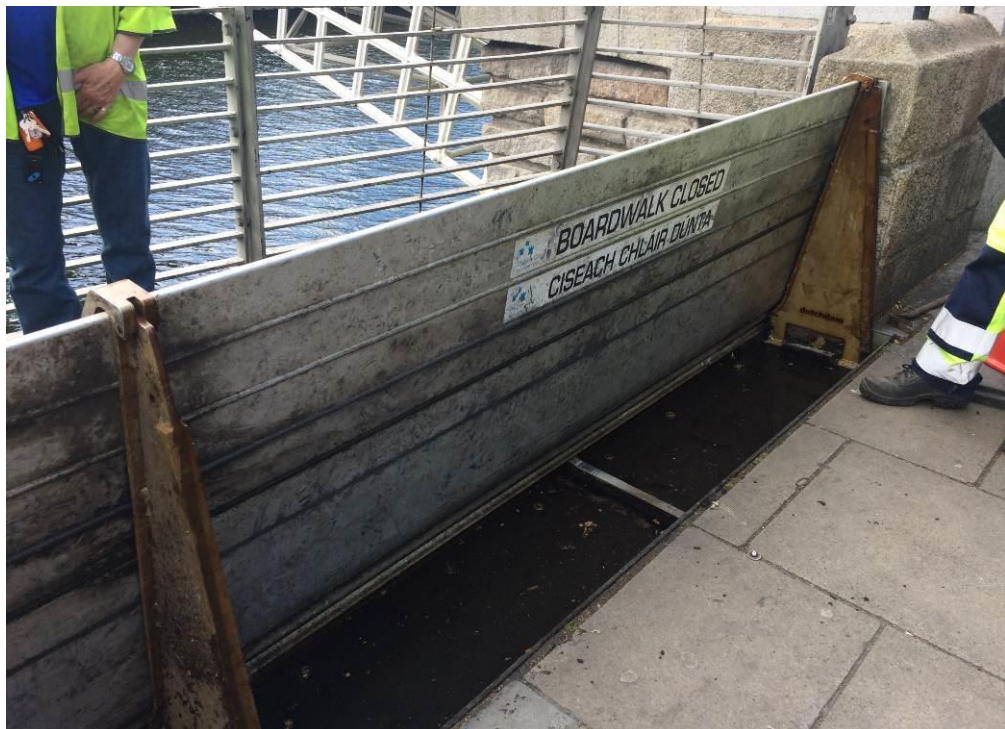
Fig. 29: Barrier in closed position

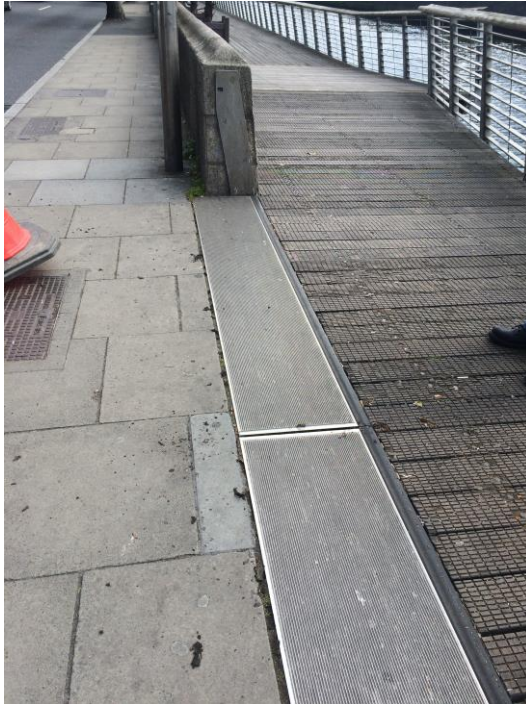
Fig. 30: Barrier in open position

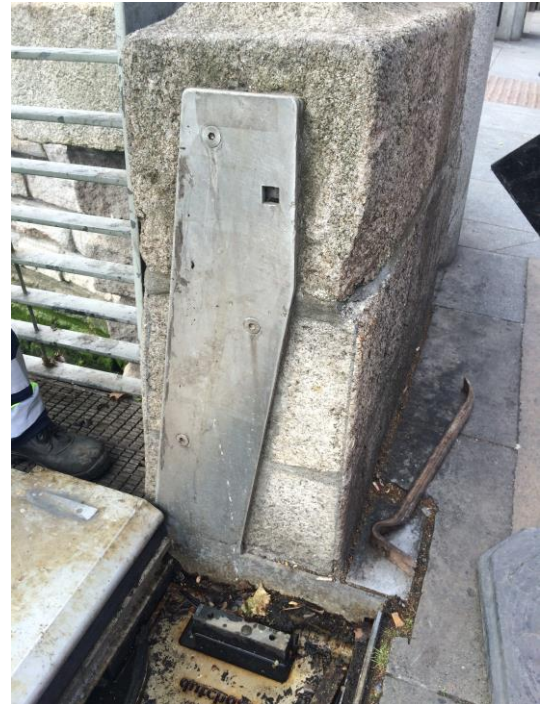
Fig. 31: Plate at jamb of opening in open position
