Addition of 134 Thomas Street, Dublin 8 to the Record of Protected Structures in accordance with Section 54 and 55 of the Planning and Development Act, 2000 (as amended).

PHOTOGRAPH OF STRUCTURE

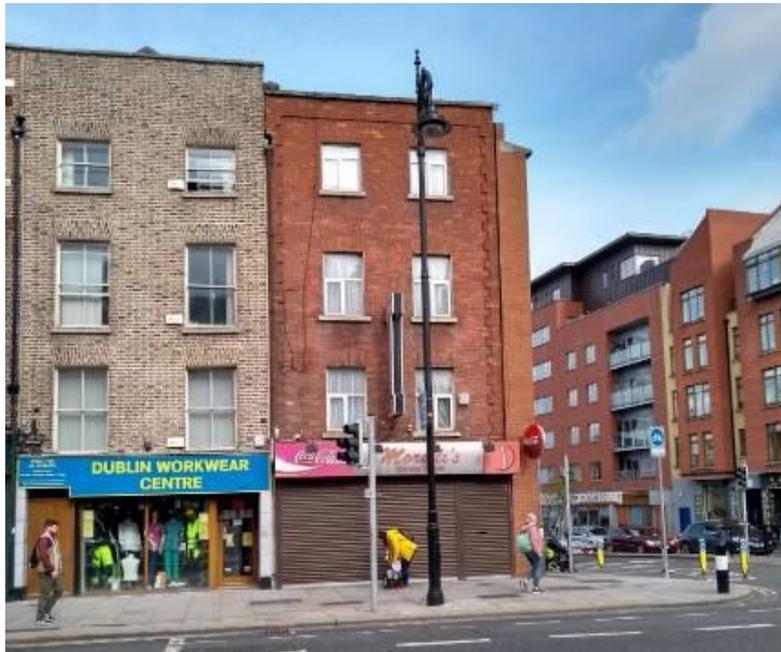
Front elevation: Red brick front elevation, *circa* 1900-1920, with red brick quoins and platband to parapet. Square-headed window openings to front elevation with replacement uPVC windows and granite sills. Modern shopfront inserted across the full width of ground floor. The side elevation has a late 20th century brick façade/retaining wall understood to have been constructed as part of the works undertaken when the adjoining building (No.133) was demolished to allow for road widening at Bridgefoot Street.

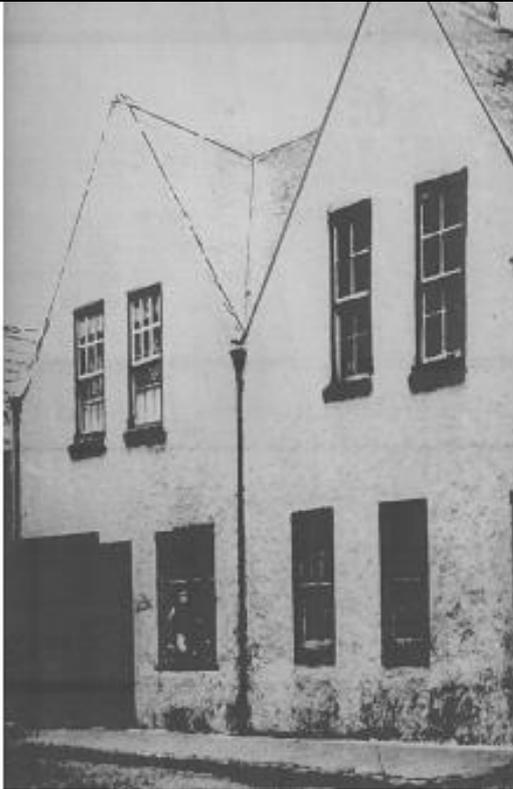
View of gable-fronted Dutch Billy house in Pimlico

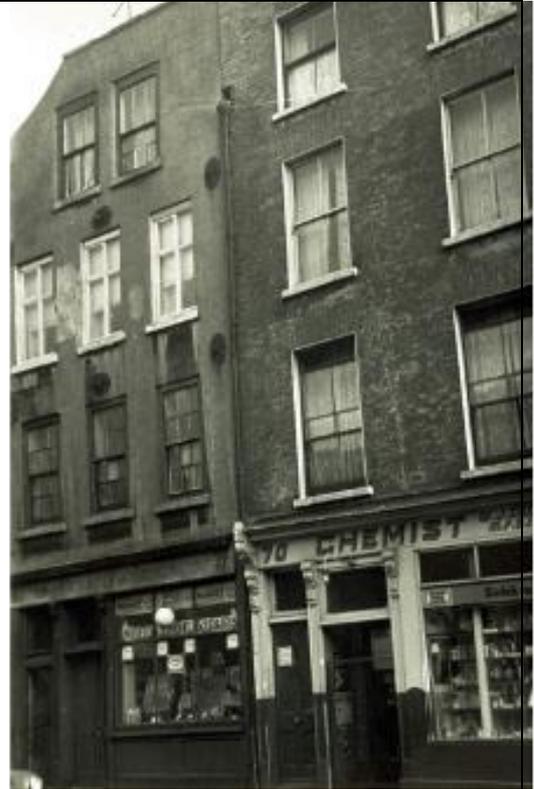
Evidence of former Dutch Billy house on Meath Street

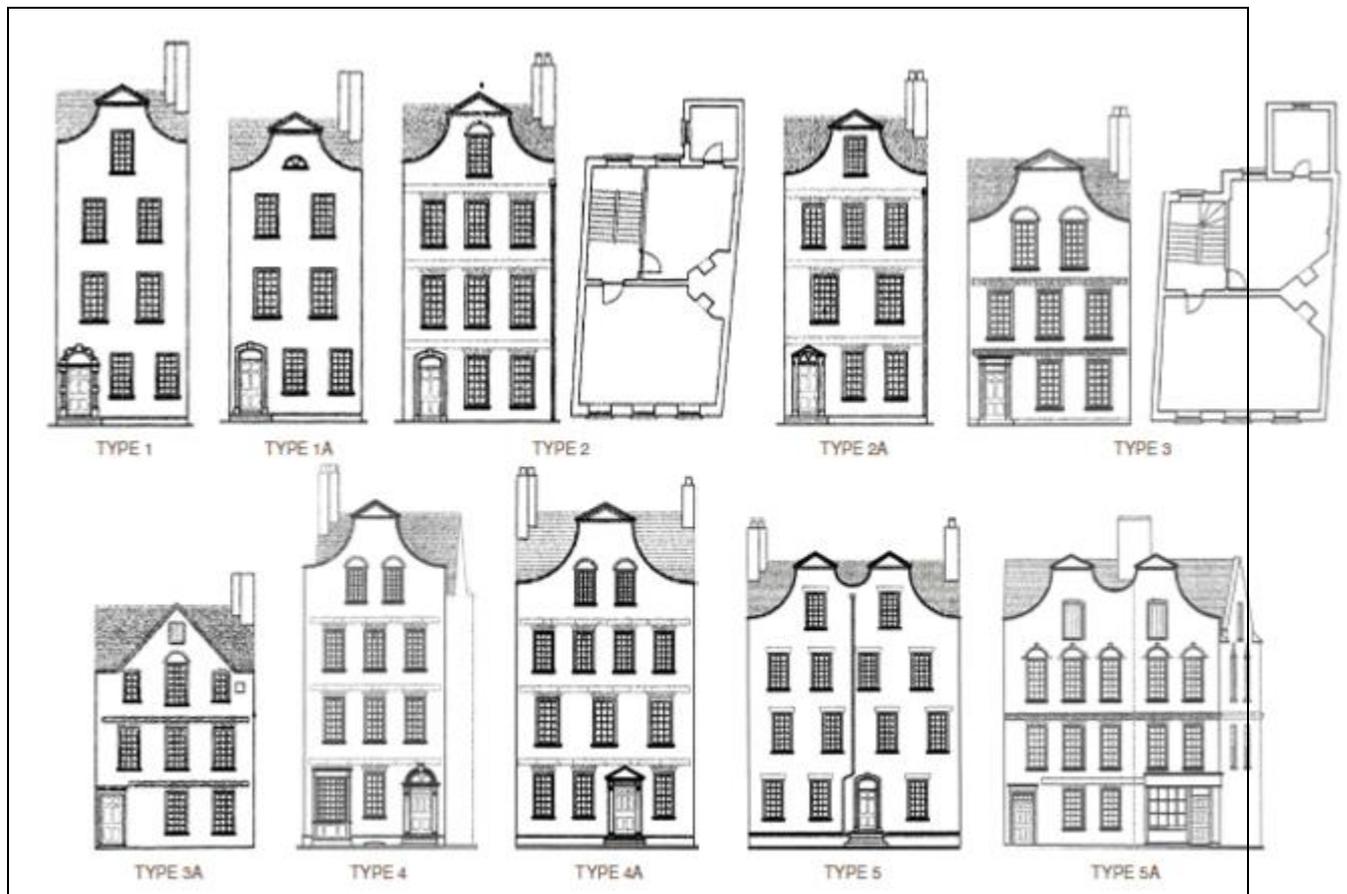
Dublin Civic Trust image showing some of the different Dutch Billy house types (2012, 5). The floorplan of No. 134 Thomas Street appears similar to Type 2 shown below.

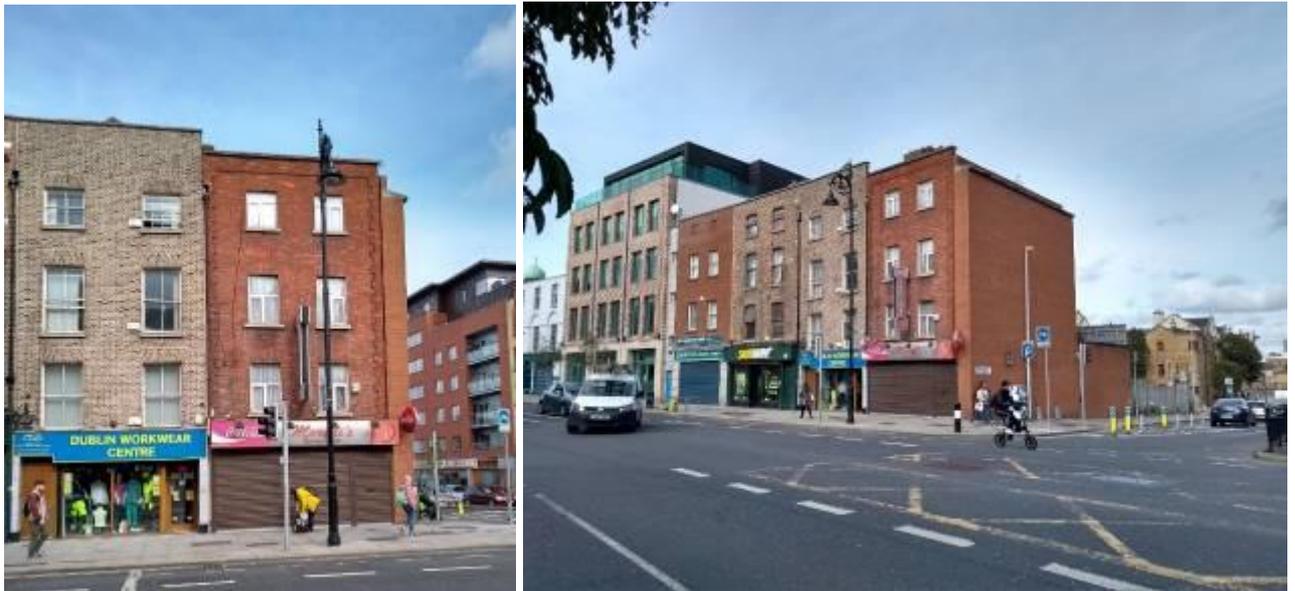
View of front elevation of end of terrace building at No. 134 Thomas Street and surrounding streetscape

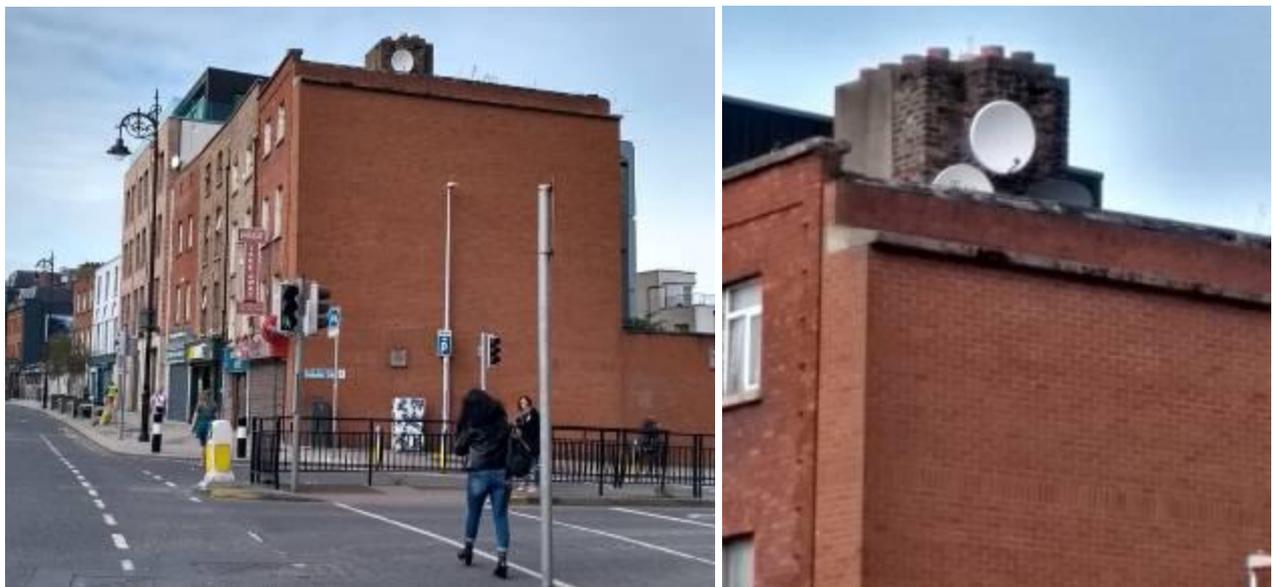
View of modern side elevation with detail of early cruciform chimneystack

While the original roof structure to the principal building is no longer present, it is likely to have been similar in form to its neighbour at No. 135 Thomas Street with whom No. 134 shares a large cruciform chimneystack. The roof of 135 Thomas Street is cruciform in plan, with the main roof ridge line running from front to back, perpendicular to the street. At some stage in the recent past, this original roof was removed from No. 134 Thomas Street and replaced with a modern flat roof. This roof has been in place since at least the 1970's.

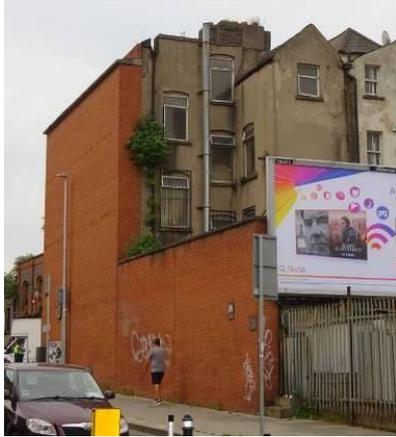
View of rear elevation with rear return

Rear elevation: Camber-arched window openings to rear elevation with square-headed replacement uPVC windows. Modern cement based render to rear elevation. Man-made replacement slate roof to closet return. Though the roof covering to the closet return has been replaced with man-made slate the form and structure of the roof are understood to be early/historic.

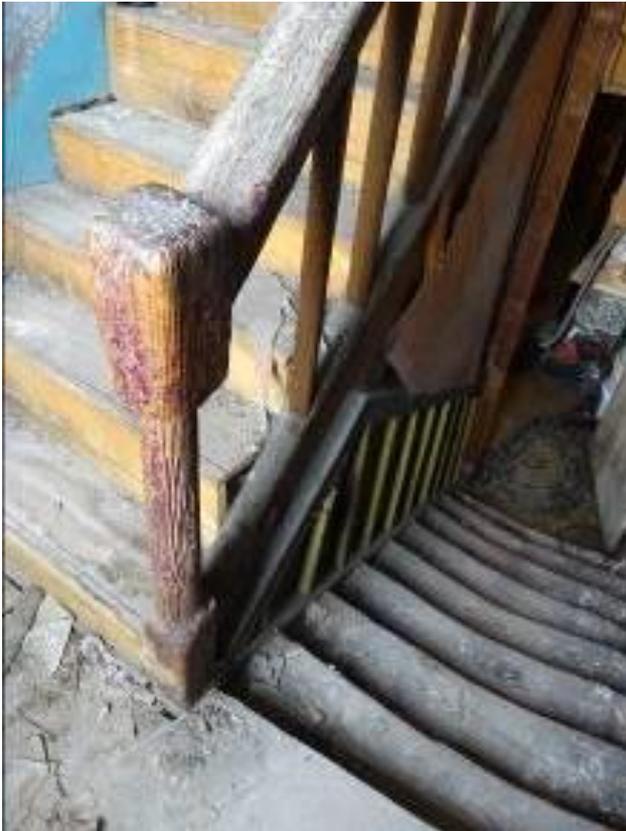
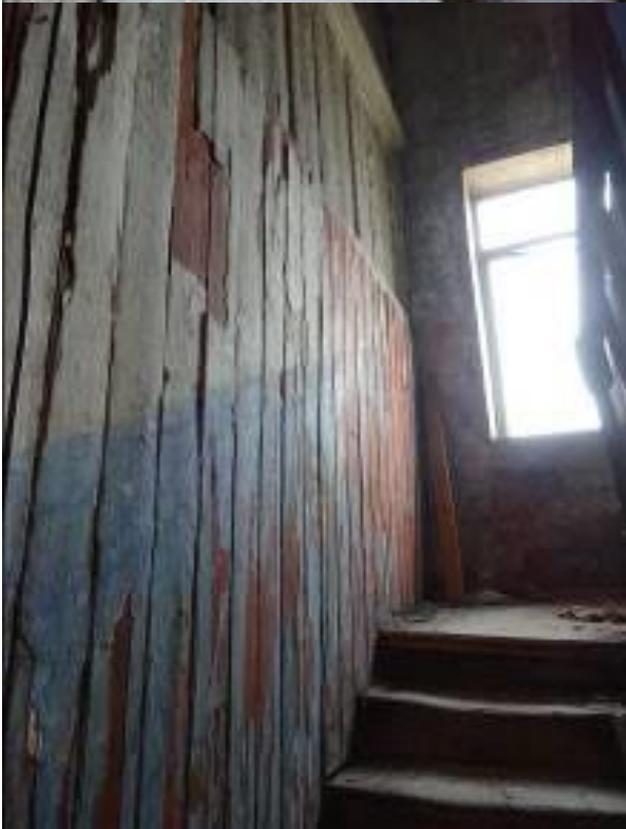
Half landing between 2nd and 3rd floor. Note early handrail, newel post and early timber panelled spine wall.

Staircase: The stairs rises from basement to third floor. It displays interlocking handrails; column newel posts with simple balusters; ogee drop/boss to underside of newel post; heavy set handrail; dished treads reflecting patina of age. The newel post is cut at half landing between first and second floor. The early timber planked wall forming the spine wall between stairwell and rear rooms is evident at first, second and third floors. The uppermost flight has been replaced though the historic carcass may have been incorporated/retained as part of these works. The newel post and balusters in this location are historic and have been retained.

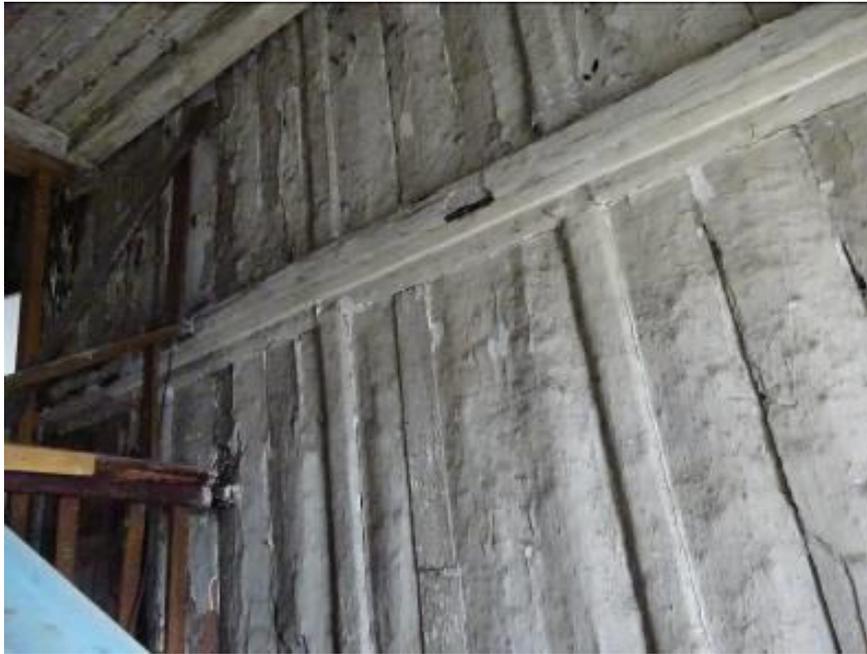
Third floor landing. Note early panelled wall.

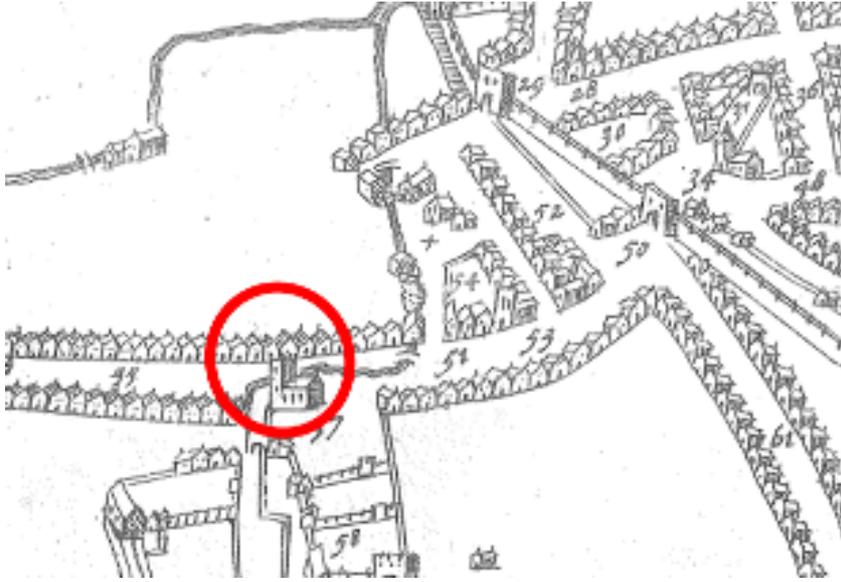
The 1610 map shows a terrace of gable-fronted buildings in the approximate location of the present Nos. 134-136 Thomas Street. Saint Catherine's church is also shown but this building is likely to be the early 13th century Medieval parish church which predates the present building. The present church was built c. 1765 on the same site as the earlier church.

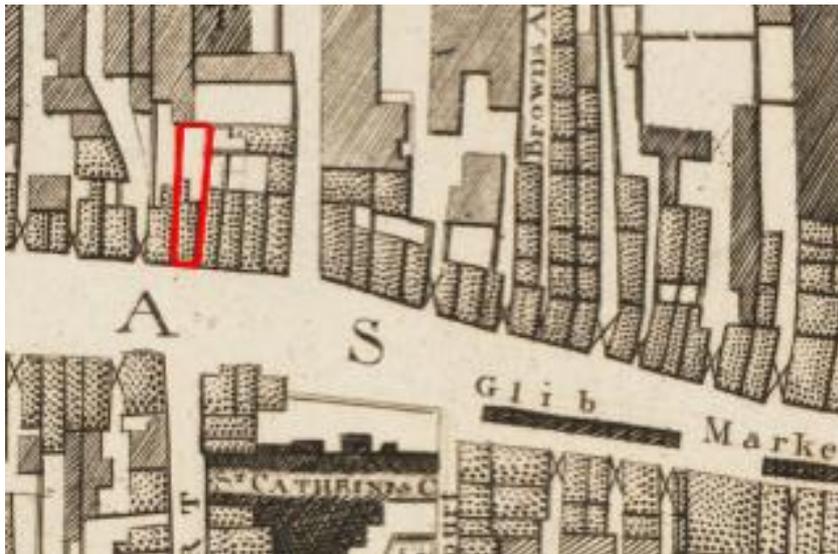
Rocque's map of 1756 shows Nos. 134 and 135 Thomas Street with their small rear returns. No. 134 Thomas Street (outlined in red) also has an additional outbuilding attached to the rear of the return. Bridgefoot Street was narrower at this time with 4 buildings to the east of No. 134 Thomas Street rather than the two shown on the later 1847 OS map. The 13th century church of St Catherine's is still in place with buildings constructed in front of it facing Thomas St.

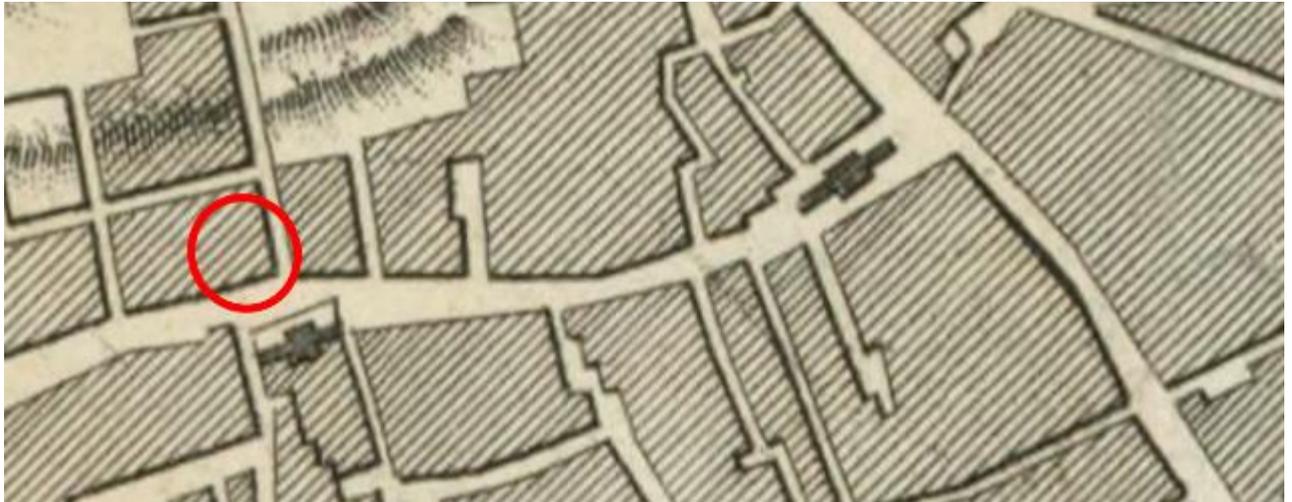
Belin's maps of 1764 still shows the 13th century St. Catherine's Church and the terrace of houses where No. 134 Thomas Street is located. Thomas Street has been made wider at this location with the buildings which were located to the front of the church are now demolished.

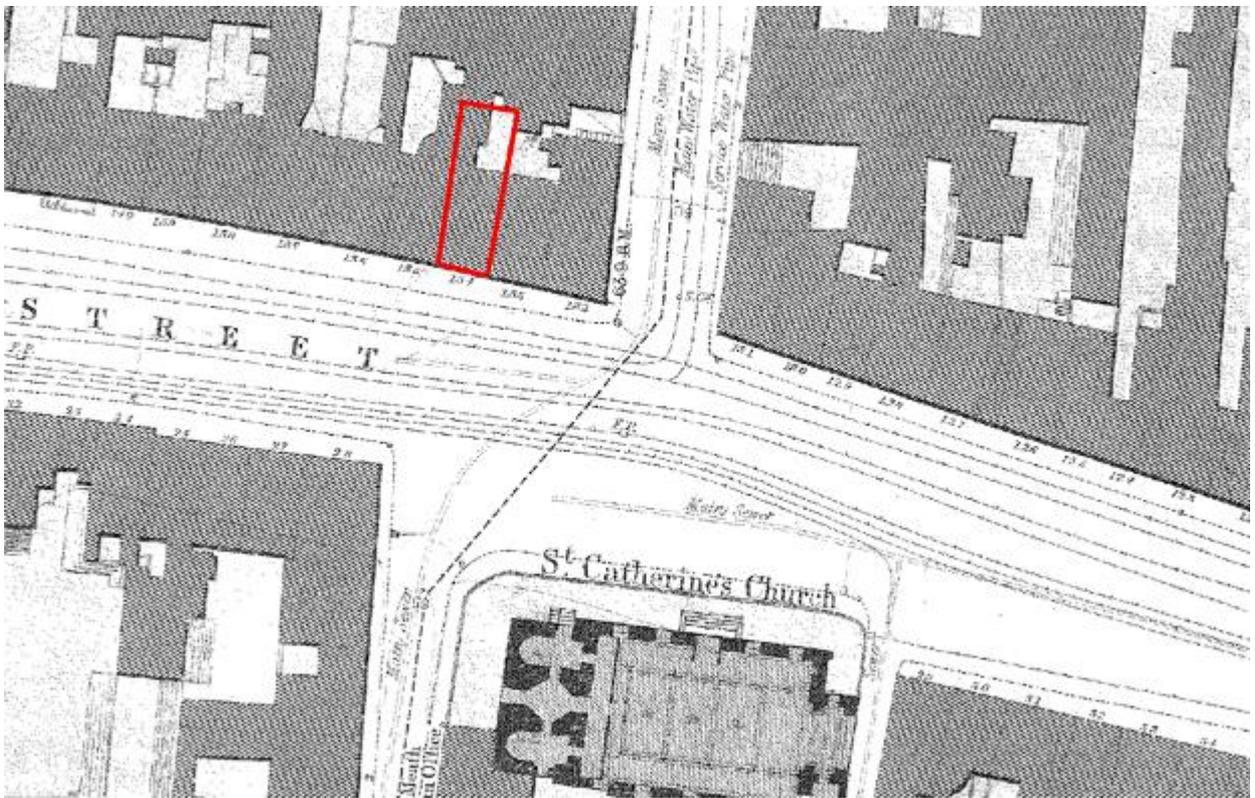
1847 Ordnance Survey – No. 134 Thomas St is clearly shown with rear return and additional outbuildings to rear site. Nos. 132 and 133 Thomas Street are also clearly shown which have since been demolished. St Catherine's church, constructed c. 1765 is also shown to the south. There are no buildings to the front of the church.

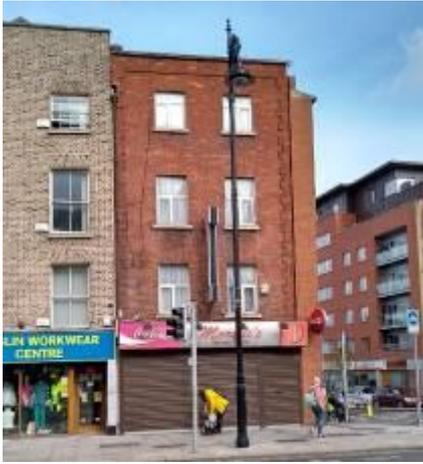
NIAH Assessment for 134 Thomas Street, Dublin 8

<p>Reg. No. – 50080339 Date - 1720 – 1760 Previous Name – N/A Townland – N/A County – Dublin City Categories of Special Interest – ARCHITECTURAL Rating –Regional Original Use – House In Use As – Apartment/Shop</p>
<p>Description: Formerly terraced, now end-of-terrace two-bay four-storey house, built c.1740, having late nineteenth-century facade, with recent shopfront to ground floor. Four-storey return to rear. Recent flat roof hidden behind parapet to front (south) having granite capping. Pitched roof to return. Brown brick cruciform shared chimneystack. Red brick walls having red brick quoins and platband at parapet level. Rendered walls to rear. Recent red brick to east elevation. Square-headed window openings having granite sills. Segmental-arched window openings to rear having square-headed windows with rendered infill above. Replacement uPVC windows. Ground floor openings shuttered.</p>

<p>Appraisal: Despite considerable alterations, this house retains early proportions typical of Dublin townhouses. Its large central cruciform chimneystack shared with its neighbour to the west is a feature of Dutch Billys. Dutch Billys were a common building type in the seventeenth and early eighteenth century, with gabled front facades, and many were later altered with the addition of the parapet roof fashionable in the Georgian era. Like many of the neighbouring houses, the ground floor subsequently had a commercial use. Thomas Street was laid out by the early eighteenth century and is an important thoroughfare linking the city centre with the west. Originally a mid-terrace building, no.133 was demolished by 1980, while no.132 was subsequently also demolished.</p>
