Dublin Waste to Energy Ash Management Plan

Dublin Waste to Energy (DWtE) Project

Construction Phase Environmental Monitoring Report - Quarter 3 (July - September) 2016

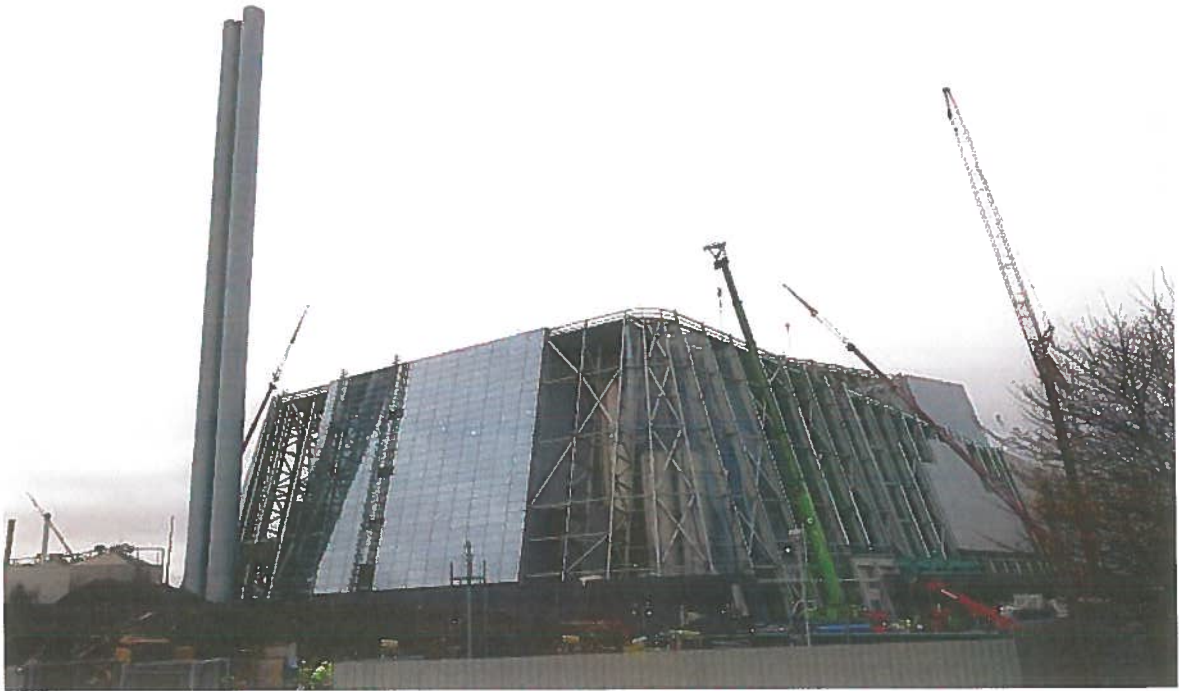
Site Aerial View Looking Southeast November 2016 (Copyright PML)

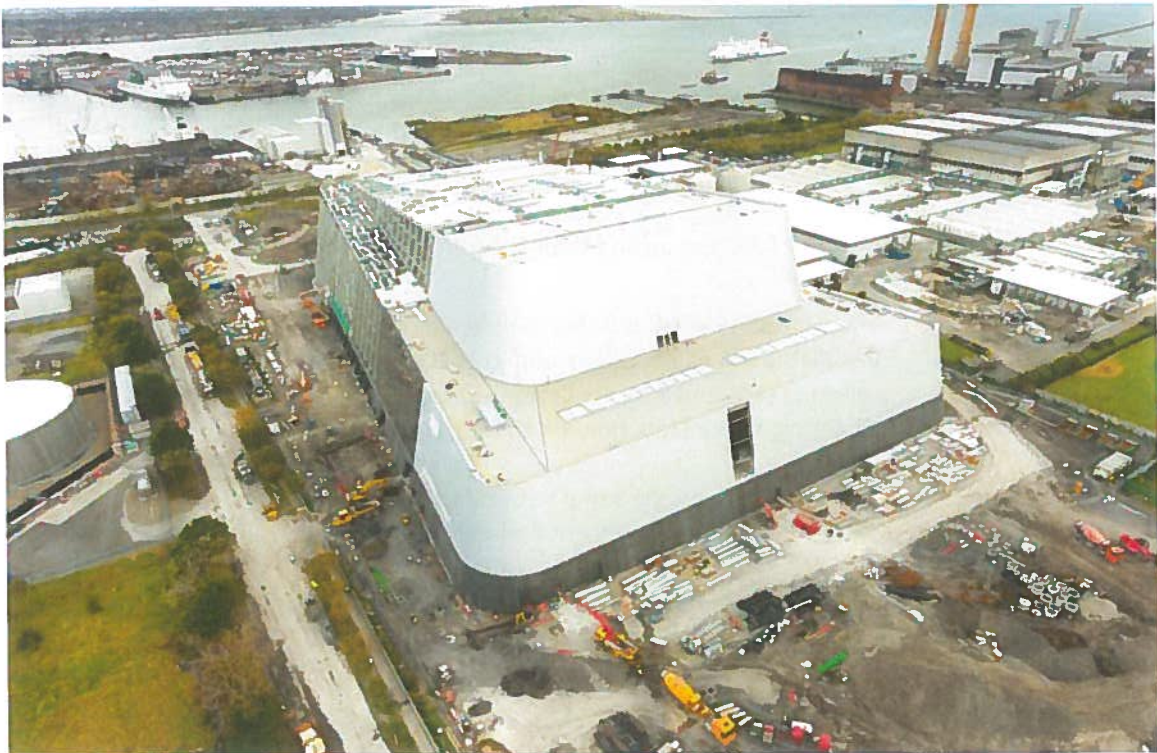
Site Aerial View Looking Northeast October 2016 (Copyright PML)

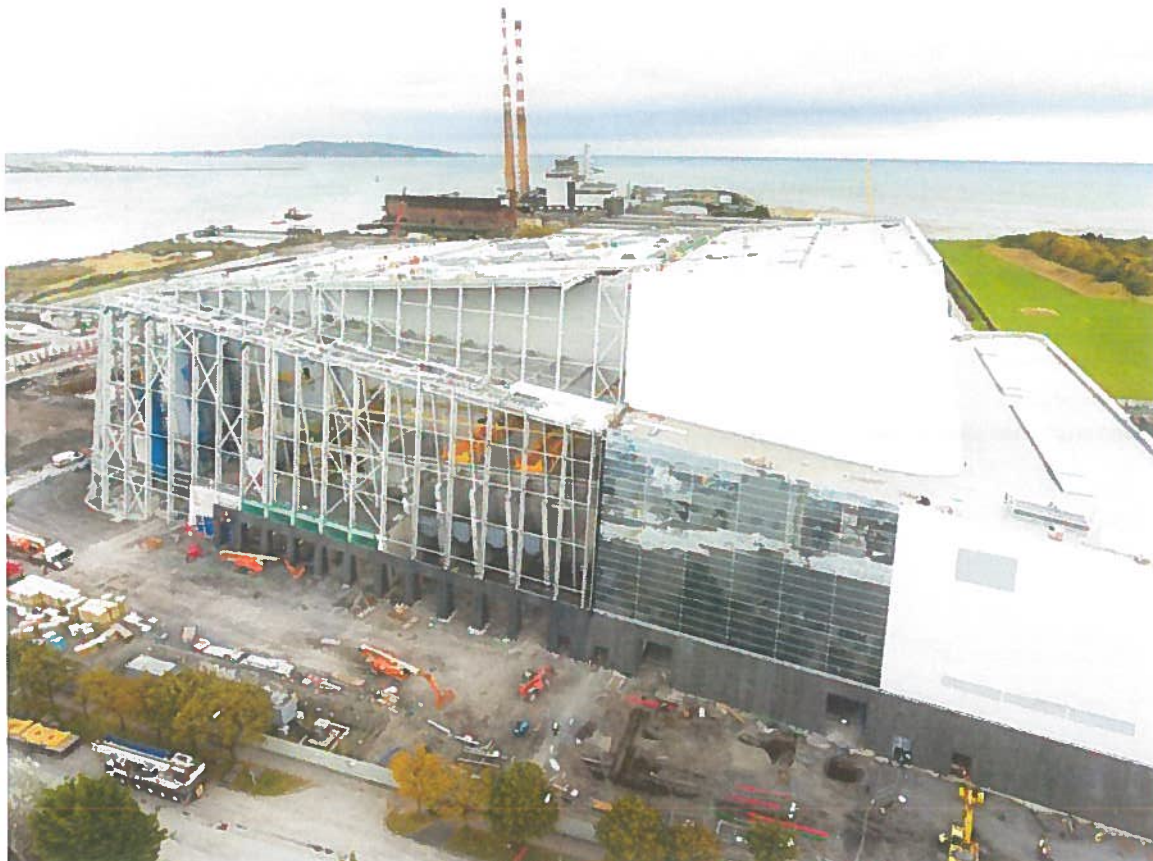
Site Aerial view looking East October 2016 (Copyright PML)

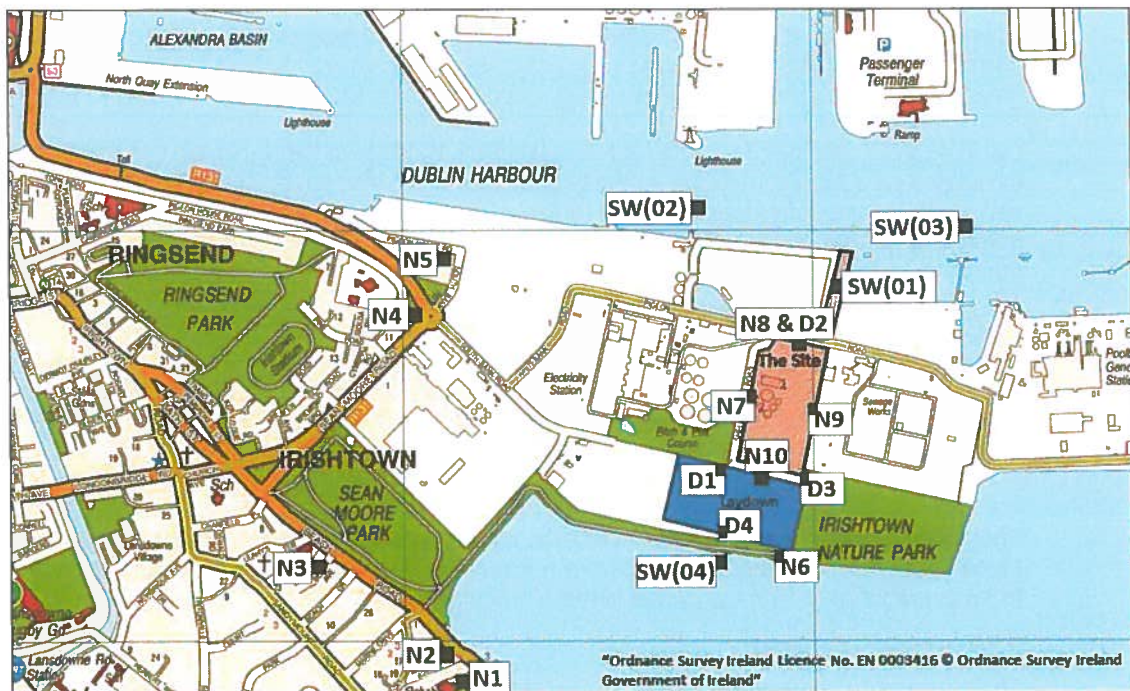
- N1 - Rehab Institute
- N2 – Seafort Avenue
- N3 – Beach Avenue
- N4 – Leukos Road
- N5 – Pigeon House Road
- N6 – Walkway (Irishtown Nature Reserve)

Figure 2.1: Environmental Monitoring Locations

The closest sensitive receptors to the site are the residential properties at Pigeon House Road which are located approximately 865m west of the site boundary. A map of sensitive locations and environmental monitoring points (noise, dust and surface water) are included in Figure 2.1.

Monitoring of noise levels at sensitive locations is required during construction to assess compliance with the requirements of the Environmental Impact Statement (EIS) and An Bord Pleanála Order-29S.EF2022, Condition 13d. Refer to Figure 2.1 in Section 2 for the monitoring locations.

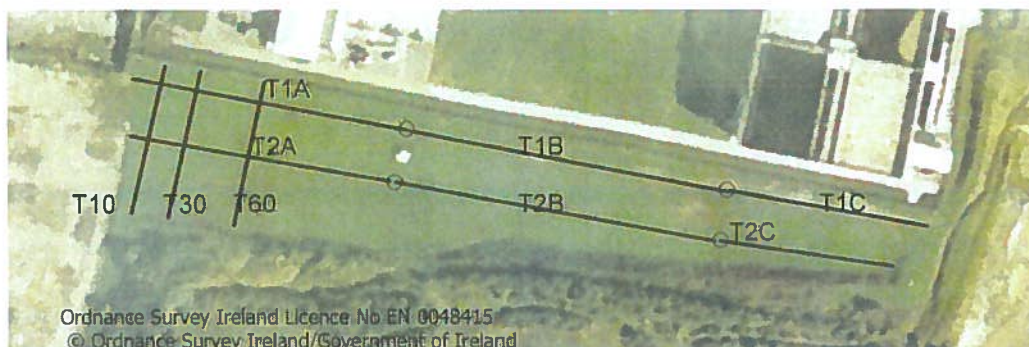
Figure 2. Transect layout on the compensatory grassland

Transect 1 lies 10 metres away from the boundary fence between the compensatory grassland and Ringsend WWTP. Transect 2 lies parallel to transect 1. Both transects are divided into three sections A, B and C, as indicated by circles on Figure 2. The transects are equidistant from the mounded inspection access to the submarine pipeline, visible as a white area which is the landmark for transect sections A/B. Transect 10 lies 10 metres from the western edge of the compensatory grassland, T30 and T60 are 30 and 60 metres from the western edge of the grassland respectively.

distance from the DWTE site and construction compound. In general, counts were scheduled for periods of dry weather to minimise washing out of goose droppings by rainfall. Dropping density was calculated per metre² to facilitate comparison between areas. Transects were laid out using measurements and landmarks within the compensatory grassland as shown in Figure 2 below.

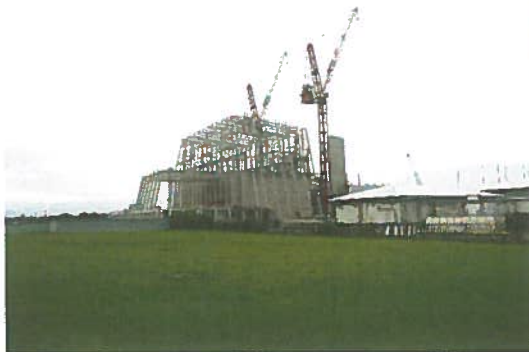
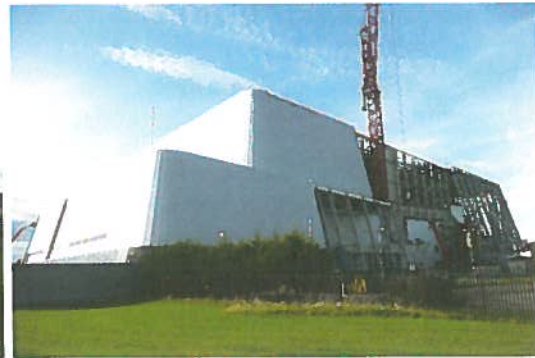
Plate 1. Dublin Waste to Energy Facility under construction

Further to a commencement notice issued to Dublin City Council, construction work on the Dublin Waste to Energy Facility commenced on 14th December 2009. Work was suspended temporarily in May 2010. The Project Agreement regarding the Dublin Waste to Energy Facility was signed on Friday 19th September 2014. Site clearance and setup commenced in October. Piling works at the approved project site, using Continuous Augered Piles (CFA Piles), commenced during the week starting 20th October, initially with one piling rig and subsequently with three rigs. Piling and foundation works continued through the winter season. Construction of above ground structures commenced in March 2015. The temporary construction compound was enclosed in January 2015, with work on the eastern boundary closest to the compensatory grassland taking place during the week commencing 12th January. A setback of at least 20 metres wide from the eastern edge of the compound was provided, as required under Condition 13(b). Construction of above ground structures, cladding, and installation of equipment has continued through 2015 and 2016.

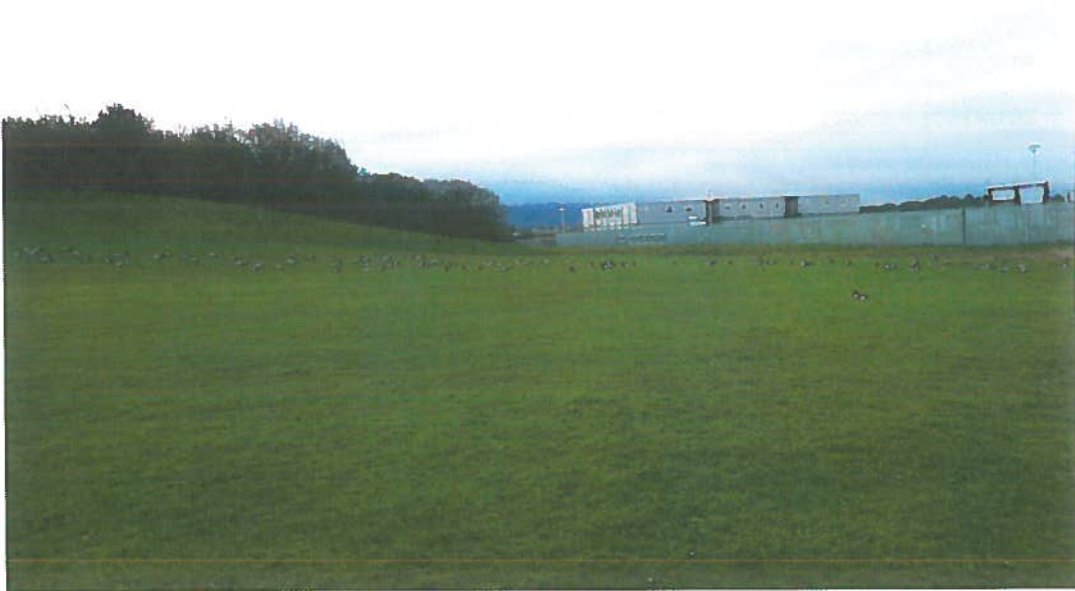
Plate 1. Brent geese on the compensatory grassland on 26th November 2015. The DWTE temporary construction compound can be seen in the background.

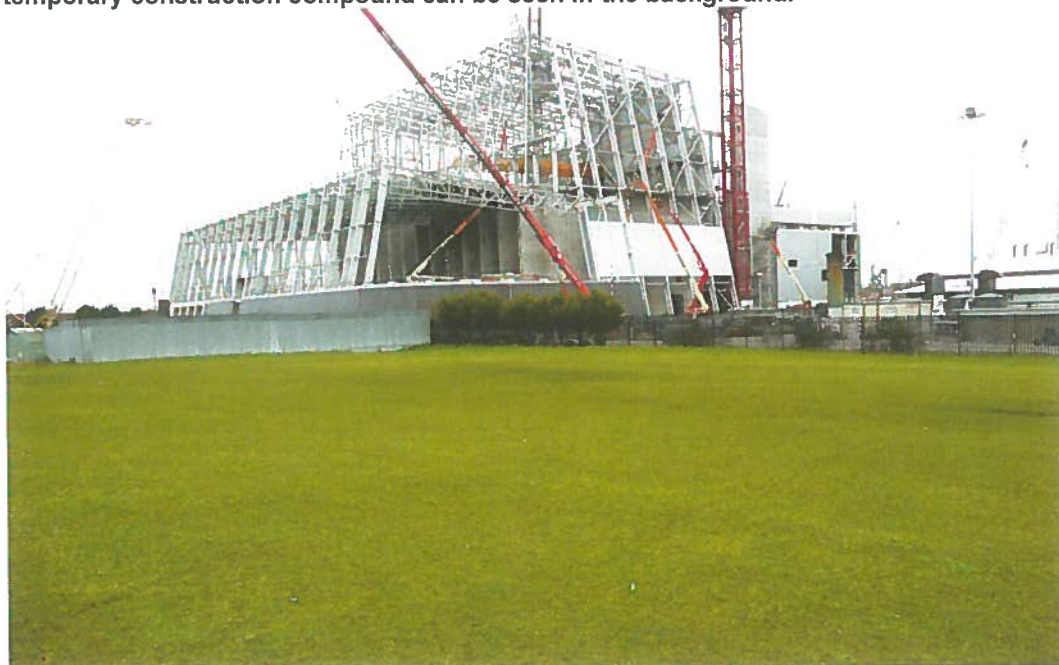
Plate 2. Closely grazed grassland on 25th February 2016.

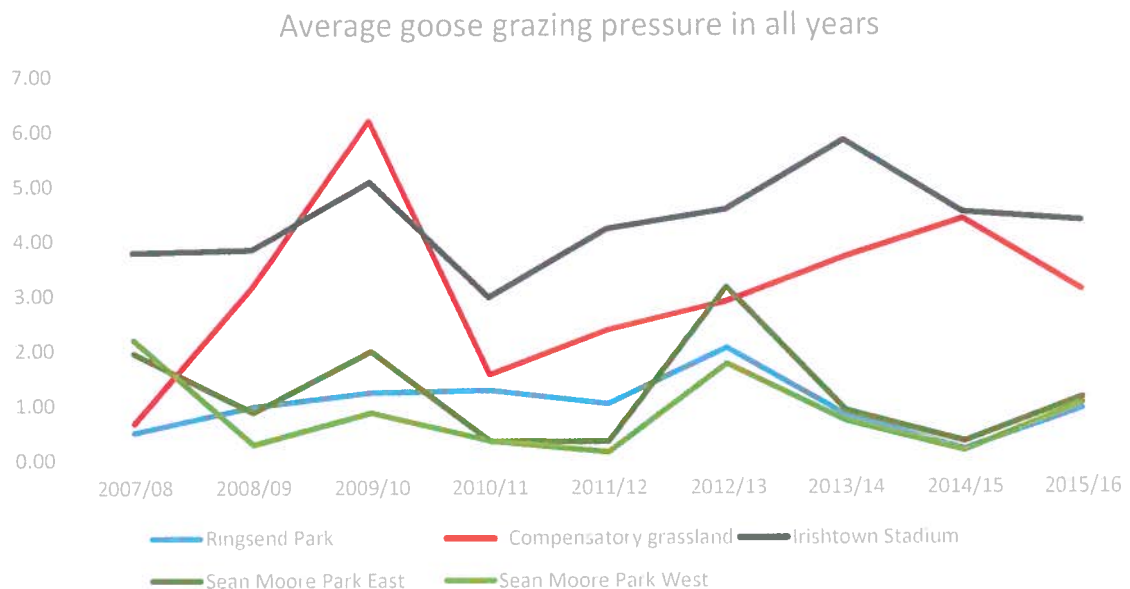
Figure 4. Light-Bellied Brent goose grazing pressure (droppings/m²) averaged across all transects, in each winter season of the monitoring programme.

Use of the compensatory grassland was lower in 2015/16 than in the previous two seasons, and at 3.08 droppings/m² was equivalent to the 3.10 droppings/m² monitoring programme average use for this site (Table 7).

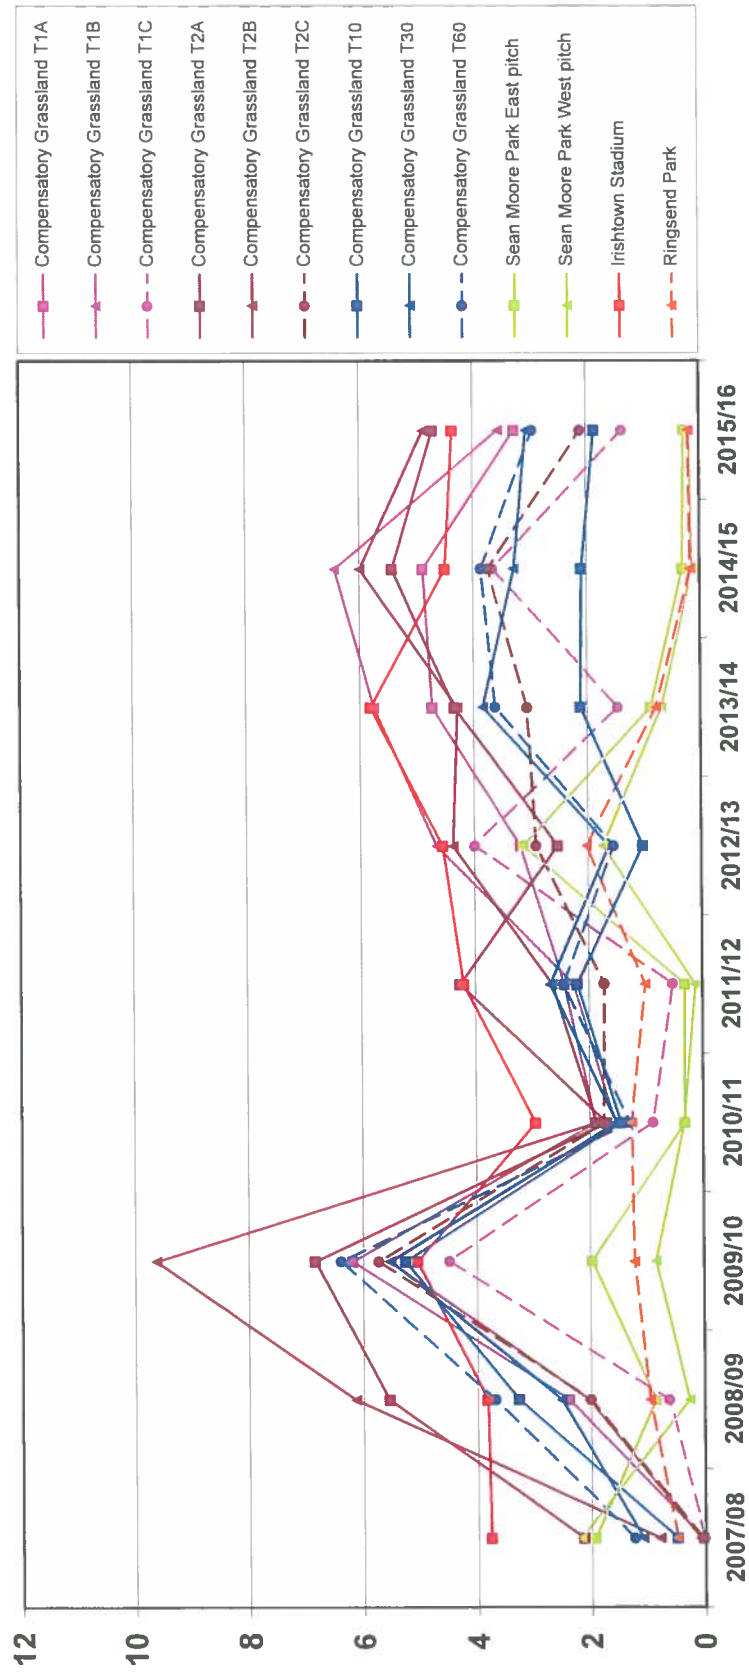
Figure 6. Mean density of goose droppings/m² recorded on the transects in 2007/08, 2008/09, 2009/10, 2010/11, 2011/12, 2012/13, 2013/14, 2014/15 and 2015/16.

Note: data are averaged for each transect across all survey dates in each season.
