Report on the Shaw House, 33 Synge Street, Dublin 8.

Appendix 1 - Notes on Inspection of 33 Synge Street, GB Shaw Birthplace

Appendix 2 – Engineer’s Report

Re: No. 33 Synge Street – Shaw birthplace

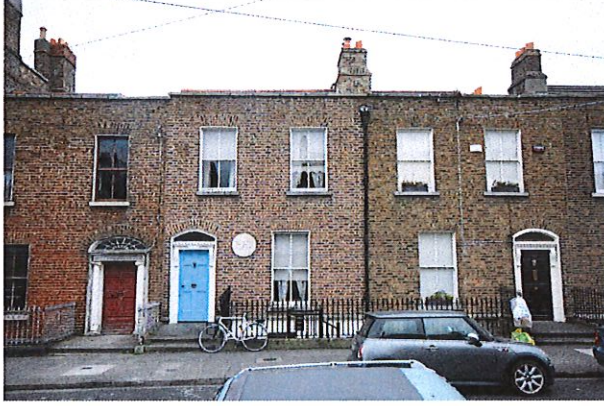
| | Photograph | Location | Comment |
|--|---|---|---|
| | | Front elevation showing adjacent derelict building (No 34 on LHS) | |

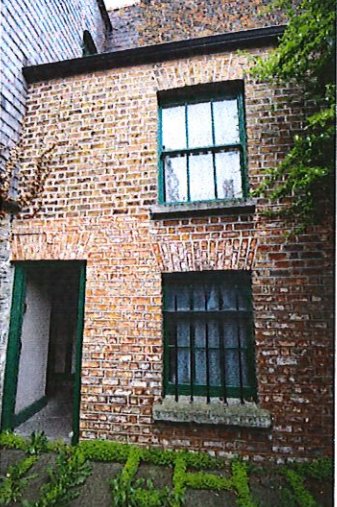
| | Photograph | Location | Comment |
|--|---|---|---|
| | | Side elevation to rear return (Lower window is toilet, upper window is GB Shaw bedroom) | |

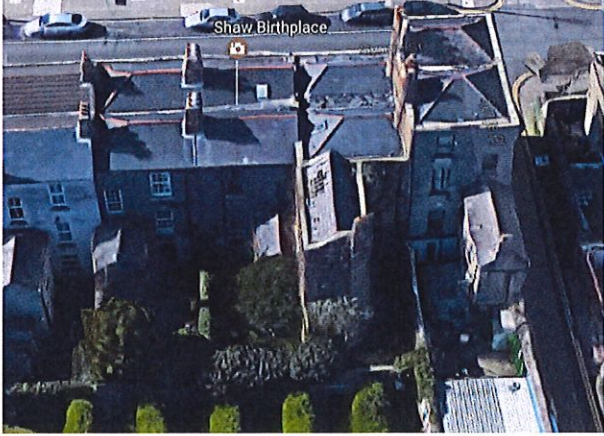
| | Photograph | Location | Comment |
|--|---|---|---|
| | | Aerial view of No 33 showing large rear return to No 34 | |
