SMALL SHELTER  
HERBERT PARK, DUBLIN 4

**Restoration Feasibility Study**

October 2017

HOWLEY HAYES ARCHITECTS

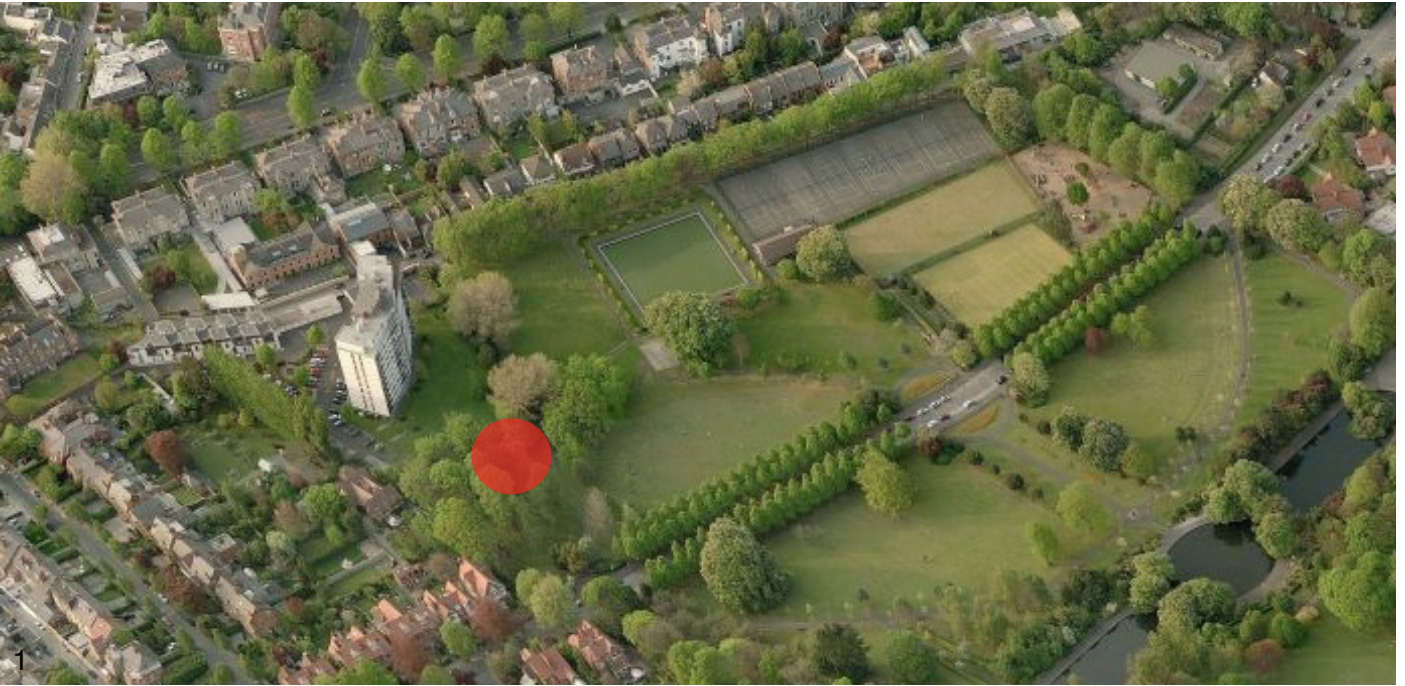
- 1: Aerial view of the north side of Herbert Park with location of small shelter indicated in red.  
2: View of exterior in 2014.  
3: Detail showing post, bracket, eaves and ceiling lining.  
4: View of interior in 2014.  
5: Detail showing post disengaged from base plinth.
