Report No. 71/2023  
Report of the Assistant Chief Executive

**Review of the Architectural Heritage Assessment of 18 Moore Street, Dublin 1, dated 21 March 2022, with reference to the motion brought forward from the Planning and Urban Form SPC meeting of September 2021 for the addition of the façade of 18 Moore Street to the Record of Protected Structures, as agreed at the monthly meeting of the City Council on 7 November 2022.**

Architectural Heritage Assessment of **18 Moore Street, Dublin 1**, in relation to the City Council Motion to add the terrace at 10-25 Moore Street to the Record of Protected Structures

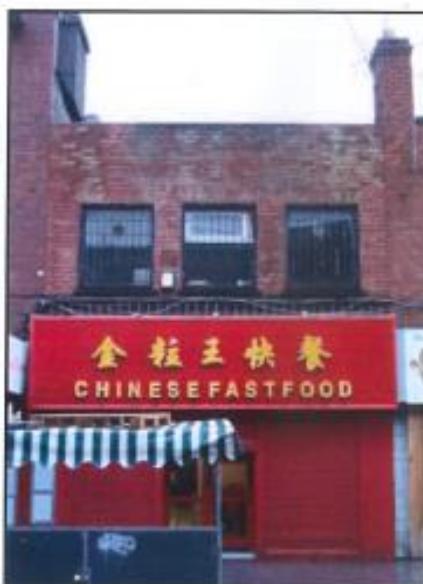
Plate 50

Both houses were in ruins immediately prior to the Rising and the façades reflect this in fabric and composition (Plates 50 and 51). The opening up of plaster from within No. 17 and No.20 both revealed concrete block party walls, thus confirming the post-1916 date. There were no claims made subsequent to the battle and evidence from the Ordnance Survey suggests that No. 19 was still unbuilt upon as late as 1939.

No. 18 Moore Street

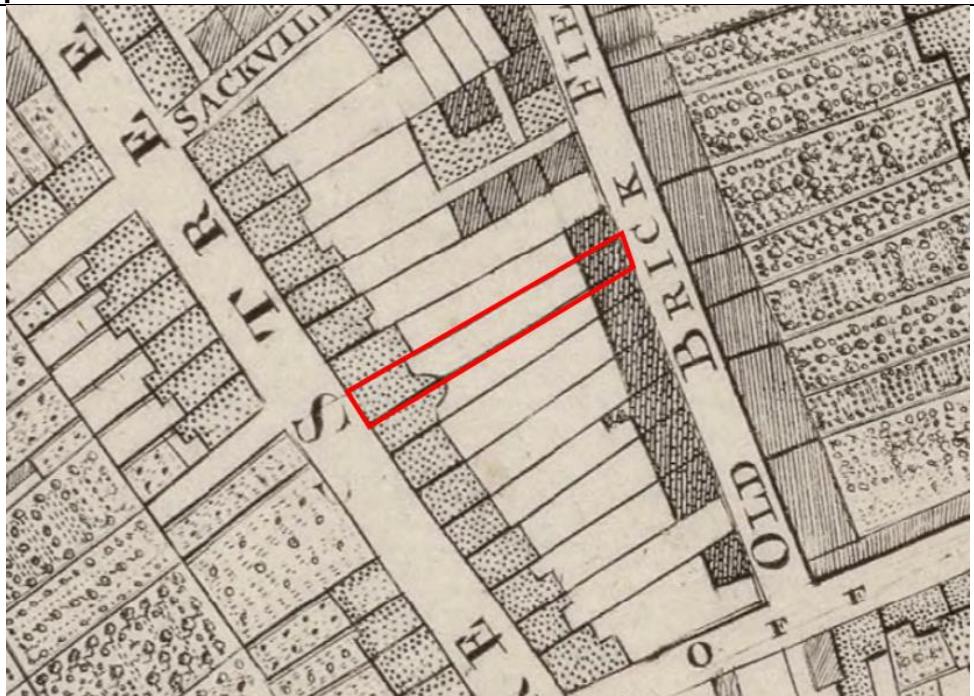
No. 18 Moore Street does not appear on Rocque’s 1756 or 1757 Map but does on his 1773 map: *An Accurate Survey of the City and Suburbs of Dublin by Mr John Rocque with Additions and Improvements by Mr. Bernard Scale*’ (Fig. 6). The street is shown as developed with No. 18 in place. The plots on Moore Street stretched back to what is now Moore Lane, then called ‘Old Brick Field Lane’, named after the ‘Old Brick Field’ shown on the earlier 1757 Rocque Map.

Fig. 6: Extract from 1773 Map '*An Accurate Survey of the City and Suburbs of Dublin by Mr John Rocque with Additions and Improvements by Mr. Bernard Scale*'. The street is shown as developed with Nos. 10-25 in place. No. 18 is shown sharing a small closet return with No. 17. Stable structures to rear lane are shown in black hatching.

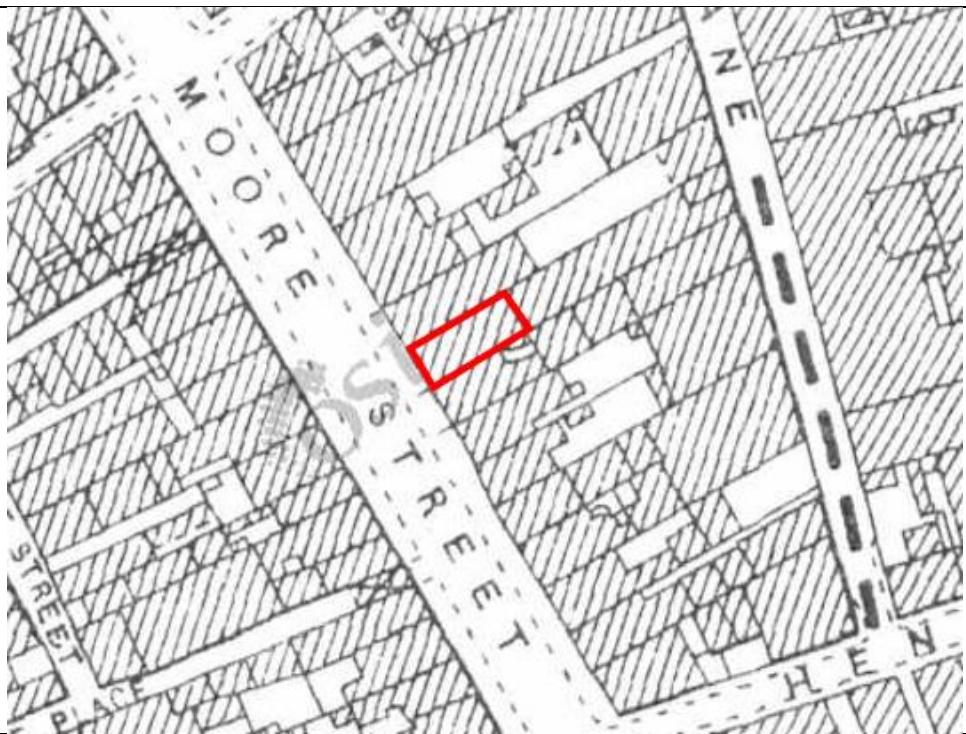
Fig. 7: Extract from the 1907 OS 25 inch map showing the location of 18 Moore Street. The site is shown completely covered by buildings.
