RE: Amended Review of the Architectural Heritage Assessment of 18 Moore Street, Dublin 1, dated 21 March 2022, with reference to the motion brought forward from the Planning and Urban Form SPC meeting of September 2021 for the addition of the façade of 18 Moore Street to the Record of Protected Structures, as agreed at the monthly meeting of the City Council on 7 November 2022.

Amended Review of the Architectural Heritage Assessment of 18 Moore Street, Dublin 1

Architectural Heritage Assessment of **18 Moore Street, Dublin 1**, in relation to the City Council Motion to add the terrace at 10-25 Moore Street to the Record of Protected Structures

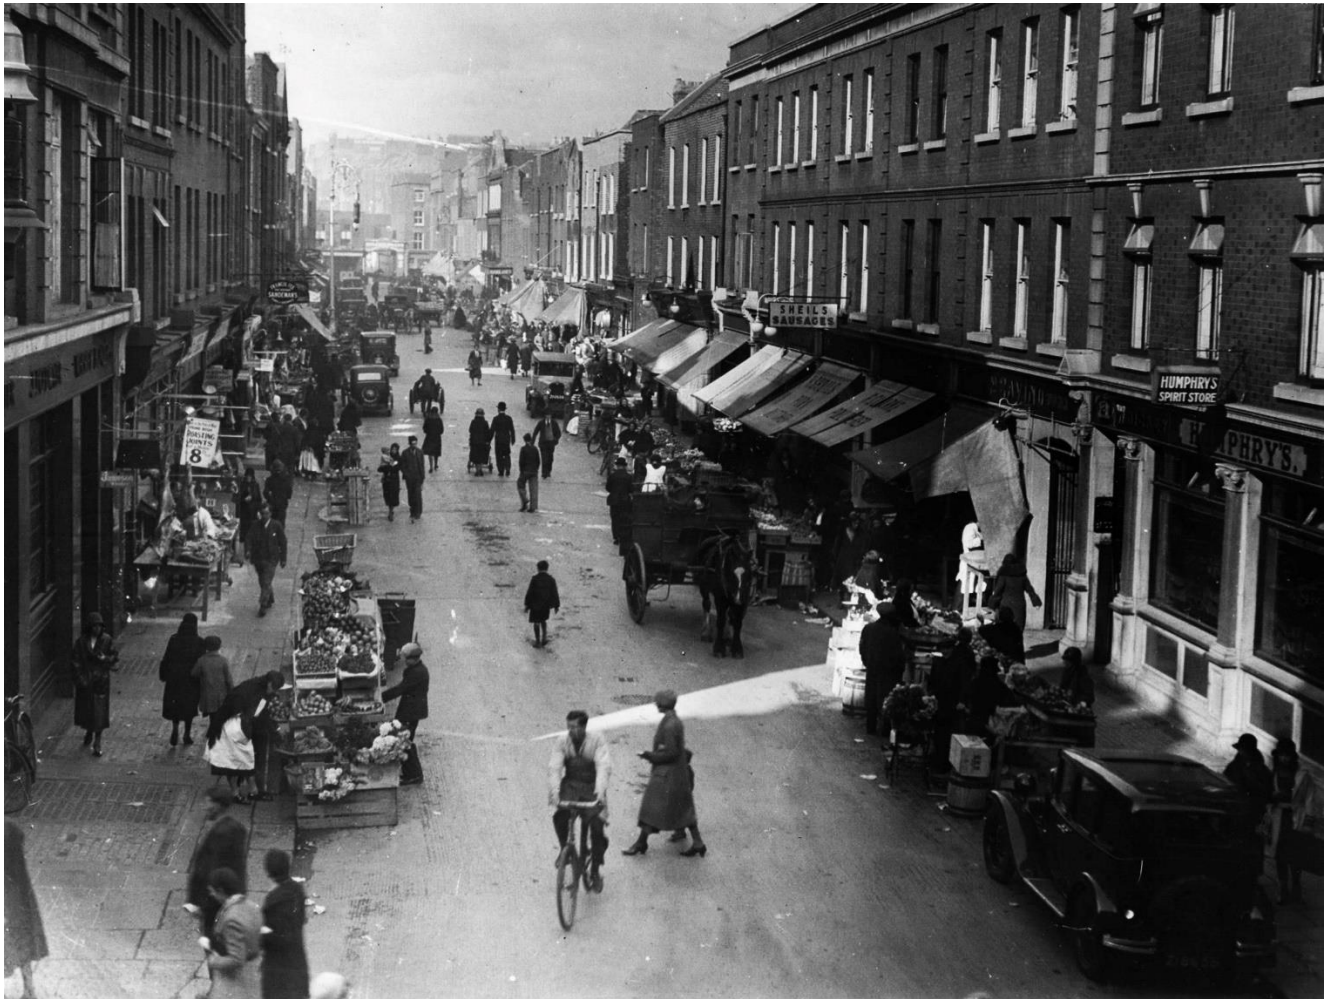
Photograph Moore Street, 1930

The point at which the height of the building was reduced can be established as happening sometime between 1930 and 1950. Photographic evidence from a picture taken in 1930 shows damage and a collapsed wall at second floor level to no. 18 Moore Street.

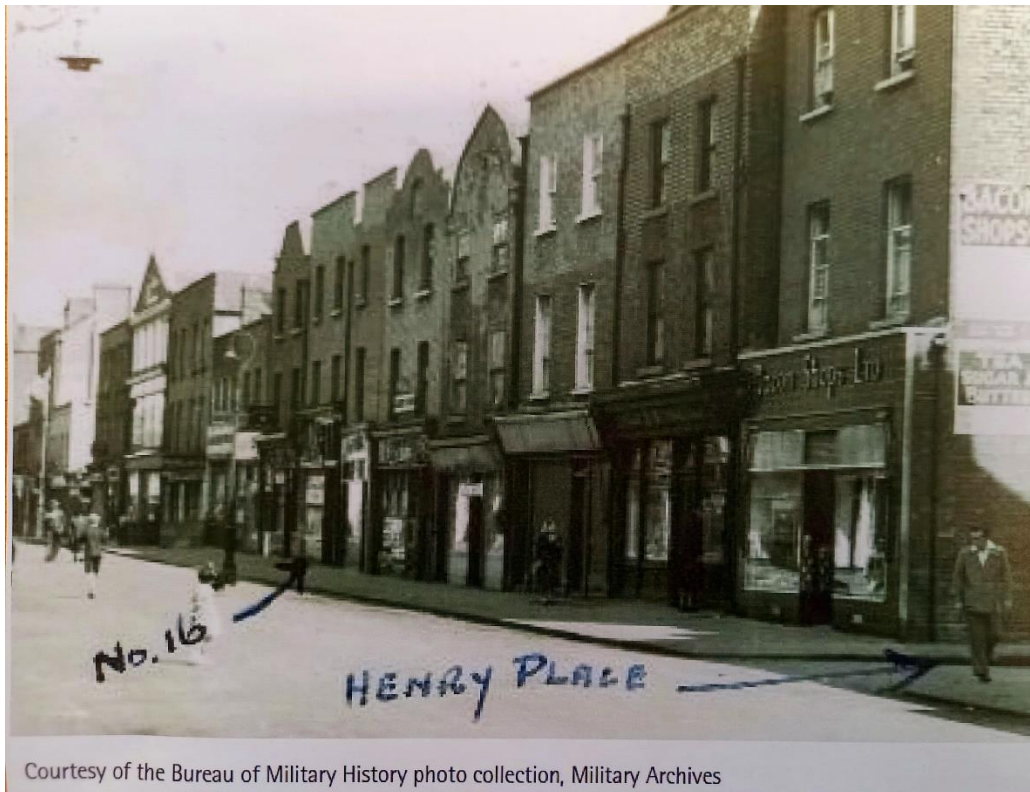
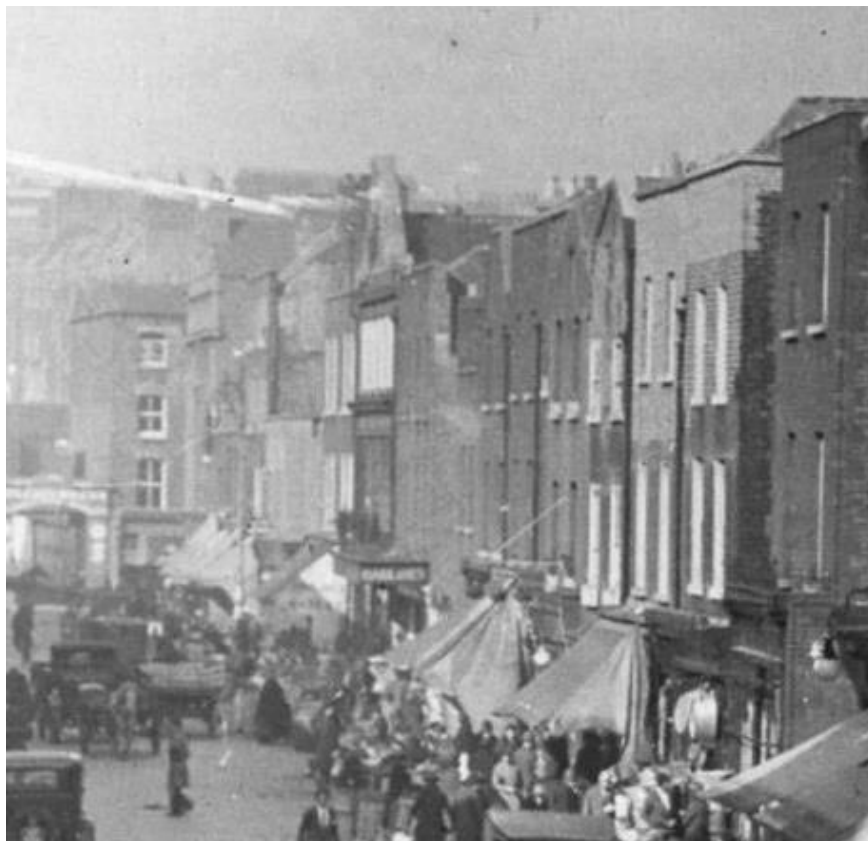
Moore Street 1950s, Bureau of Military History (low-res copy) top
Cropped Enlargement from Photograph of Moore Street, 1930 below

It is somewhat unclear, but what seems to be referred to as the damage to 18 Moore Street (see Appendix 2, Photo 02 further above), may be interpreted as the side of the three storey front facade of No. 20, exposed by the lower height of 19 Moore Street. See also the 1950s photograph of Nos. 10-25 Moore Street by the Bureau of Military History (below).
