Addition of 'Two surviving sections of historic brick and calp boundary wall (Remains of walled garden associated with the former Marino Demesne), Saint Vincent's GAA Club, Pairc Naomh Uinsionn, Malahide Road, Dublin 3', to the Record of Protected Structures in accordance with Section 54 and 55 of the Planning and Development Act, 2000 (as amended).

Procedure Followed

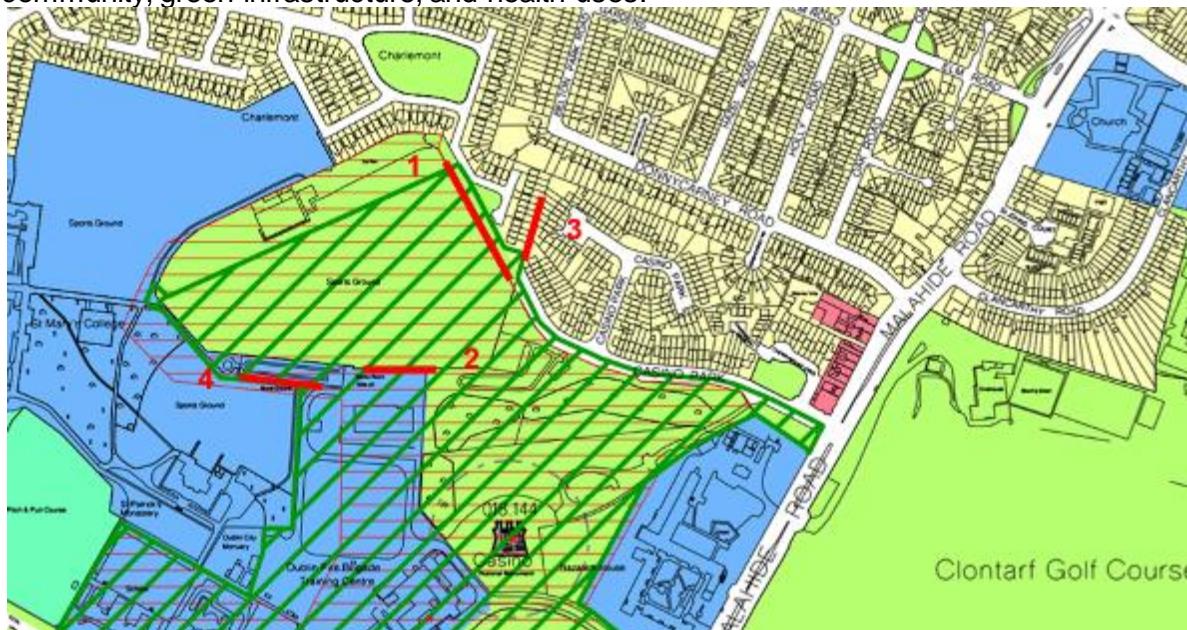
Fig.1: Site location and zoning map for historic boundary walls. The four sections of surviving historic boundary wall are highlighted in solid red line on the zoning map above.

The 2009 document describes four intact sections of walls (see Fig 1: zoning map above and Fig. 2 below for locations of walls). These four sections of wall were assessed.

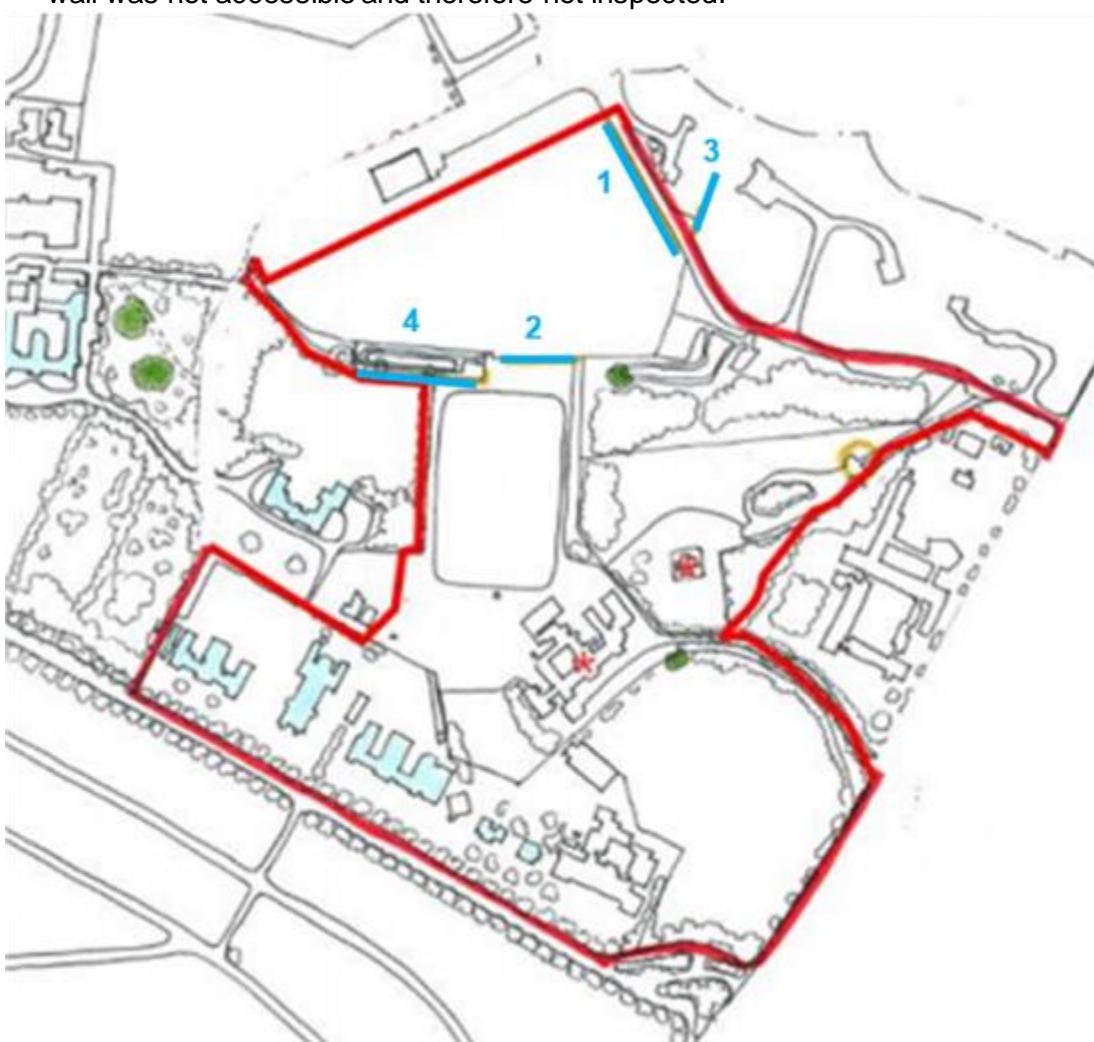
Fig.2: Map showing boundary of the Casino, Marino ACA in red. The location of the surviving four sections of former demesne wall are shown in blue.

The extent of the proposed Protected Structure status and curtilage is outlined in Fig.2 of this document (below).

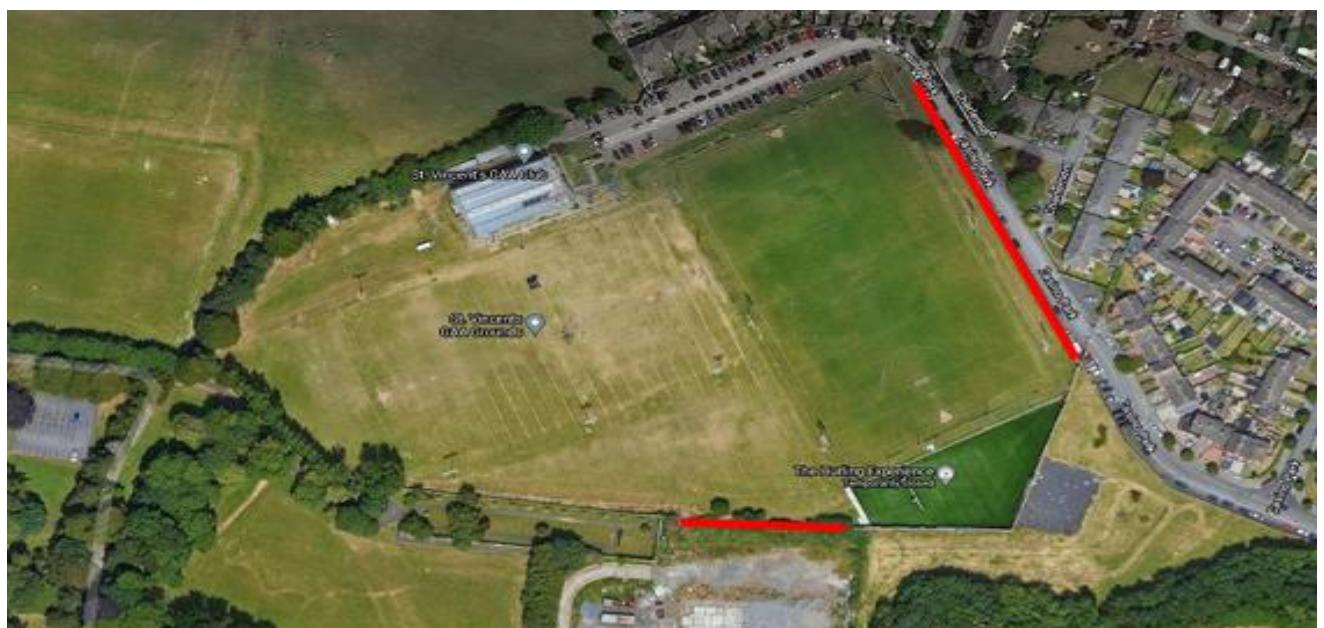
Fig.6: Aerial Photograph showing location of walls to be added to RPS

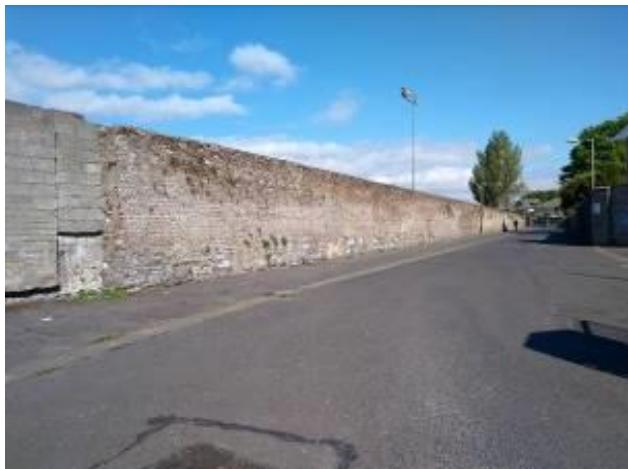
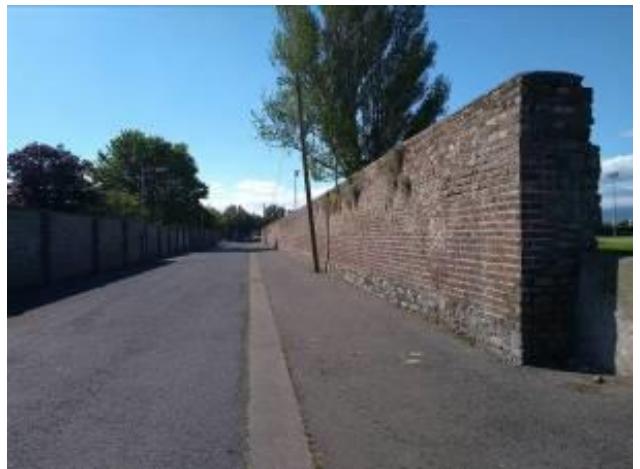
**Wall 1: Views of northeast section of wall running alongside entrance lane to club.
This section is the longest surviving section.**

- Wall 1: The site inspection confirmed that the most intact section of wall was a long section of wall located to the north-eastern side of the GAA grounds. This first section of wall running northwest-southeast is the most visible and despite some inappropriate repairs survives largely intact. This wall has been subject to a number of patch repairs with concrete blocks and has been repointed with a modern cement based mortar in places. The wall is calp limestone with brick facing having a calp limestone base. The historic bricks are quite weathered but are relatively intact apart from a small number of areas of damage. The original lime mortar joint is visible in a number of locations with a penny struck finish.

View of north side of wall running alongside entrance lane to club

It is proposed to add the two most intact and visible sections of wall to the Record of Protected Structures (Wall no. 1 & 2). Wall 3 is not considered to meet the criteria as only a short section is visible to the public, the rest is located in the back gardens of modest houses in the Casino Park and Charlemont estates. There are sheds built up against it and it is difficult to ascertain the condition and intactness of the wall. Wall 4 is located in lands belonging to the Marino Institute of Education. The north face of this wall was visible from the GAA club and it is rendered with a hard cement based pebbledash. The southern face of the wall was not accessible. Based on the information available it is not considered to meet the criteria for addition. The opportunity will be taken to assess Wall 4 at a later date.

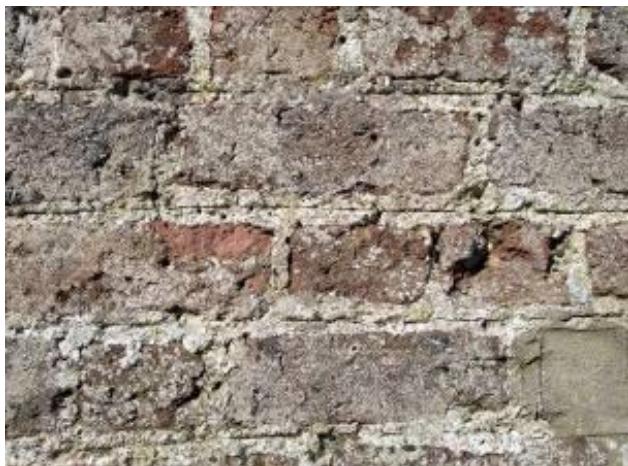
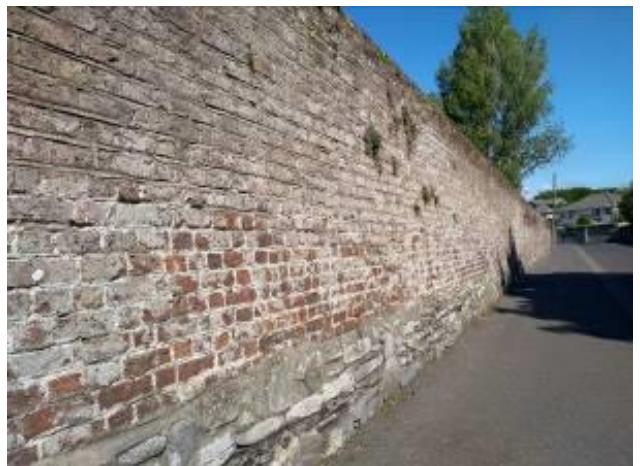
Note surviving penny struck lime mortar joint.

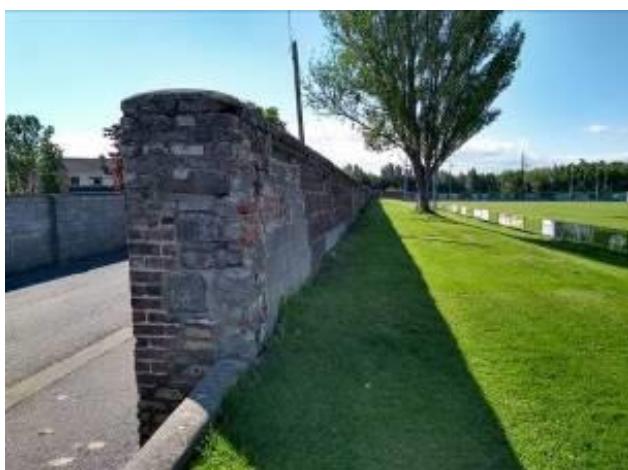
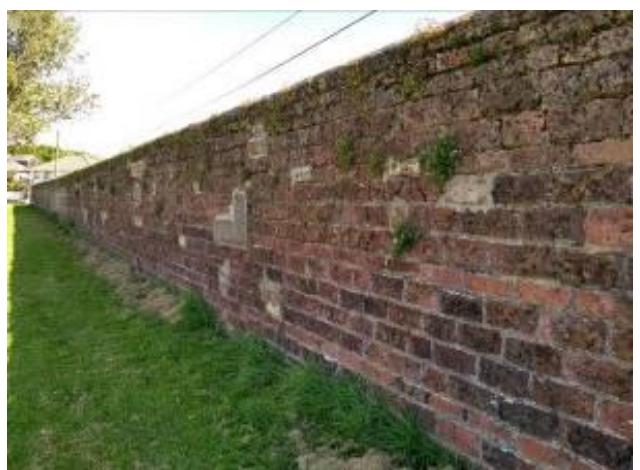
View of south side of wall

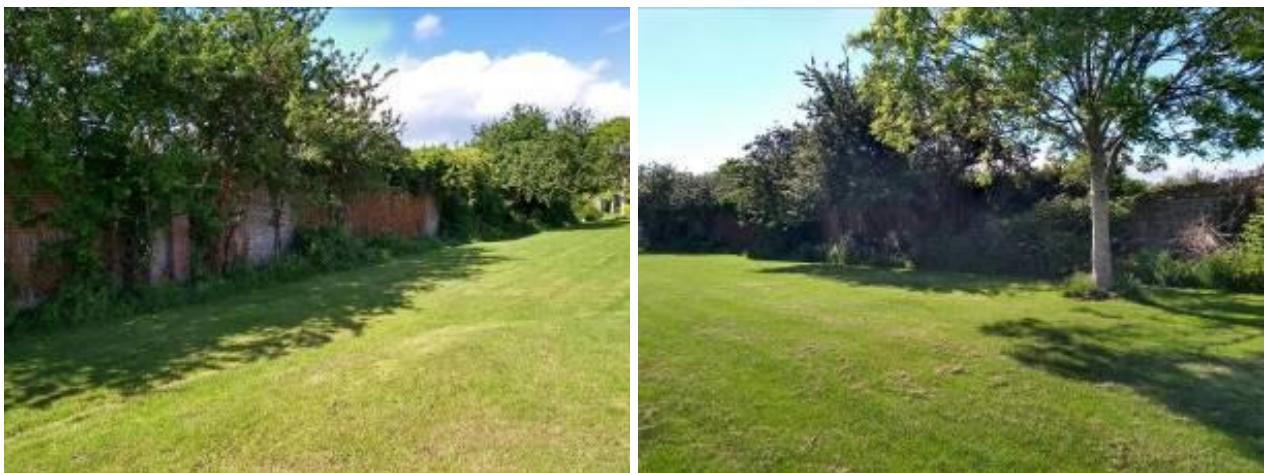
Wall 2: Views of surviving section of wall to south of St. Vincent's Club.

- Wall 2: A further second section survives to the south and forms the boundary between the GAA grounds and lands belonging to Dublin City Council. This is the next longest and most intact section to survive. It is obscured in places by vegetation

but survives relatively intact. The face of the wall visible from the GAA pitch is weathered brick. The original lime mortar joint is visible in places.

Views of brick wall to south end of GAA club. The wall is heavily overgrown in places.

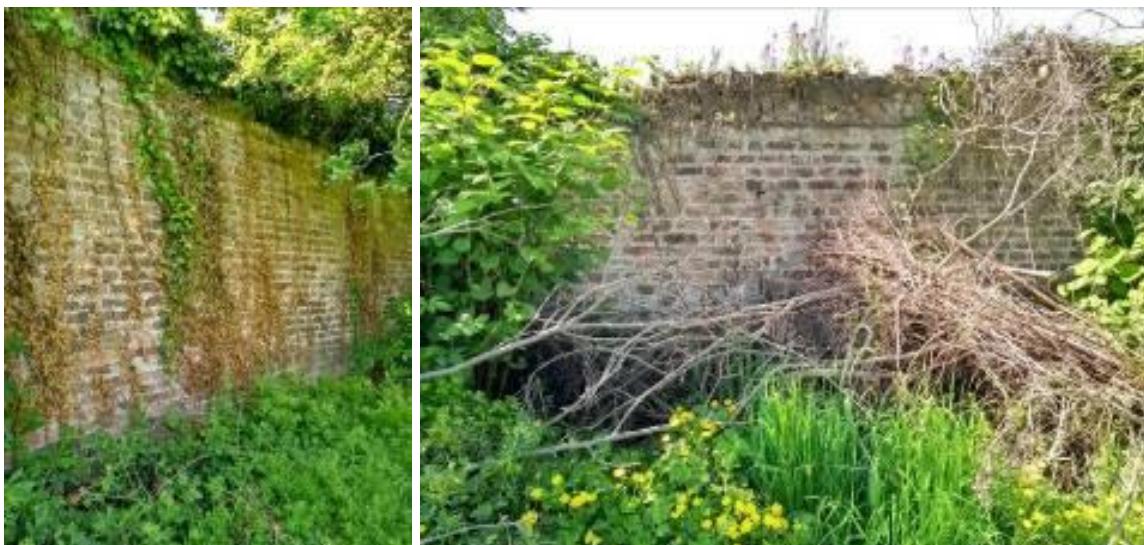
Weathered brick wall with original mortar joints visible.

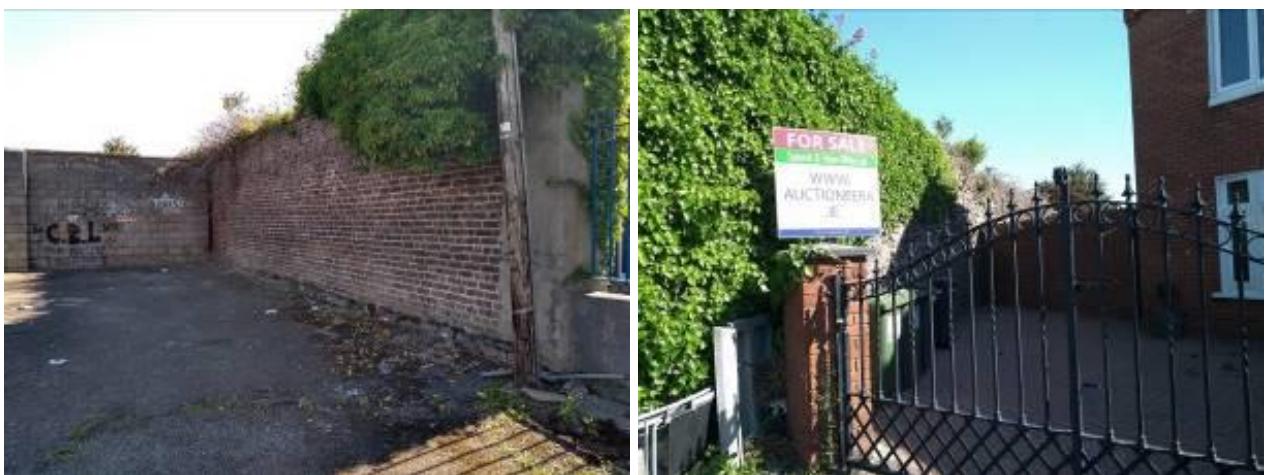
Wall 3: Views of section of wall to north of entranceway to St. Vincent's Club. Forms boundary between Charlemont and Casino Park modern housing estates

- Wall 3: A further third section is located to the north of this adjacent to the entrance gate to the GAA grounds and forms part of the boundary to 109 Casino Park. From a study of google earth it appears to continue further north and forms the rear garden boundary between Casino Park (6 houses) and Charlemont (8 houses). This wall appears to be brick on its western side and calp limestone on its eastern side. It is difficult to assess the condition and nature of this wall as it is located within the back gardens of private houses. From a study of aerial maps, a number of modern sheds are constructed against this historic boundary.

Former walled garden wall. Brick on western side and cap limestone on eastern side.

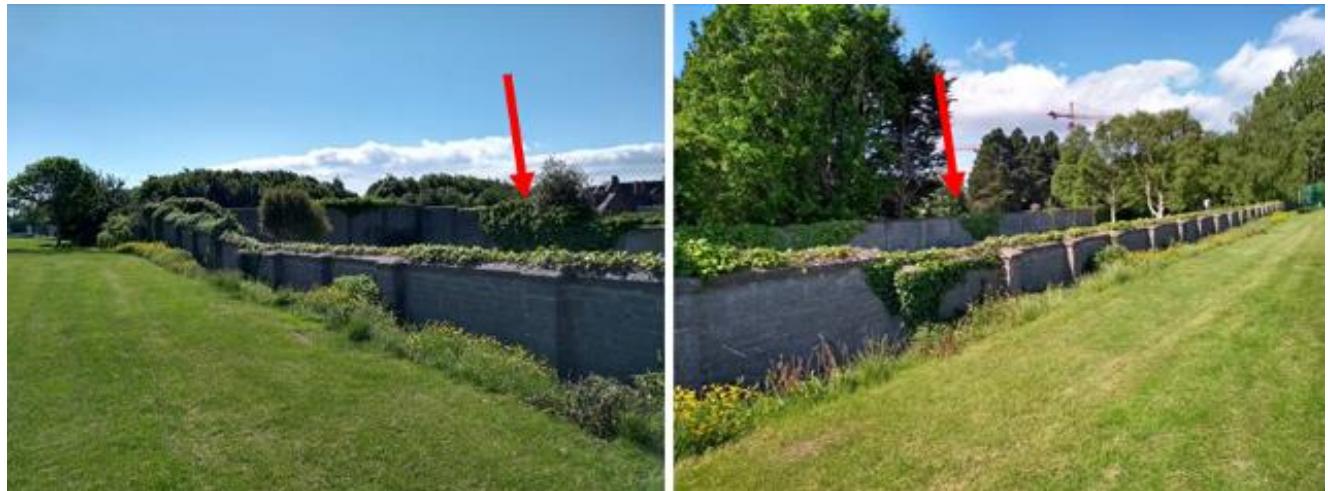
- Wall 4: The last and fourth section of historic demesne wall is located to the south between the graveyard of the Marino Institute of Education and lands belonging to that organisation. Only the north side is visible and is pebble-dashed with a hard cement mortar. From a study of aerial images, the south side of the wall appears to be largely un-rendered and appears to be historic in nature, however this section of wall was not accessible and therefore not inspected.

Wall 4: Views of surviving short section of wall to south of St. Vincent's Club. The north side of the wall are pebble dashed. According to the 2009 ACA report, this section of wall is of similar composition to the other upstanding sections. This wall forms the boundary between a graveyard and the Marino Institute of Education. This wall was not accessible.

Wall has a modern render of pebble dash. No historic fabric was visible.
